INSPECTION REPORT

End of contract

File	302821
License plate	2ACE368
Vehicle identification number	TMBJG7NX5MY111620
Dossier	2020293040
Make	Skoda Oct.Com.2.0TDI 85kW Ambi
Mileage	74987
First registration	16/02/2021
client availability date	23/02/2026
inspectionDate	09/03/2026

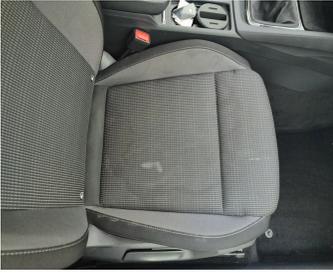
Damage within Renta-norm-scratch

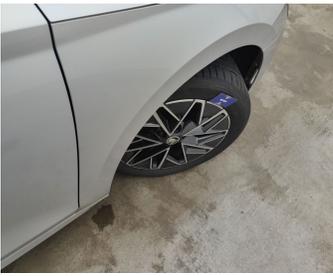
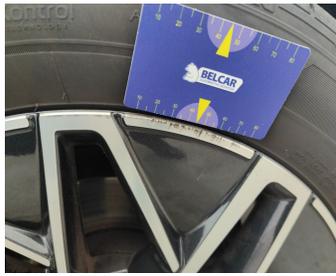
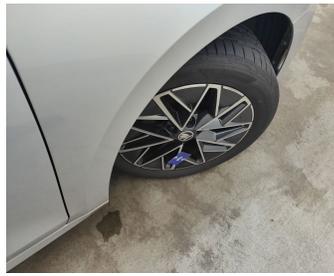
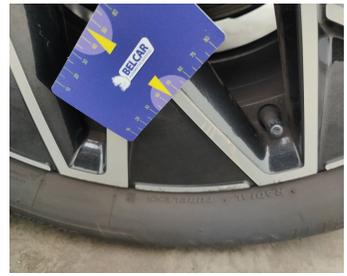
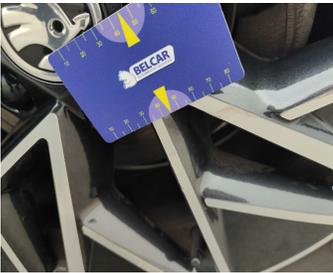
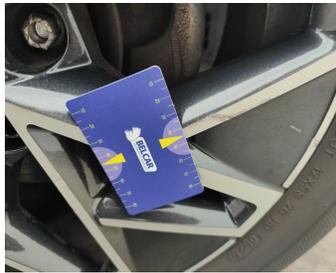
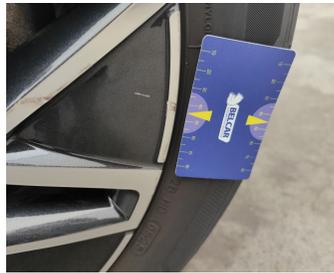
Wheel Two Tone Rear Right // Repair-scratch
