# INSPECTION REPORT

**End of contract**

| License plate | LW9983 |
| Make | Skoda Octav.Comb 1.5eTec 150 S |

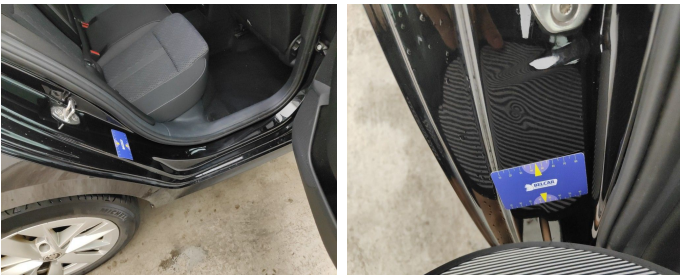
Rocker Panel Right // Smart Repair Medium-dent

| Damages | Type | Acceptable |
|---|---|---|
| 201 | Rocker Panel Right // Smart Repair Medium | Y |

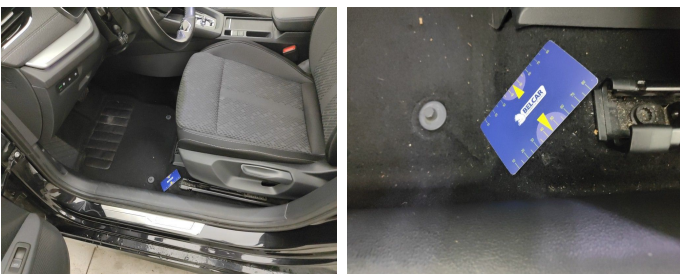
Interior // Repair 1-Incinerated

| Damages | Type | Acceptable |
|---|---|---|
| 540 | Interior // Repair 1 | N |

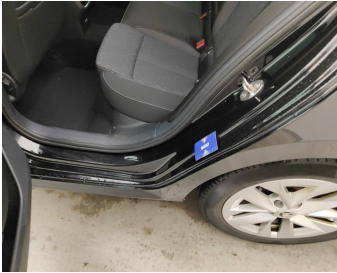
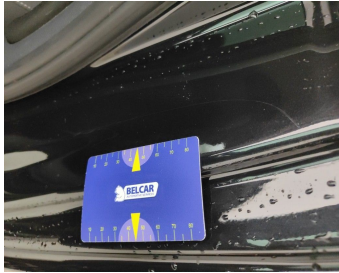
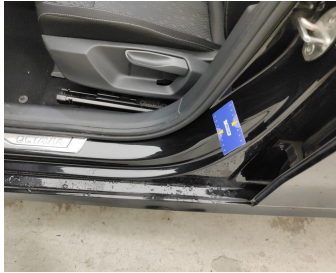
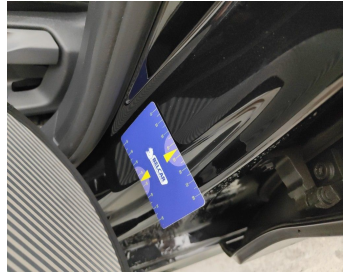
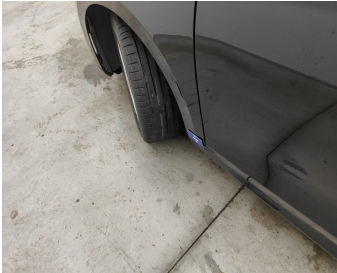
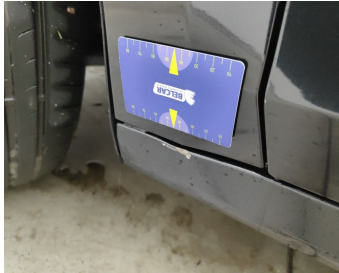
Rocker Panel Left // Repair & Painting-rust

| Damages | Type | Acceptable |
|---|---|---|
| 93 | Rocker Panel Left // Repair & Painting | N |

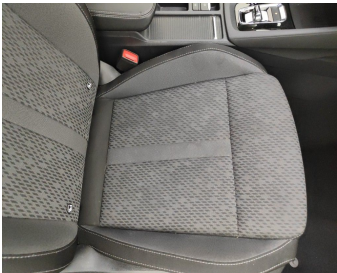
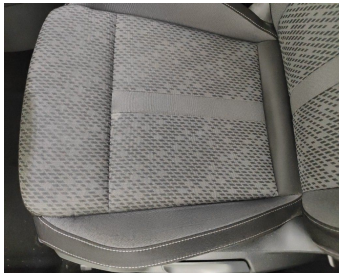
Interior Cleaning // Small-stain

| Damages | Type | Acceptable |
|---|---|---|
| 860 | Interior Cleaning // Small | Y |

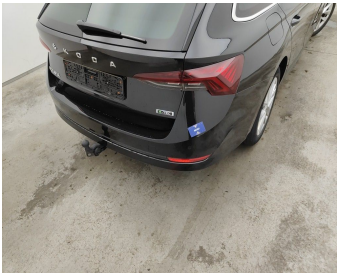
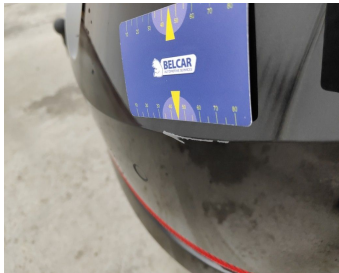
Bumper Rear // Painting-scratch

| Damages | Type | Acceptable |
|---|---|---|
| 133 | Bumper Rear // Painting | Y |

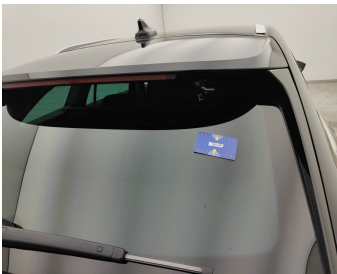
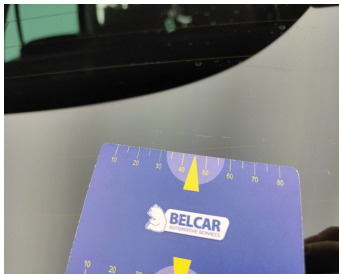
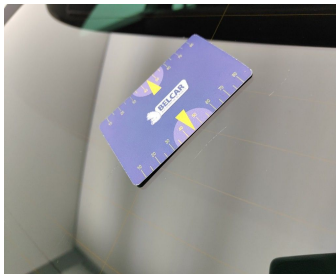
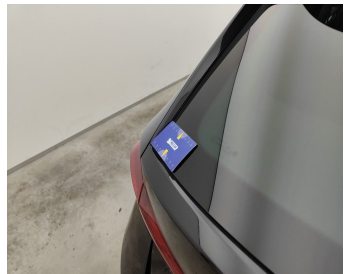
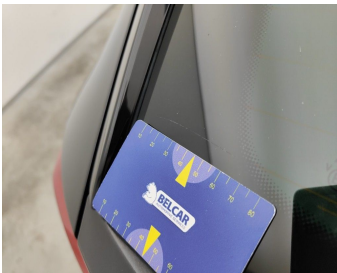
Rear Bonnet / Rear Window / Replace-scratch

| Damages | Type | Acceptable |
|---|---|---|
| 159 | Rear Bonnet / Rear Window / Replace | Y |

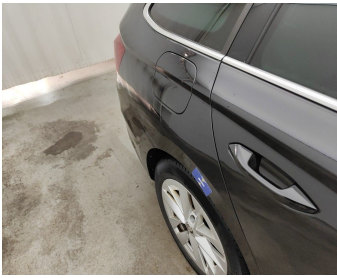
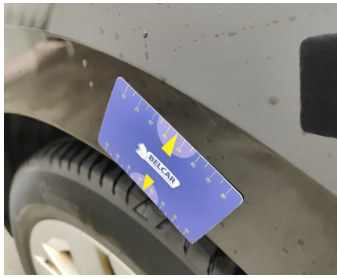
Wing Rear Right // Polish-scratch

| Damages | Type | Acceptable |
|---|---|---|
| 186 | Wing Rear Right // Polish | Y |

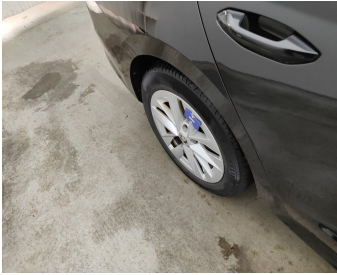
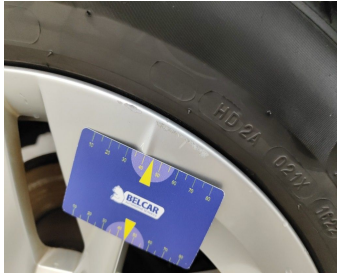
Wheel Alloy Rear Right // Repair-scratch

| Damages | Type | Acceptable |
|---|---|---|
| 331 | Wheel Alloy Rear Right // Repair | Y |

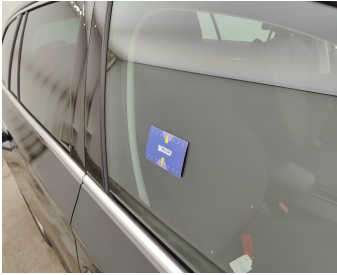
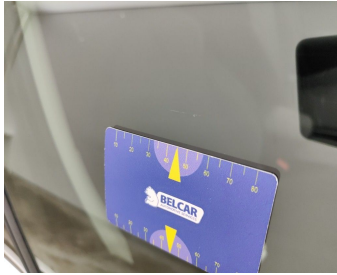
Door Front Right / Window / Replace-scratch

| Damages | Type | Acceptable |
|---|---|---|
| 219 | Door Front Right / Window / Replace | Y |

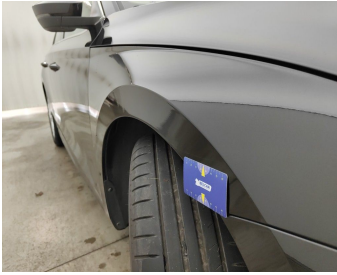
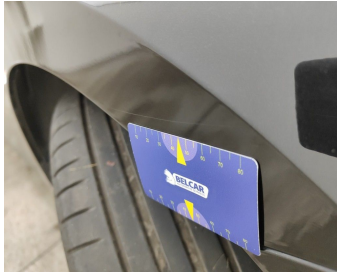
Wing Front right // Polish-scratch

| Damages | Type | Acceptable |
|---|---|---|
| 236 | Wing Front right // Polish | Y |

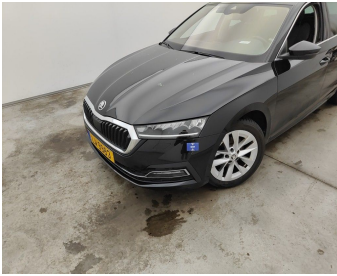
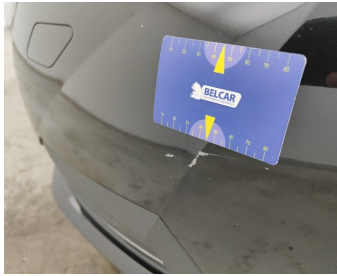
Bumper Front // Painting-scratch

| Damages | Type | Acceptable |
|---|---|---|
| 13 | Bumper Front // Painting | Y |

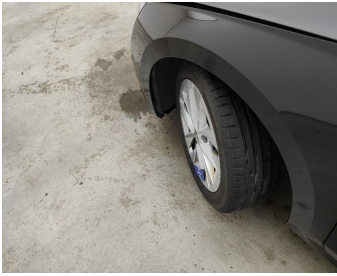
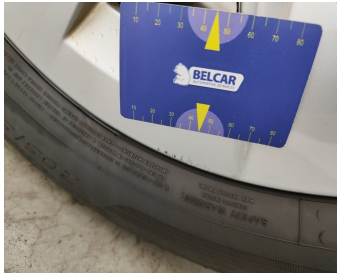
Wheel Alloy Front Left // Repair-scratch

| Damages | Type | Acceptable |
|---|---|---|
| 311 | Wheel Alloy Front Left // Repair | Y |

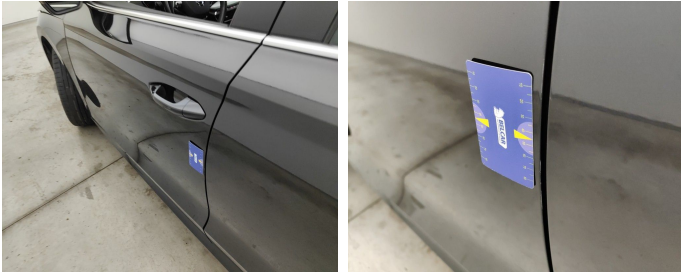
Door Front Left // Smart Repair Small-scratch

| Damages | Type | Acceptable |
|---|---|---|
| 80 | Door Front Left // Smart Repair Small | Y |

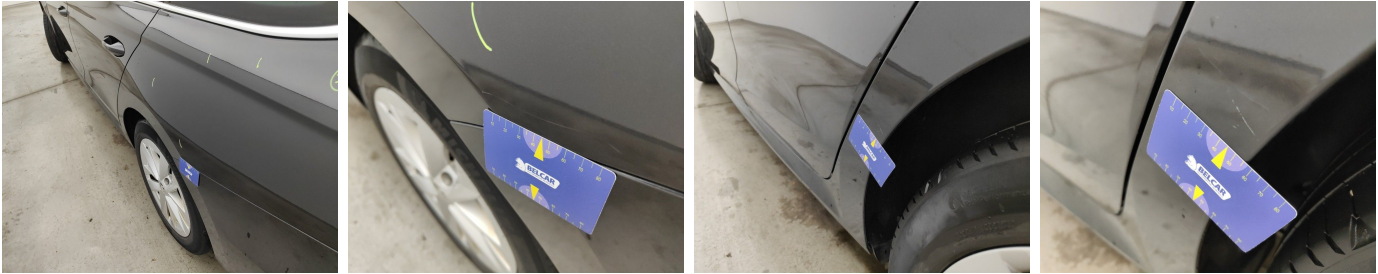
Wing Rear Left // Polish-scratch

| Damages | Type | Acceptable |
|---|---|---|
| 116 | Wing Rear Left // Polish | Y |

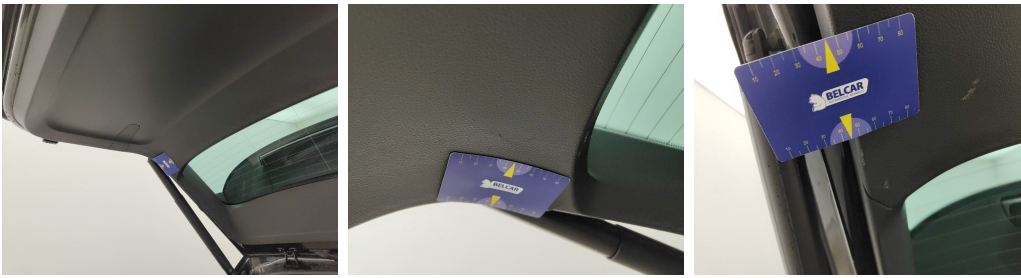
Trunk Lid Interior Coating / Complete Panel / Replace-scratch

| Damages | Type | Acceptable |
|---|---|---|
| 594 | Trunk Lid Interior Coating / Complete Panel / Replace | Y |

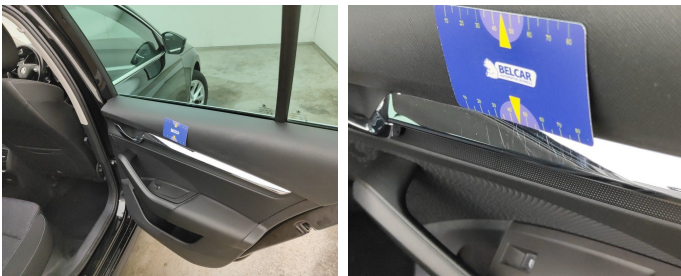
Rear Right Door Interior Coating // Repair-scratch

| Damages | Type | Acceptable |
|---|---|---|
| 641 | Rear Right Door Interior Coating // Repair | Y |

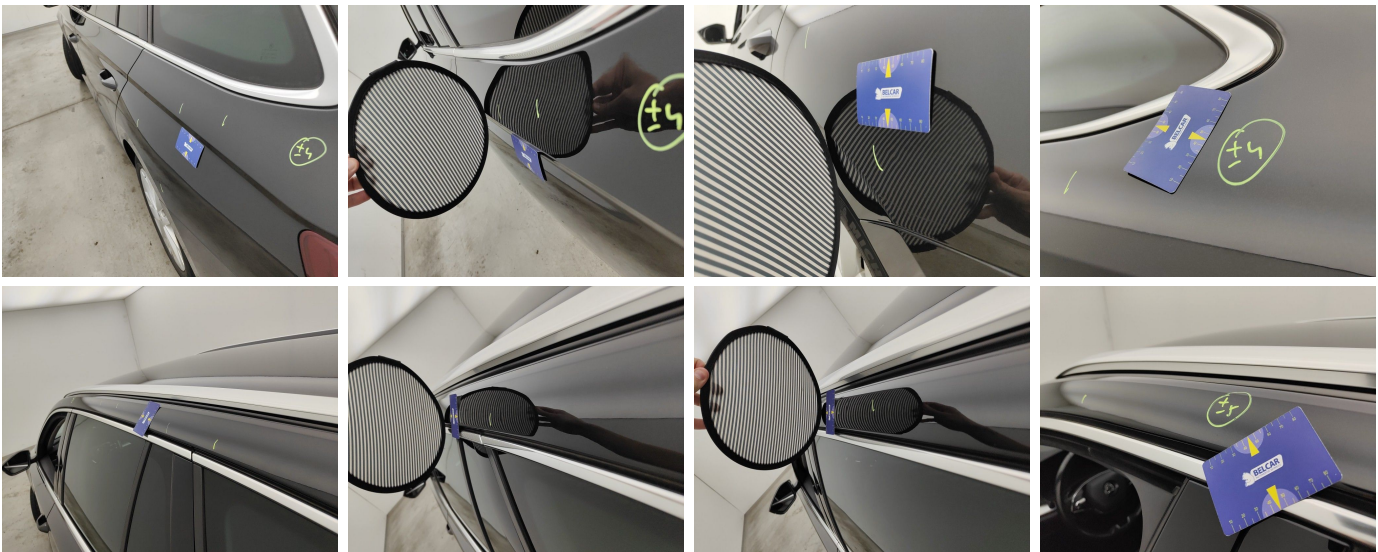
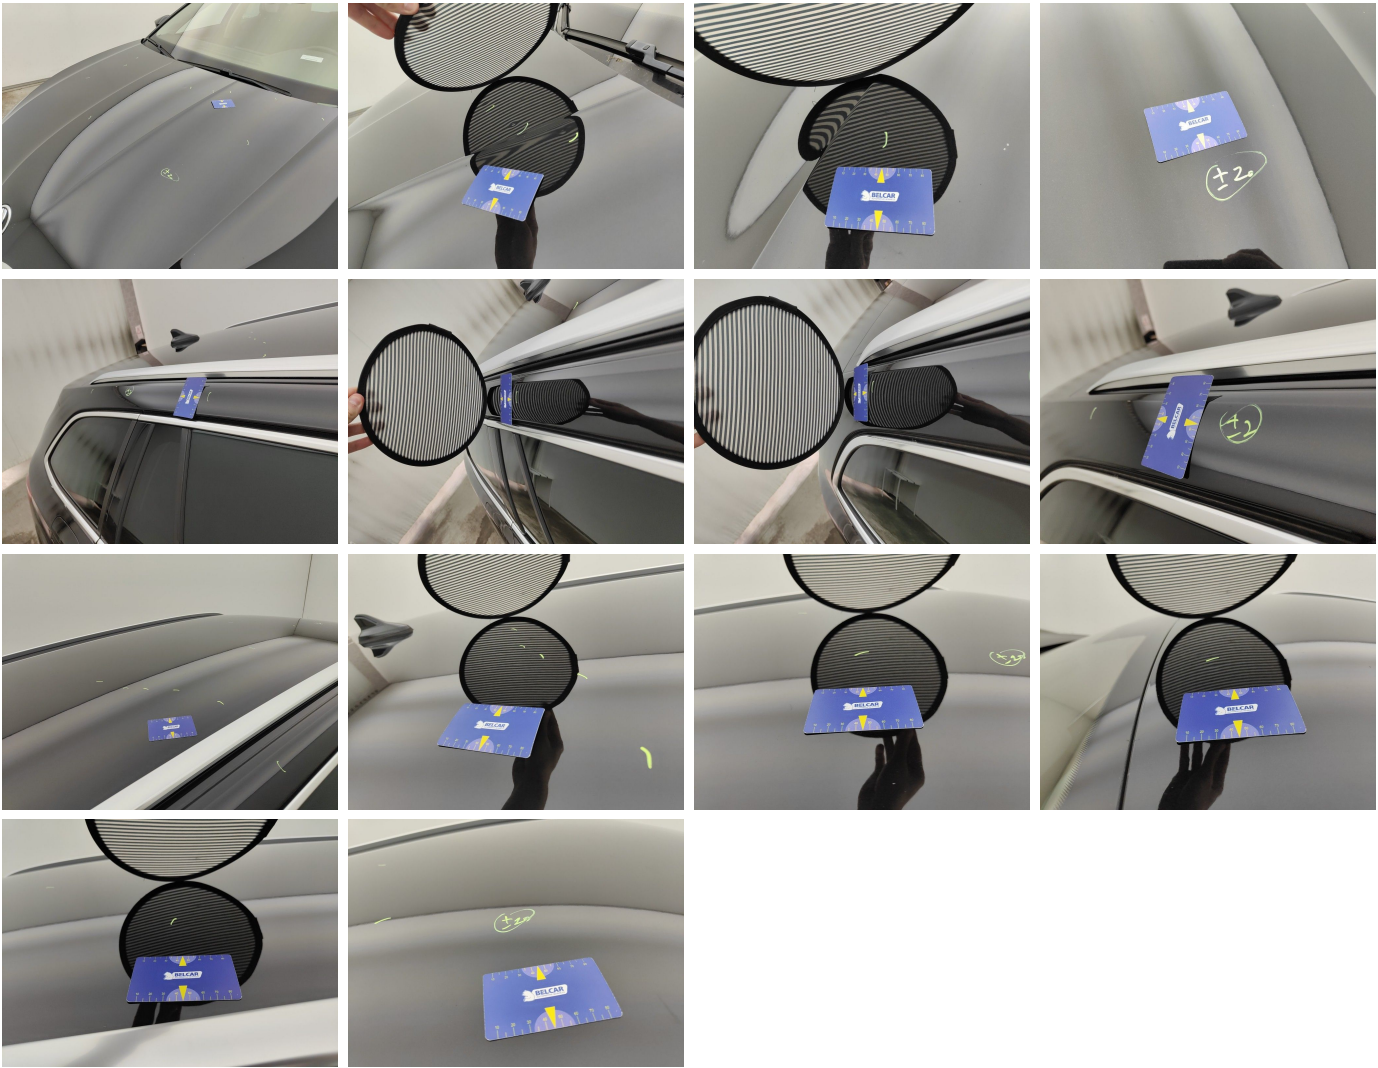
See External Expertise-dent
