# INSPECTION REPORT

End of contract

File	306688
License plate	2AAF024
Vehicle identification number	W1N2533111F915279
Dossier	2020 279 061
Make	Mercedes GLC Coupé 300de 4M
Mileage	72498
First registration	29/01/2021
client availability date	04/03/2026
inspectionDate	05/03/2026

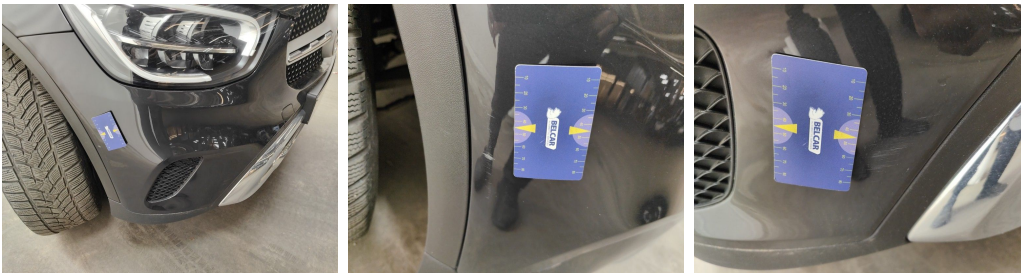
Bumper Front // Smart Repair Large-scratch

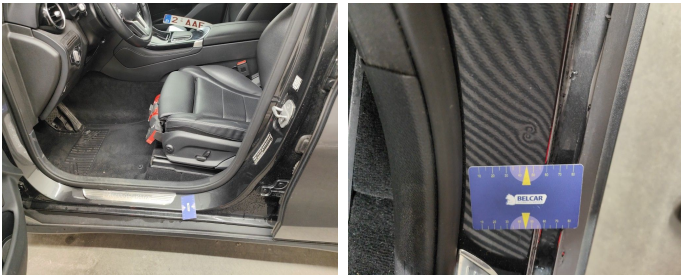
Rocker Panel Left // Smart Repair Medium-dent

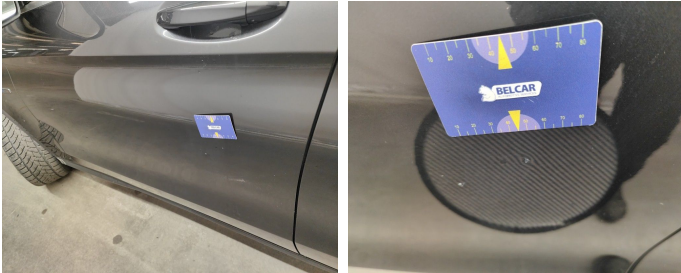
Door Front Left // Painting-scratch + dent

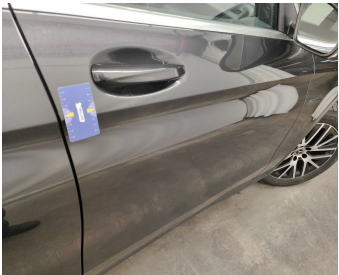
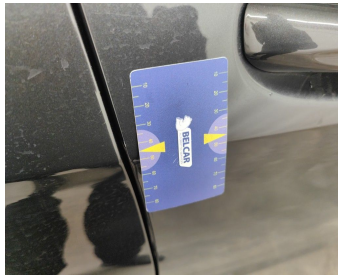
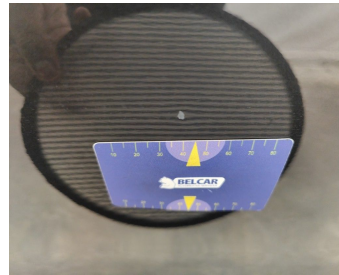
Door Front Right // Painting-scratch + dent

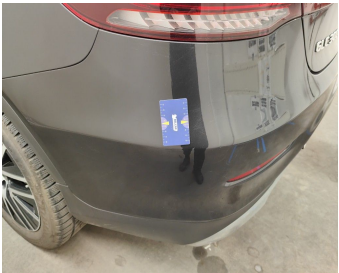
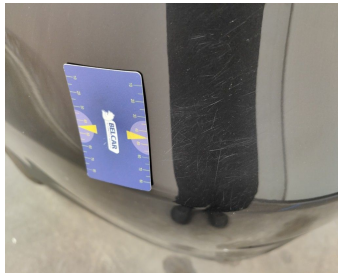
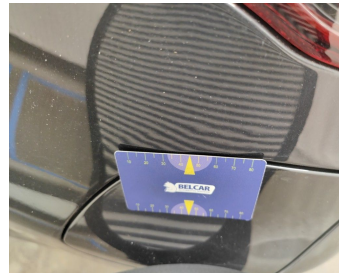
Bumper Rear // Painting-bad repair
