INSPECTION REPORT

End of contract

File	309869
License plate	TE6060
Vehicle identification number	W1NKJ0FB5RF095284
Dossier	2023122009
Make	Mercedes GLC Coupé 220d 197 4M
Mileage	65446
First registration	24/10/2023
client availability date	01/04/2026
inspectionDate	14/04/2026

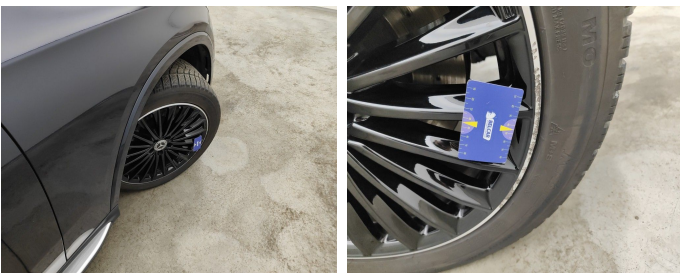
Wheel Two Tone Front Right // Repair-scratch

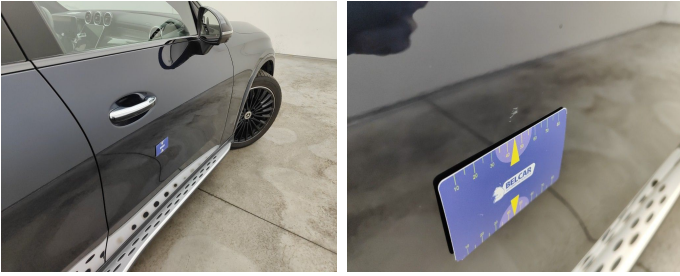
Door Front Right // Painting-scratch

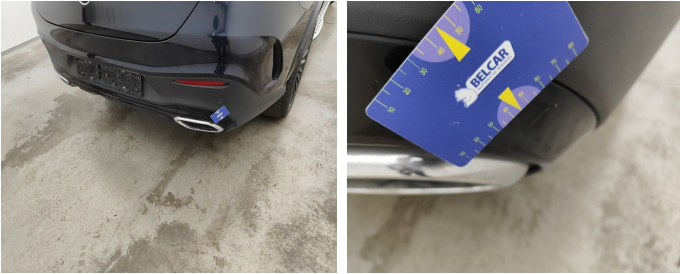
Bumper Rear / Trim Center / Replace-scratch

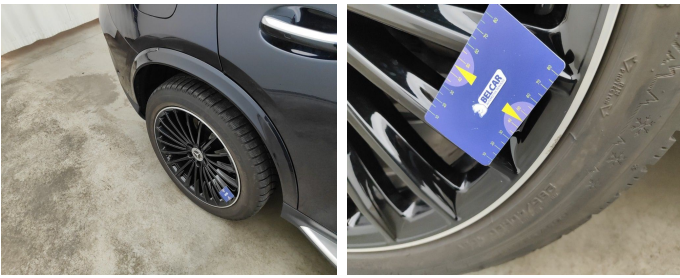
Wheel Two Tone Rear Right // Repair-scratch

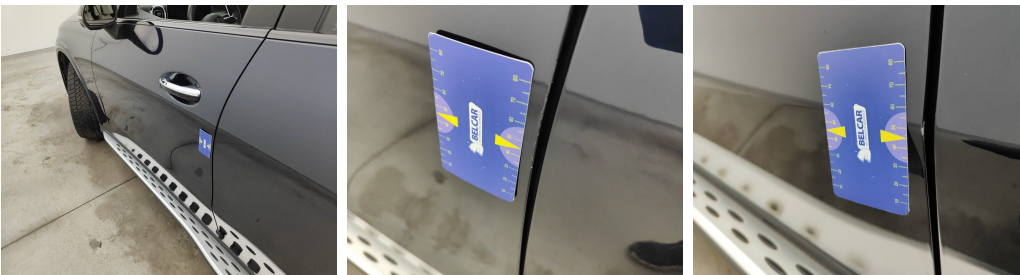
Door Front Left // Smart Repair Small-scratch

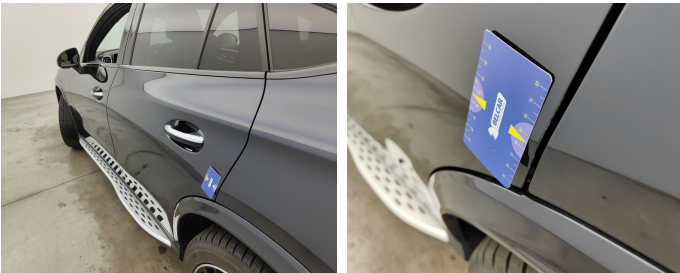
Door Rear Left // Smart Repair Small-scratch

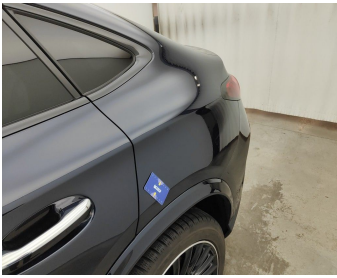
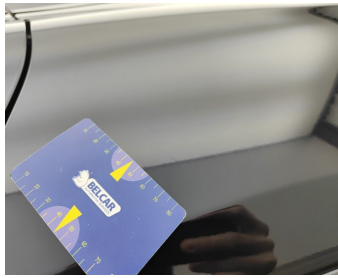
Wing Rear Left // Polish-scratch

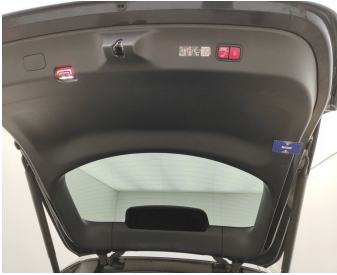
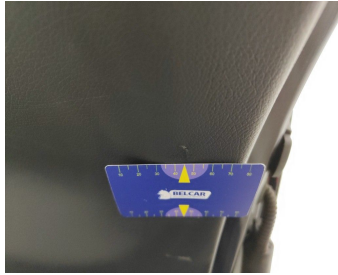
Trunk Lid Interior Coating / Complete Panel / Replace-scratch

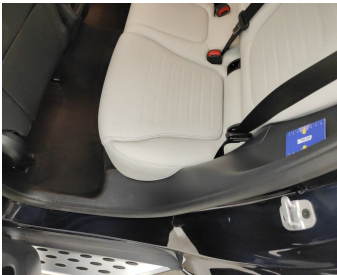
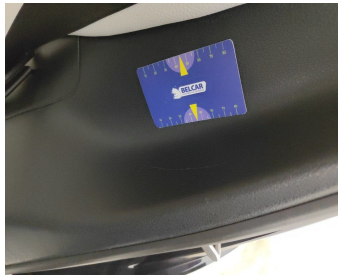
Seat Rear Left // Repair-scratch

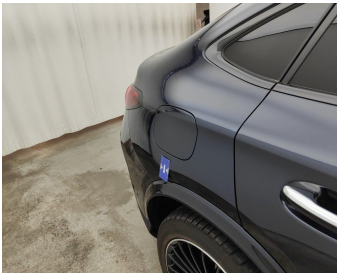
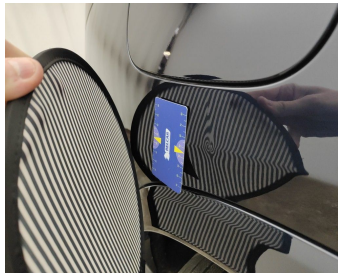
Wing Rear Right // Repair & Painting-dent

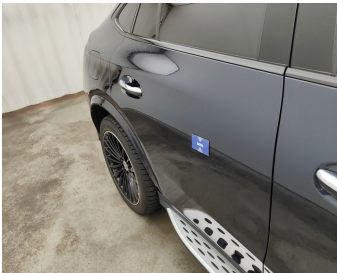
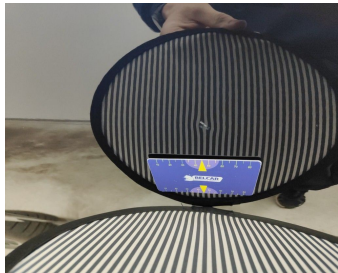
Door Rear Right // Repair & Painting-scratch + dent

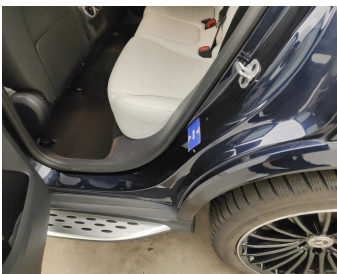
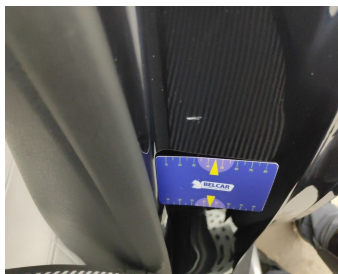
Rocker Panel Left // Smart Repair Medium-scratch + dent

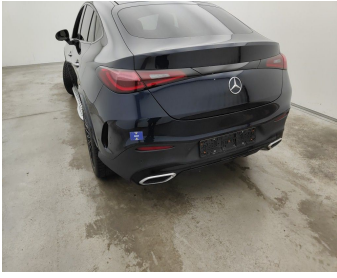
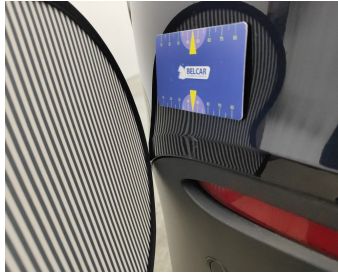
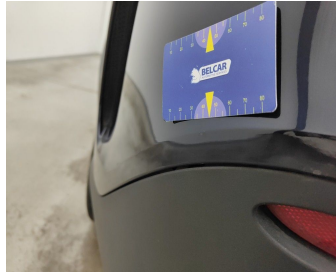
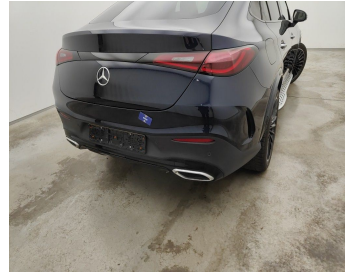
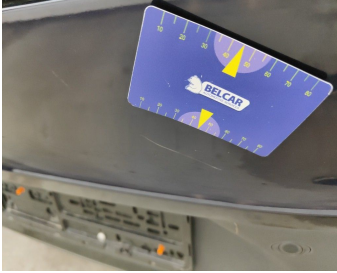
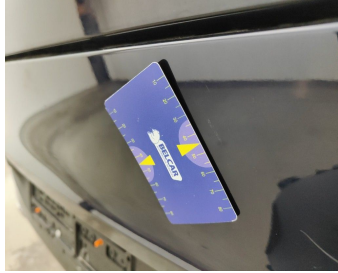
Bumper Rear // Repair & Painting-scratch + dent

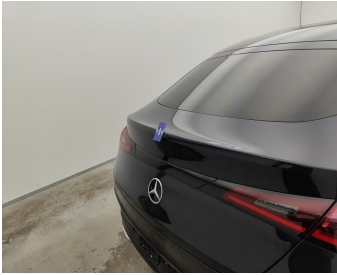
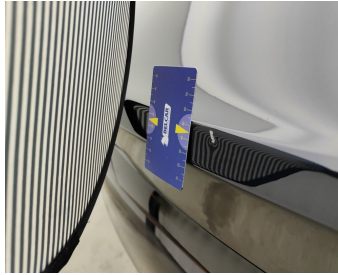
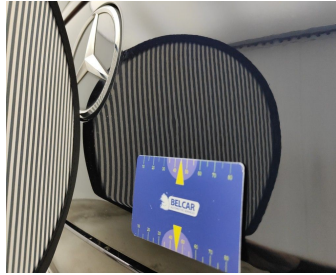
Rear Bonnet // Repair & Painting-scratch + dent

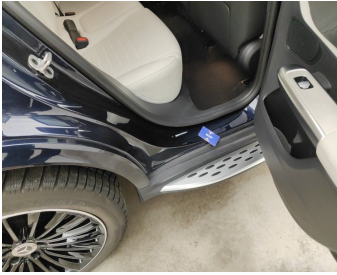
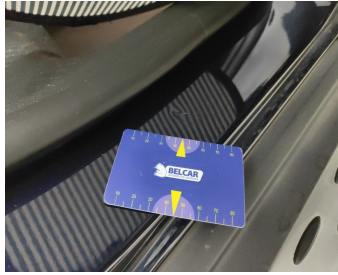
Rocker Panel Right // Smart Repair Medium-scratch + dent

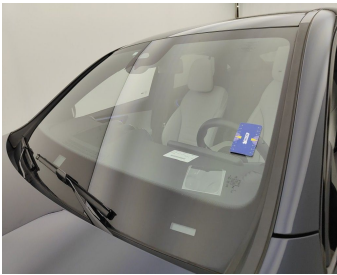
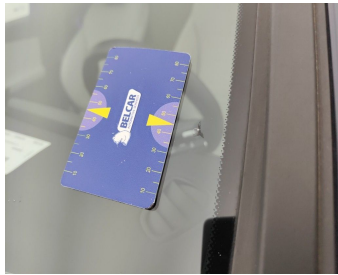
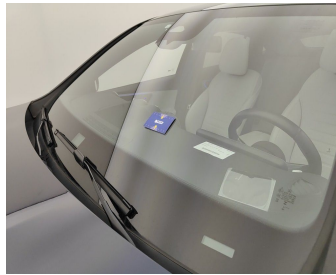
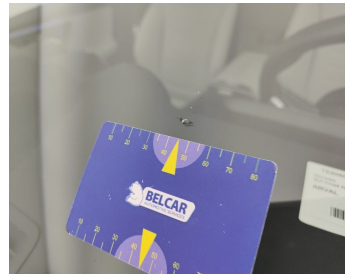
Windshield // Replace-cracked

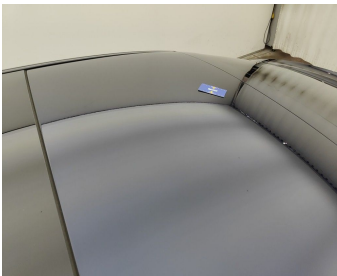
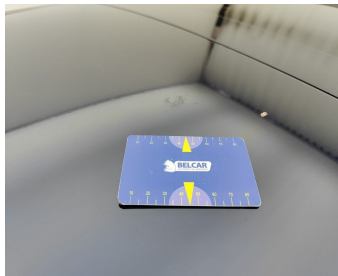
Roof // Painting-Chemical reaction

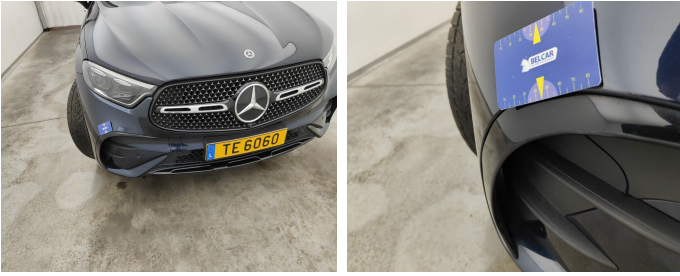
Bumper Front / Trim Right / Replace-scratch

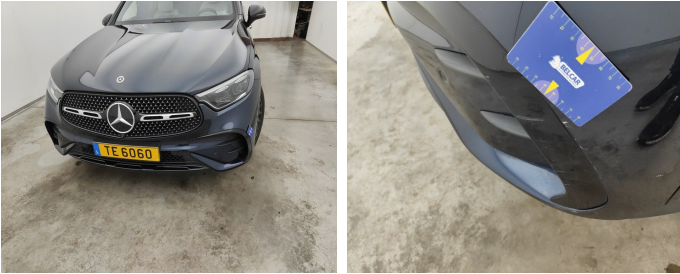
Bumper Front / Trim Left / Replace-scratch

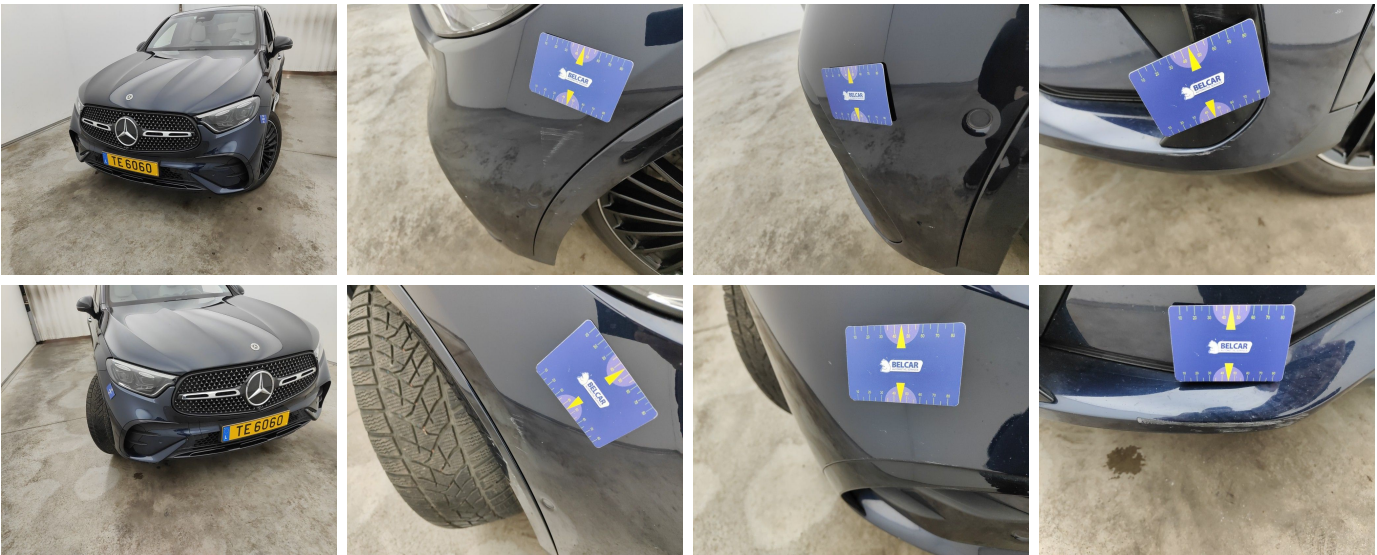
Bumper Front // Painting-scratch

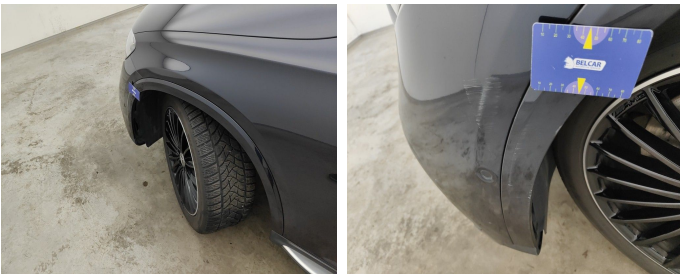
Wing Front Left / Trim / Replace-scratch

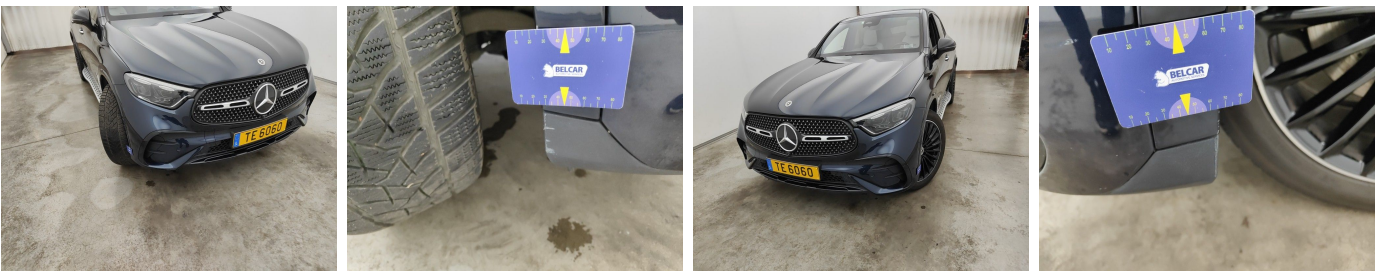
Bumper Front / Lower Cover Not Painted / Replace-scratch

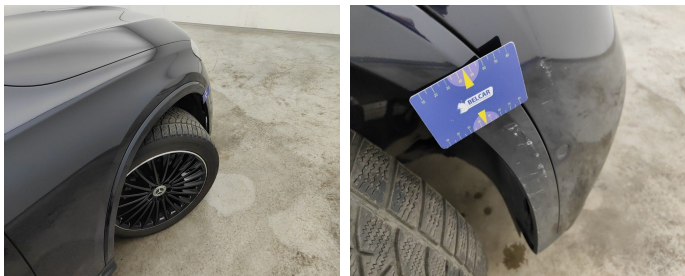
Wing Front right / Trim / Replace-scratch
