# INSPECTION REPORT

End of contract

| License plate | 1XPU514 |
| Make | Opel Viv.TD 90kW 31 L3H1 Edit. |

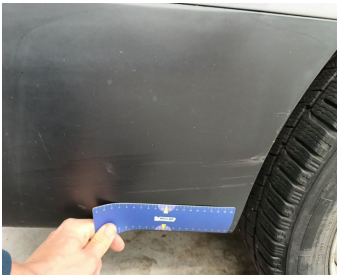
Bumper Rear // Replace without painting-scratch

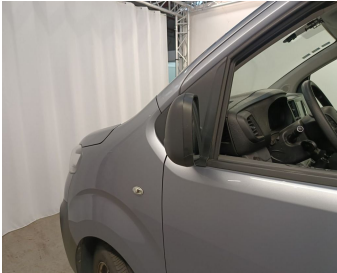
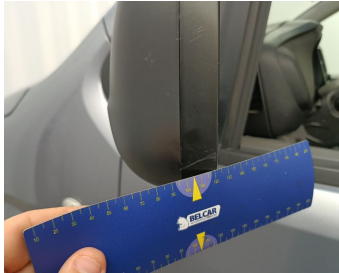
Side View Mirror Left / Shell / Replace Not Painted-scratch

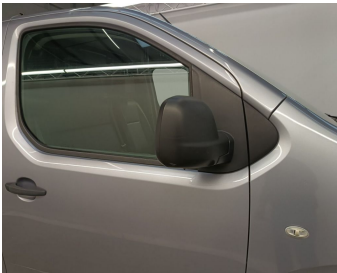
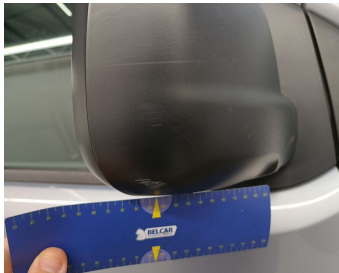
Side View Mirror Right / Shell / Replace Not Painted-scratch

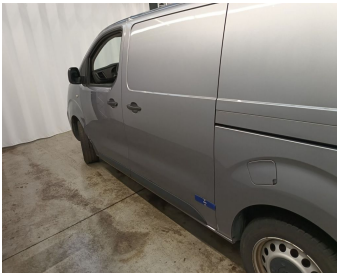
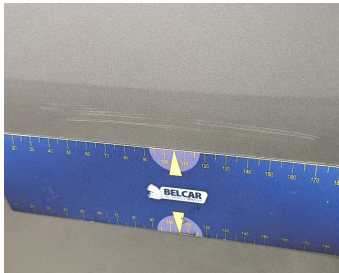
Door Rear Left // Polish-scratch

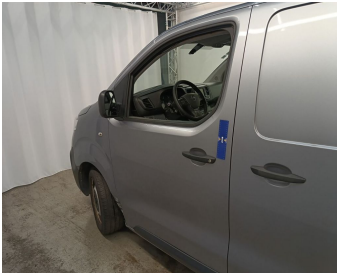
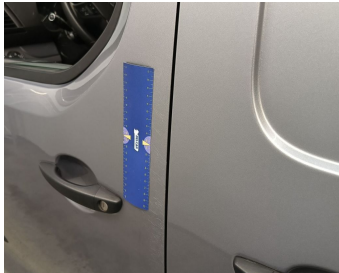
Door Front Left // Painting-scratch

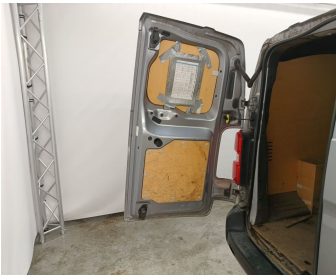
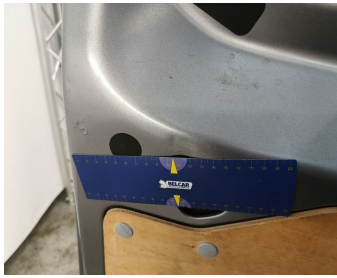
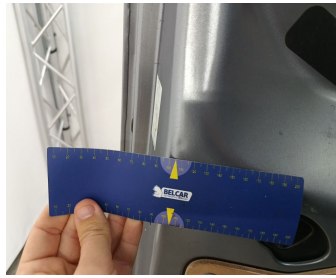
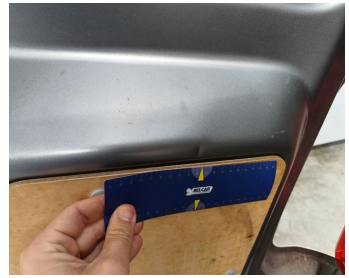
Rear Loading Door Left // Smart Repair Small-dent

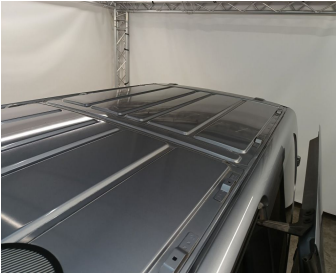
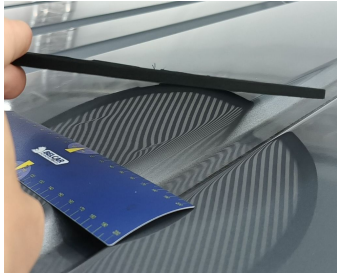
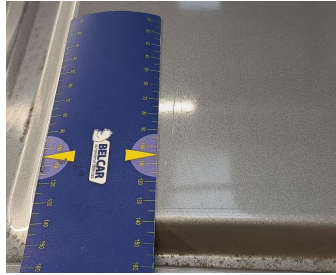
Roof // Repair & Painting-scratch + dent

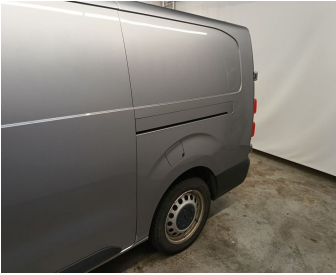
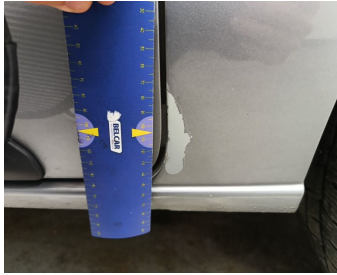
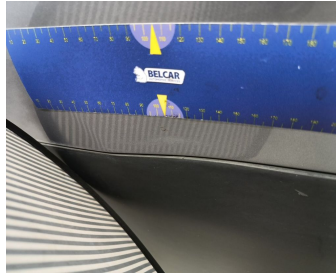
Wing Rear Left // Repair & Painting-bad repair

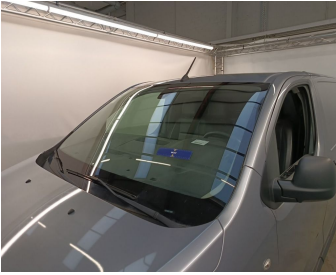
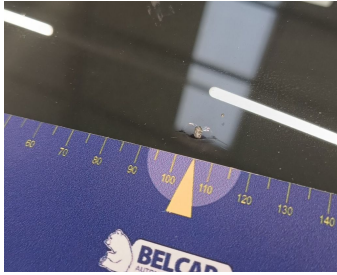
Windshield // Replace-cracked

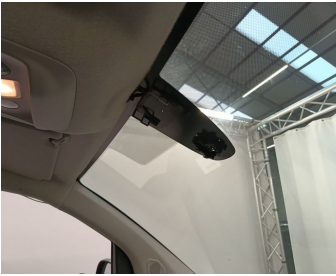
Windshield / Rear View Mirror / Replace-missing

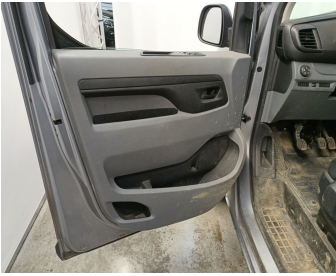
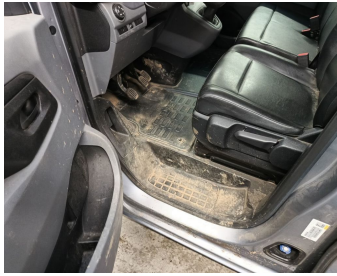
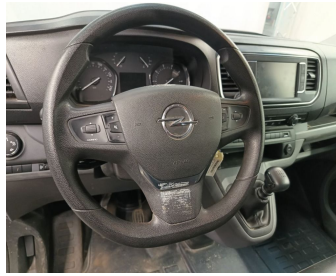
## Interior Cleaning // Small-dirty

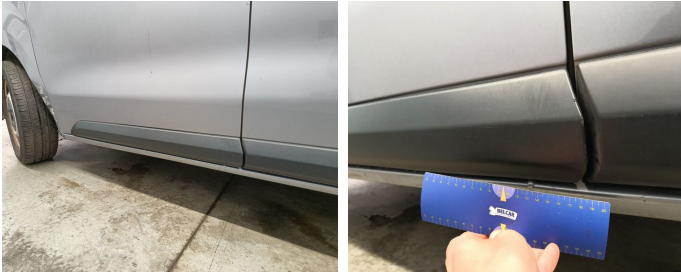
## Door Front Left / Trim / Replace-bad position

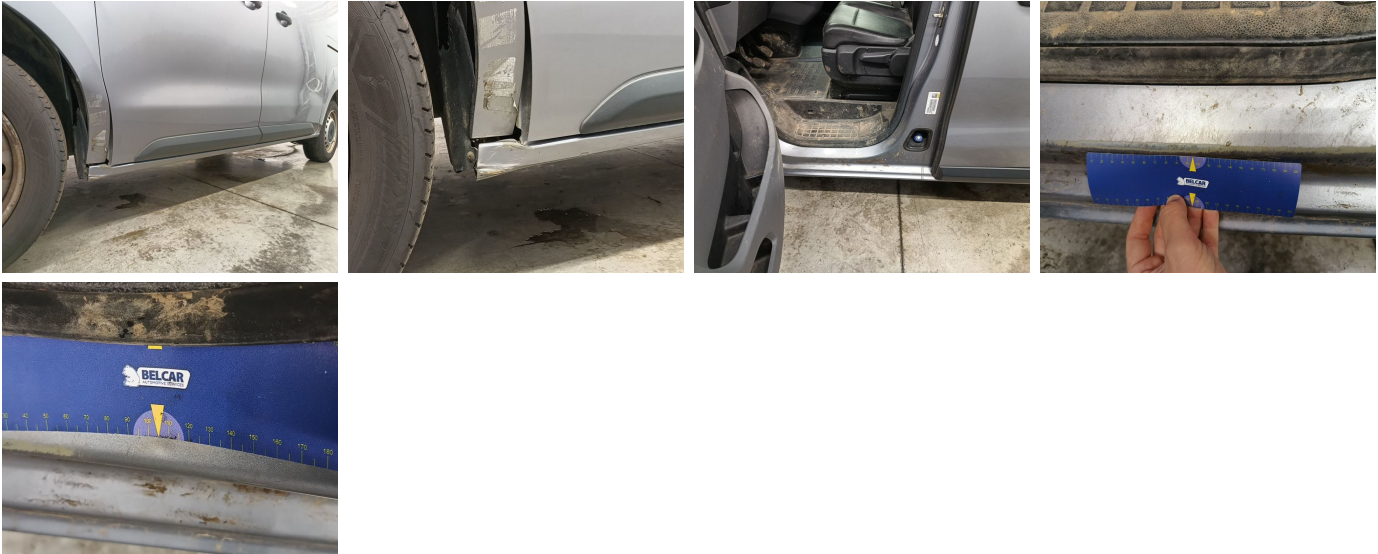
## Rocker Panel Left // Repair & Painting-scratch + dent

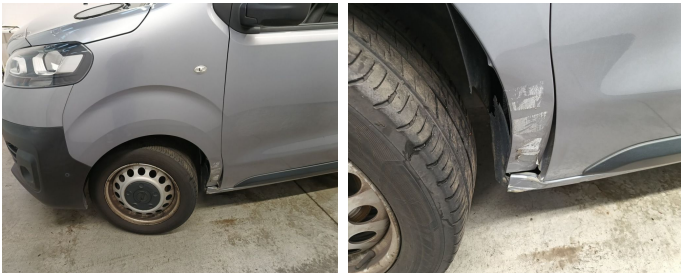
## Wing Front Left // Repair & Painting-scratch + dent

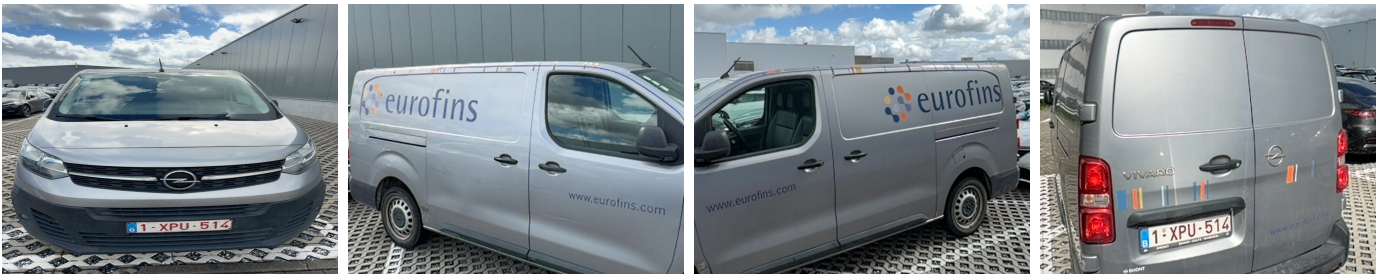
## Lettering Removal 15min-

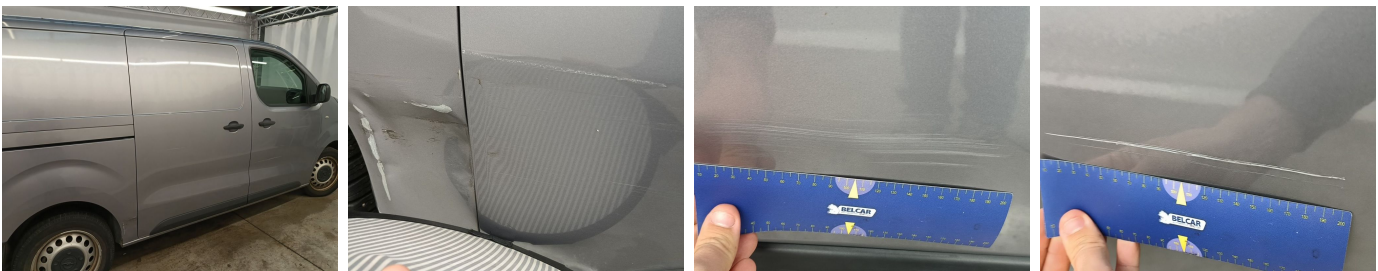
Door Rear Right // Repair & Painting-scratch + dent

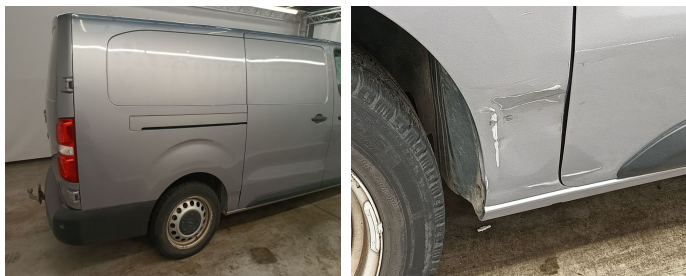
Wing Rear Right // Repair & Painting-scratch + dent

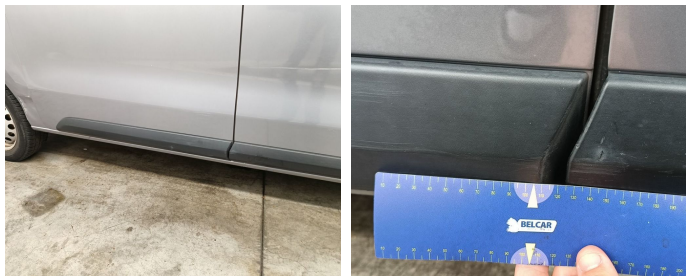
Door Rear Right / Trim / Replace-scratch

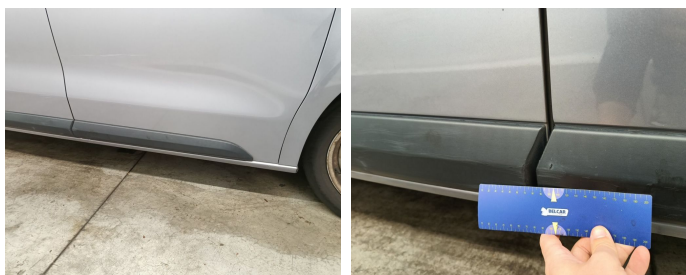
Door Front Right / Trim / Replace-scratch

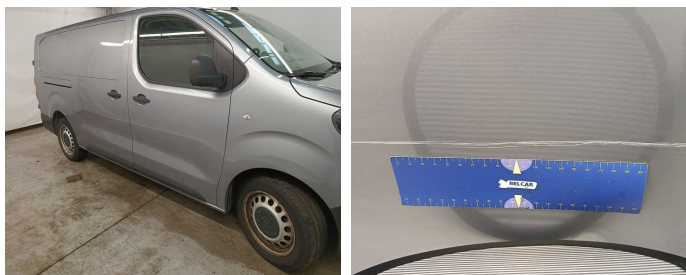
Door Front Right // Painting-scratch
