# INSPECTION REPORT

**End of contract**

| License plate | 2ACK659 |
| Make | Peugeot Part.1.5BHDi 102 L2 H |

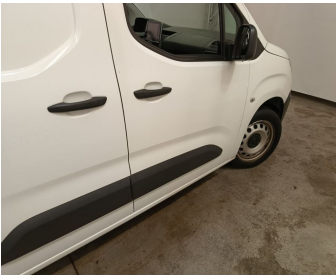
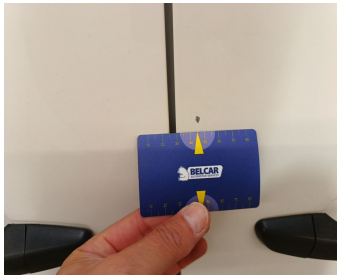
| Damages | Type | Acceptable |
|---|---|---|
| 213 | Door Front Right // Painting | Y |

Door Front Right // Painting-scratch

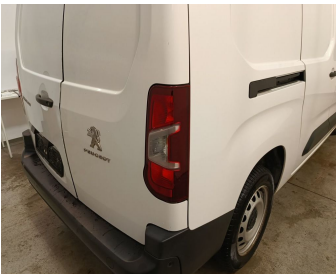
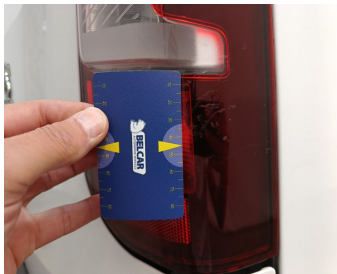
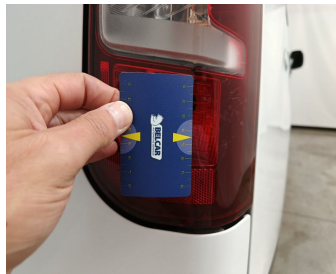
| Damages | Type | Acceptable |
|---|---|---|
| 174 | Light / Rear Right / Replace | N |

Light / Rear Right / Replace-scratch

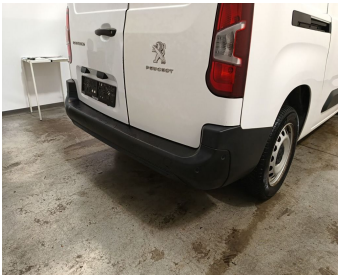
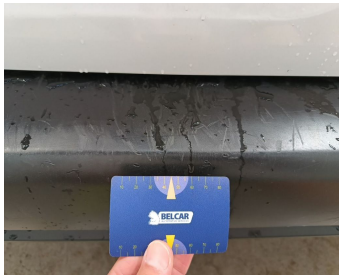
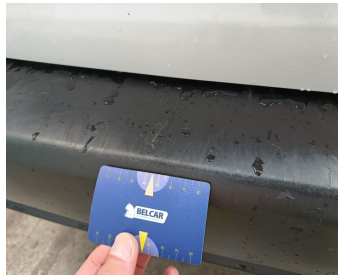
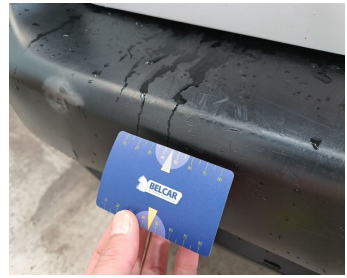
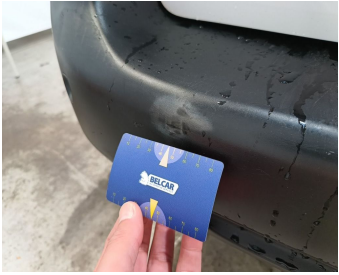
| Damages | Type | Acceptable |
|---|---|---|
| 137 | Bumper Rear // Replace without painting | Y |

Bumper Rear // Replace without painting-scratch

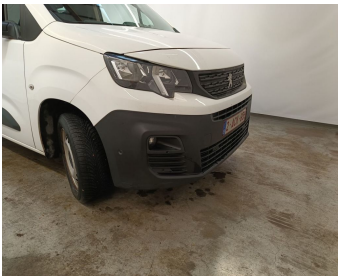
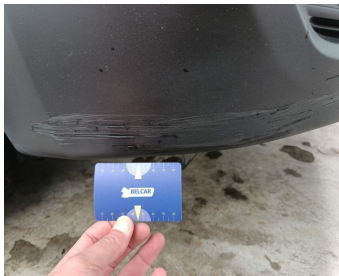
| Damages | Type | Acceptable |
|---|---|---|
| 19 | Bumper Front / Lower Cover Not Painted / Replace | Y |

Bumper Front / Lower Cover Not Painted / Replace-scratch

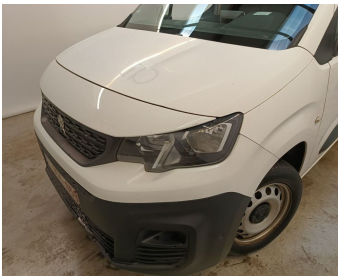
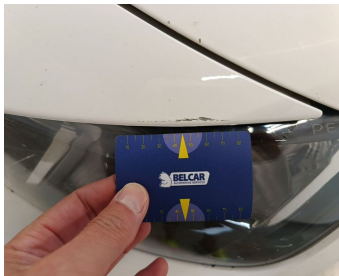
| Damages | Type | Acceptable |
|---|---|---|
| 12 | Bumper Front // Smart Repair Large | Y |

Bumper Front // Smart Repair Large-scratch

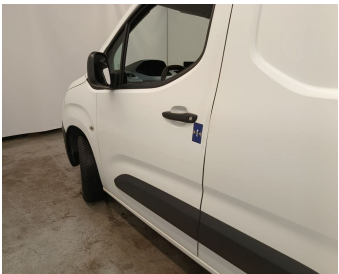
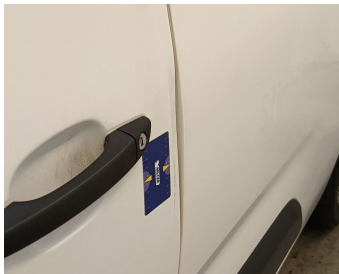
| Damages | Type | Acceptable |
|---|---|---|
| 84 | Door Front Left // Repair & Painting | Y |

Door Front Left // Repair & Painting-scratch + dent

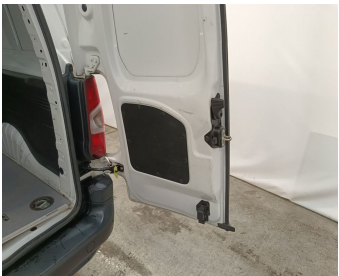
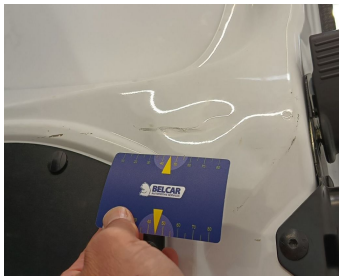
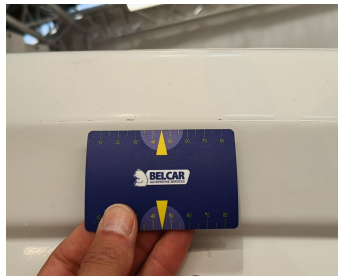
| Damages | Type | Acceptable |
|---|---|---|
| 304 | Rear Loading Door Right // Repair & Painting | Y |

Rear Loading Door Right // Repair & Painting-scratch + dent

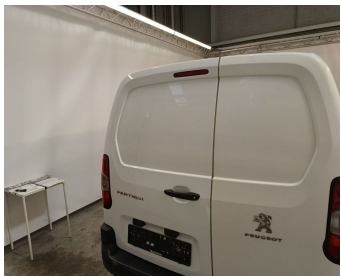
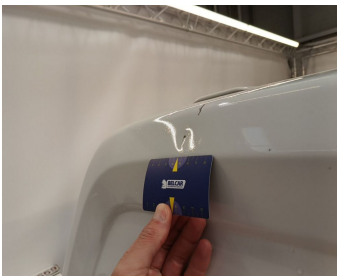
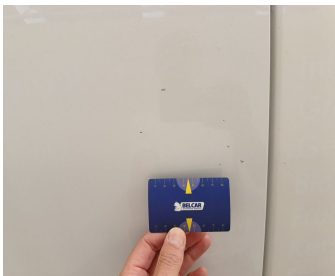
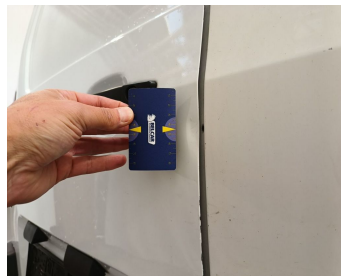
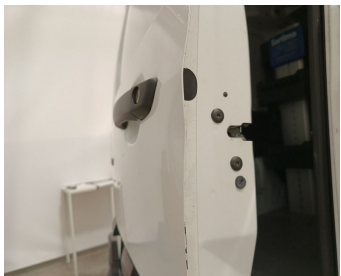
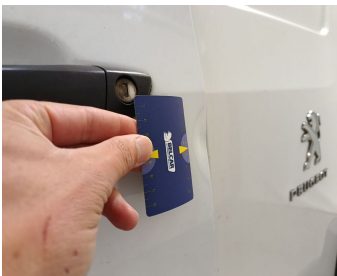
| Damages | Type | Acceptable |
|---|---|---|
| 294 | Rear Loading Door Left // Repair & Painting | N |

Rear Loading Door Left // Repair & Painting-scratch + dent

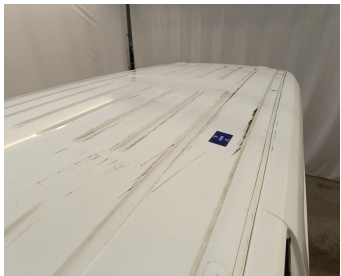
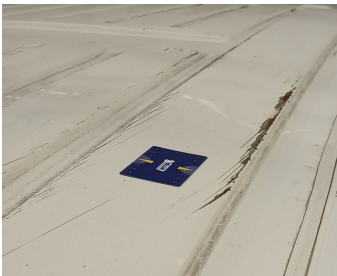
| Damages | Type | Acceptable |
|---|---|---|
| 163 | Roof // Repair & Painting | N |

Roof // Repair & Painting-rust

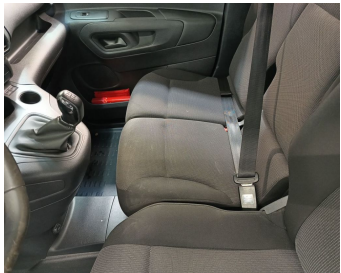
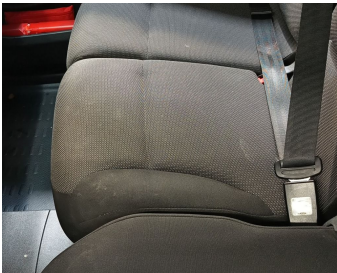
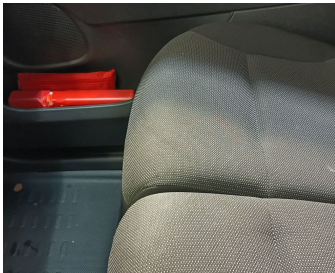
| Damages | Type | Acceptable |
|---|---|---|
| 860 | Interior Cleaning // Small | Y |

Interior Cleaning // Small-stain

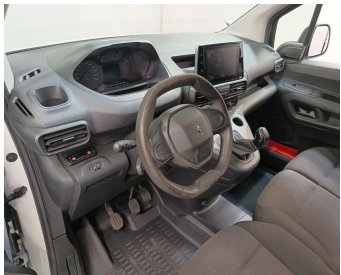
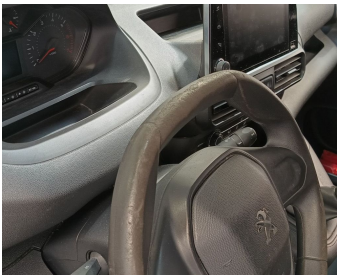
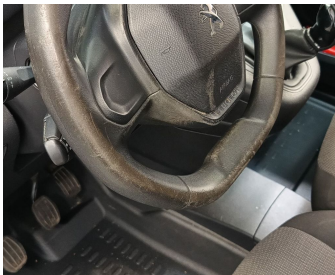
| Damages | Type | Acceptable |
|---|---|---|
| 569 | Dashboard / Steering Wheel / Replace | Y |

Dashboard / Steering Wheel / Replace-worn

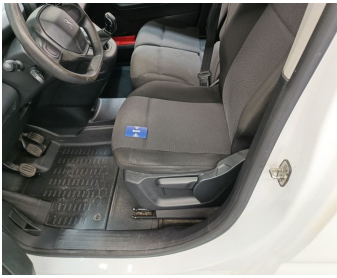
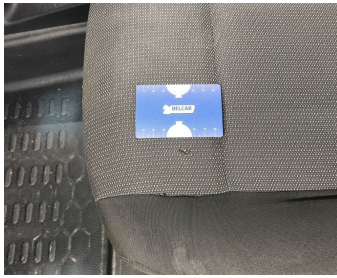
| Damages | Type | Acceptable |
|---|---|---|
| 412 | Seat Front Left / Bottom Coating / Replace | N |

Seat Front Left / Bottom Coating / Replace-hole

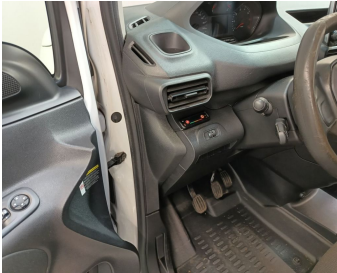
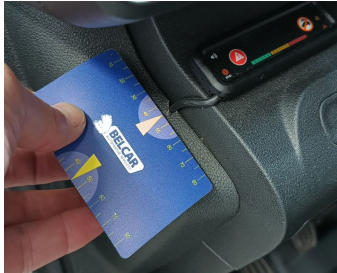
| Damages | Type | Acceptable |
|---|---|---|
| 564 | Dashboard // Replace Completely | Y |

Dashboard // Replace Completely-N comf / out of order

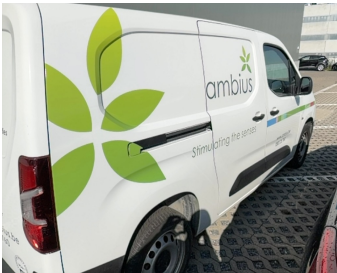
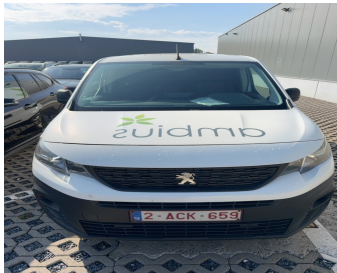
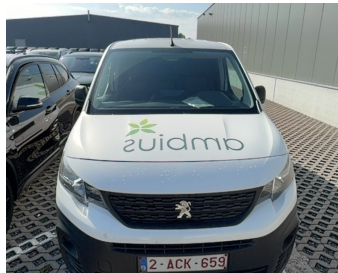
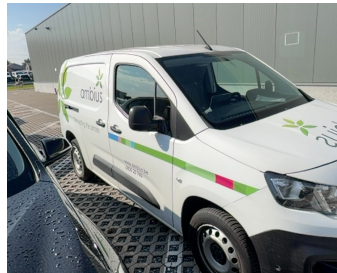
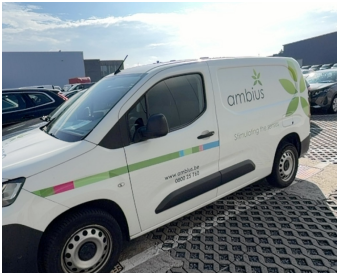
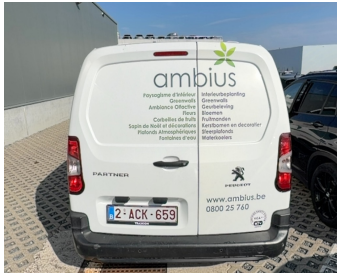
| Damages | Type | Acceptable |
|---|---|---|
| 891 | Lettering Removal 15min | N |

Lettering Removal 15min-
