INSPECTION REPORT

End of contract

| License plate | XY4778 |
| Make | Peugeot 2008 1.2 PT 130 Allure |

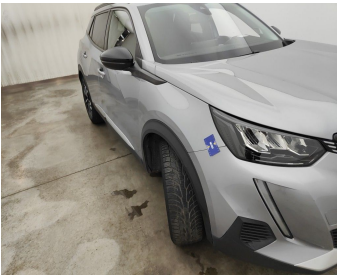
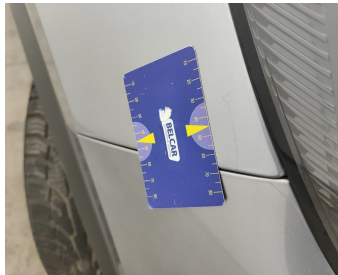
Bumper Front // Polish-scratch

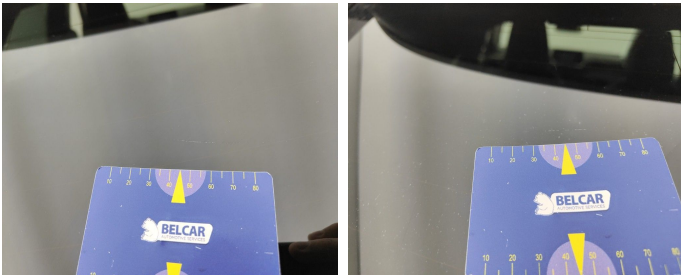
Rear Bonnet / Rear Window // Replace-scratch

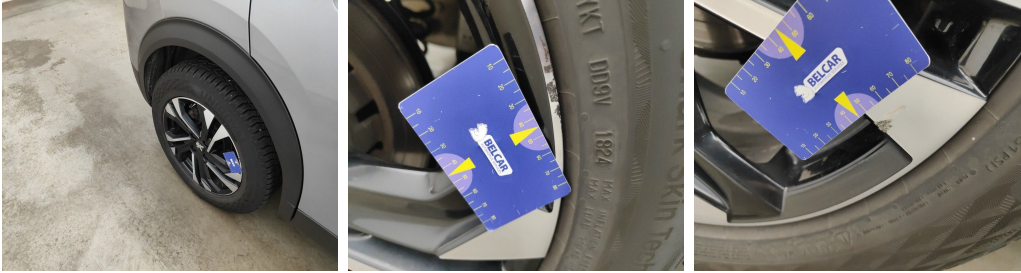
Wheel Two Tone Rear Right // Repair-scratch

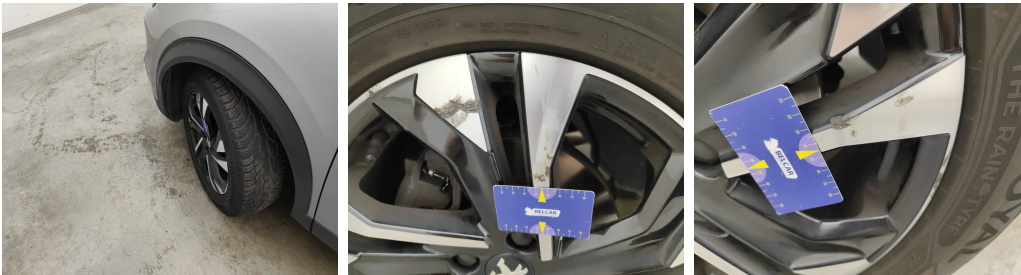
Wheel Two Tone Front Left // Repair-scratch

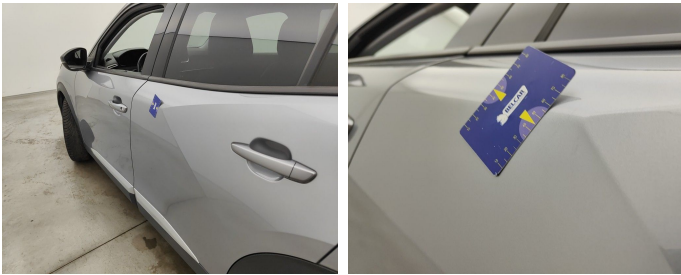
Door Rear Left // Polish-scratch

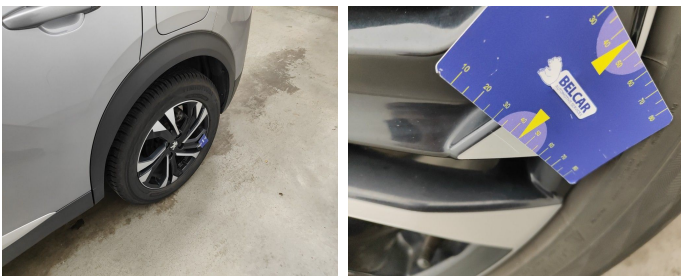
Wheel Two Tone Rear Left // Repair-scratch

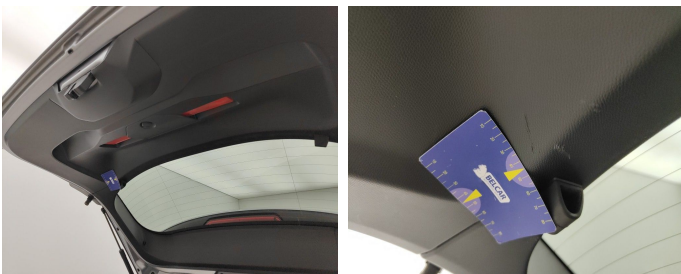
Trunk Lid Interior Coating / Complete Panel / Replace-scratch

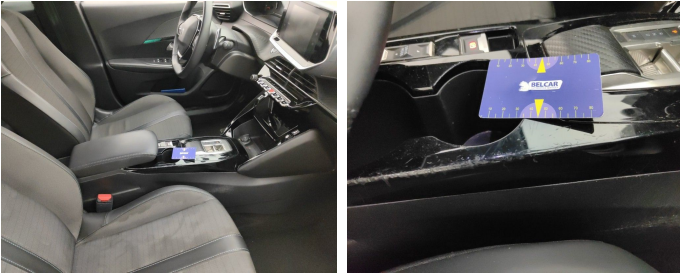
Central Console // Repair-scratch

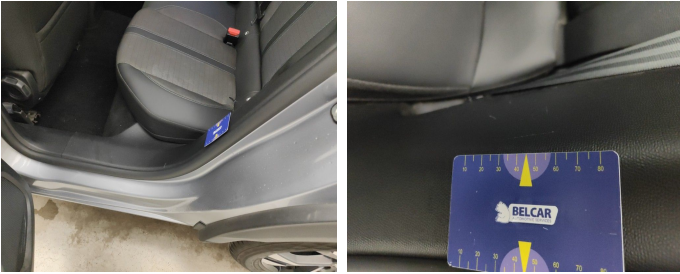
Seat Rear Left // Repair-scratch

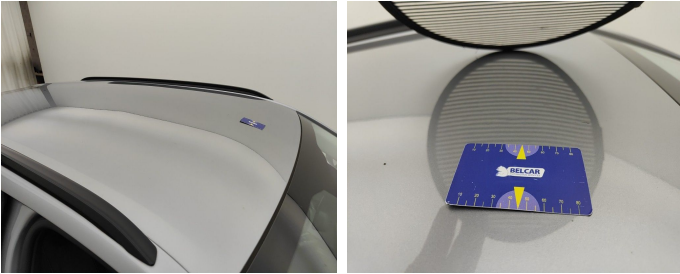
Roof // Smart Repair Medium-dent

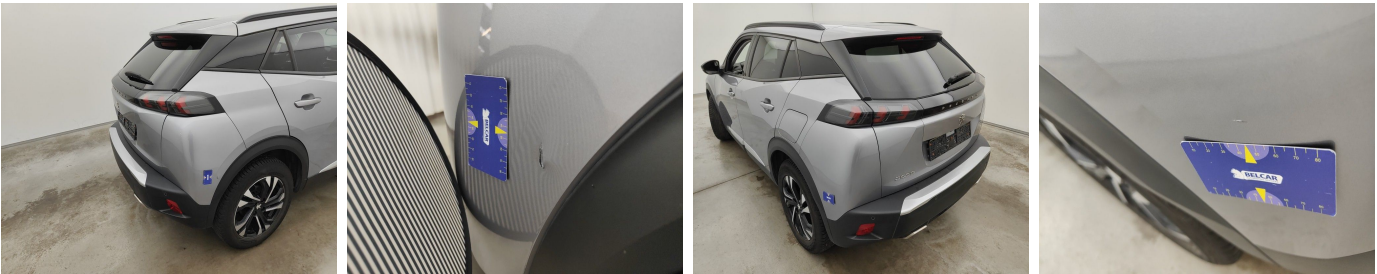
Bumper Rear // Repair & Painting-scratch + dent

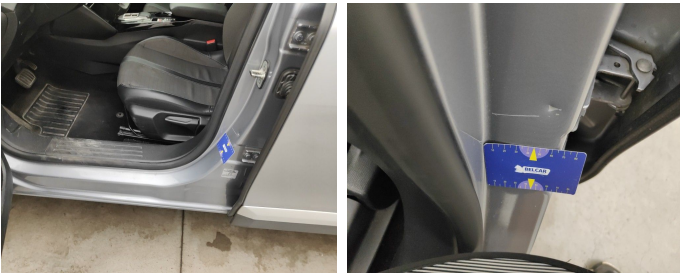
Rocker Panel Left // Smart Repair Medium-scratch + dent

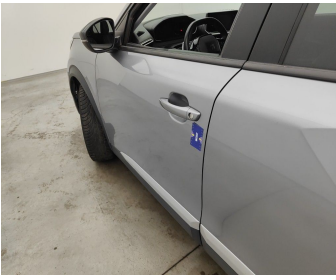
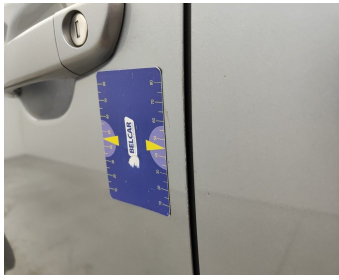
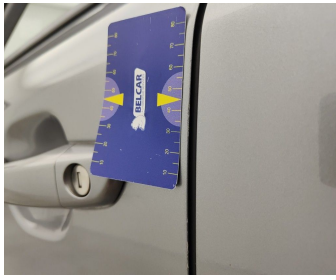
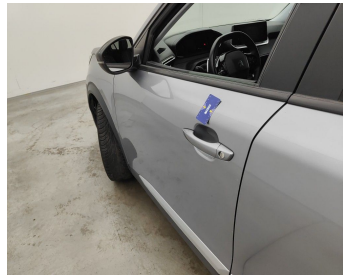
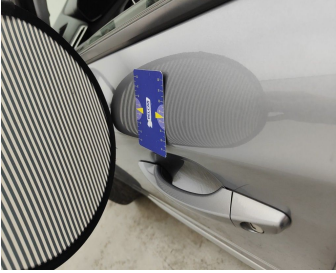
Door Front Left // Repair & Painting-scratch + dent

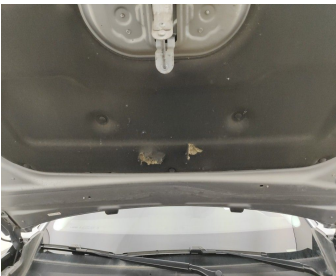
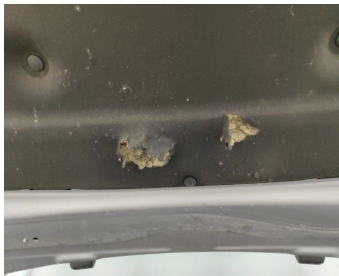
Front Bonnet / Insulation / Replace-tear

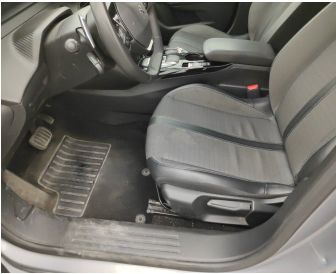
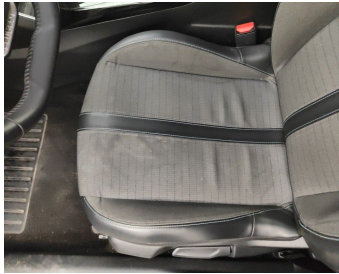
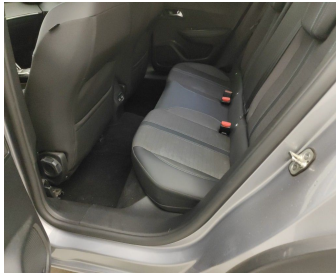
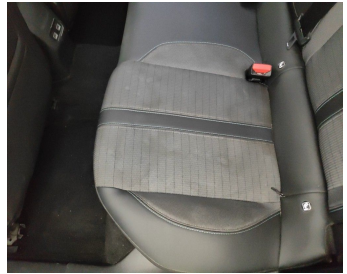
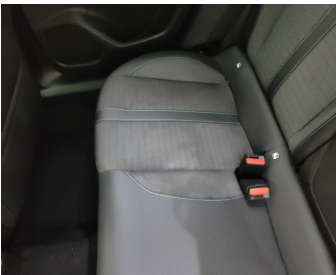
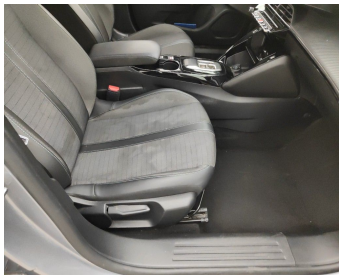
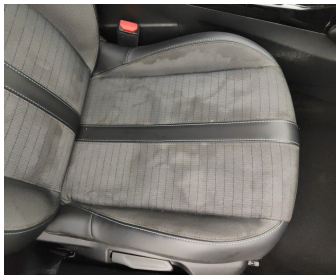
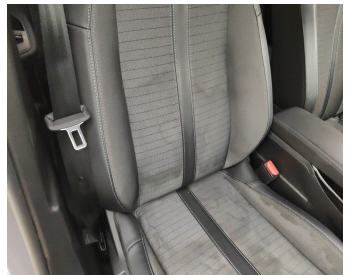
Interior Cleaning // Small-stain

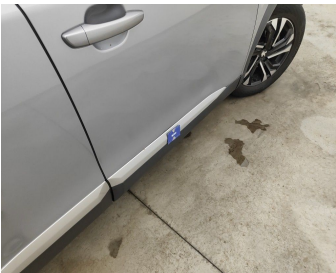
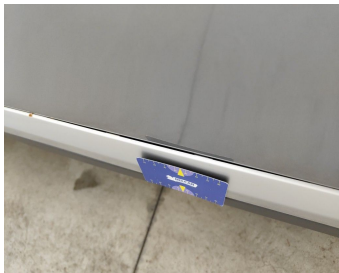
Door Front Right / Trim / Replace-bad position
