# INSPECTION REPORT

**End of contract**

| License plate | 2DEY680 |
| Make | Opel Astra 1.2 81kW Business E |

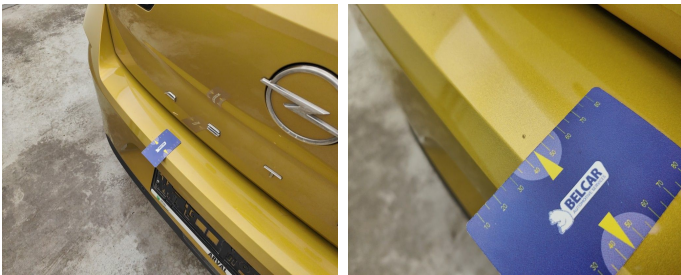
| Damages | Type | Acceptable |
|---|---|---|
| 131 | Bumper Rear // Smart Repair Medium | Y |

Bumper Rear // Smart Repair Medium-scratch

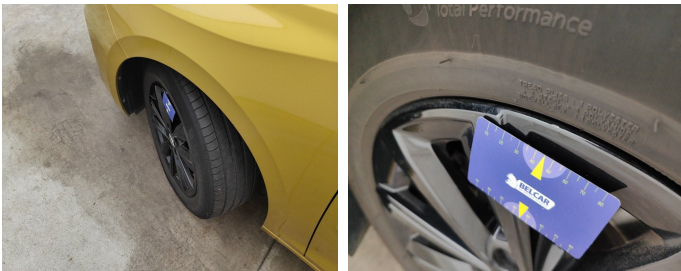
| Damages | Type | Acceptable |
|---|---|---|
| 311 | Wheel Alloy Front Left // Repair | Y |

Wheel Alloy Front Left // Repair-scratch

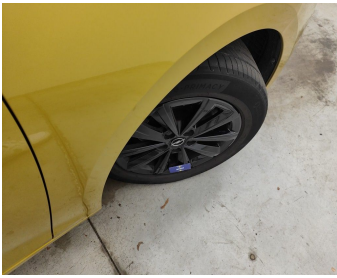
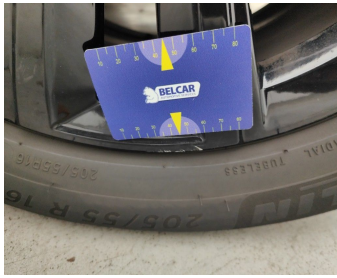
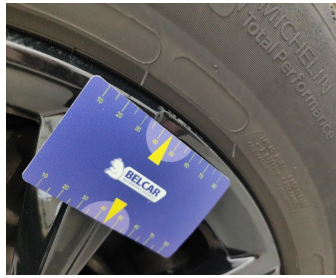
| Damages | Type | Acceptable |
|---|---|---|
| 341 | Wheel Alloy Front Right // Repair | Y |

Wheel Alloy Front Right // Repair-scratch

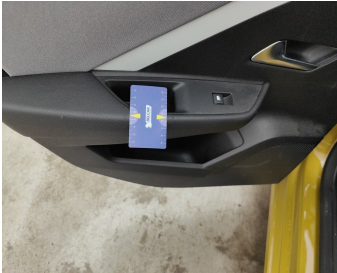
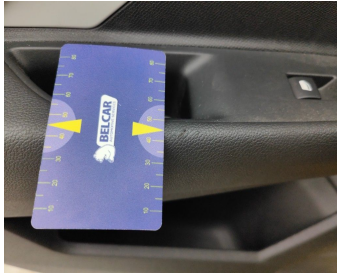
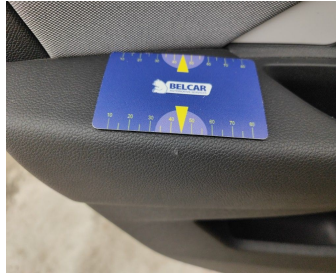
| Damages | Type | Acceptable |
|---|---|---|
| 634 | Rear Left Door Interior Coating // Replace Completely | N |

Rear Left Door Interior Coating // Replace Completely-scratch

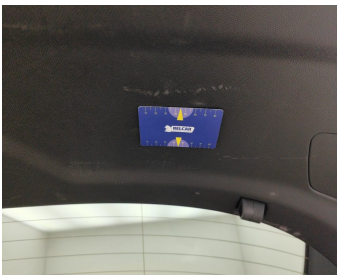
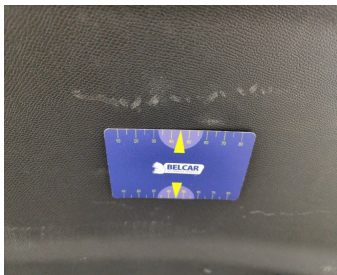
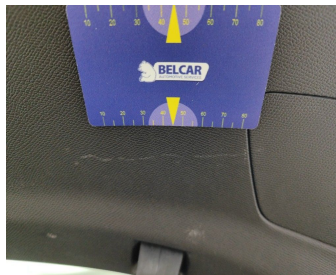
| Damages | Type | Acceptable |
|---|---|---|
| 594 | Trunk Lid Interior Coating / Complete Panel / Replace | Y |

Trunk Lid Interior Coating / Complete Panel / Replace-scratch

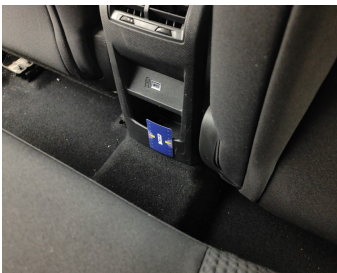
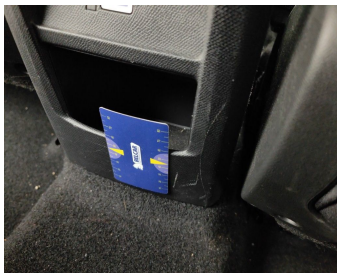
| Damages | Type | Acceptable |
|---|---|---|
| 551 | Central Console // Repair | N |

Central Console // Repair-scratch

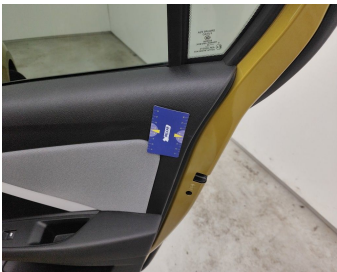
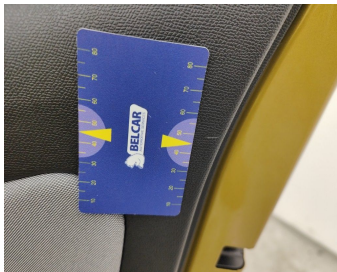
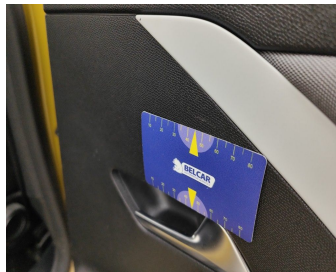
| Damages | Type | Acceptable |
|---|---|---|
| 644 | Rear Right Door Interior Coating // Replace Completely | Y |

Rear Right Door Interior Coating // Replace Completely-scratch

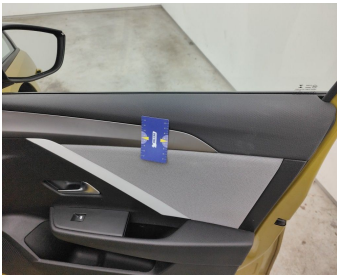
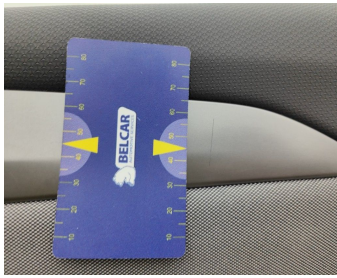
| Damages | Type | Acceptable |
|---|---|---|
| 621 | Front Right Door Interior Coating // Repair | Y |

Front Right Door Interior Coating // Repair-scratch

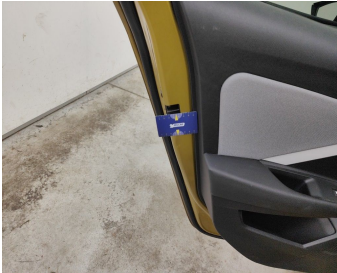
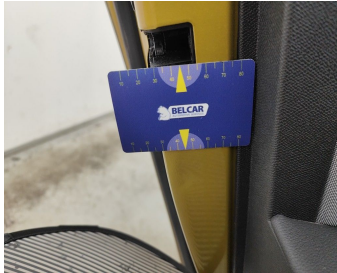
| Damages | Type | Acceptable |
|---|---|---|
| 100 | Door Rear Left // Smart Repair Small | Y |

Door Rear Left // Smart Repair Small-dent

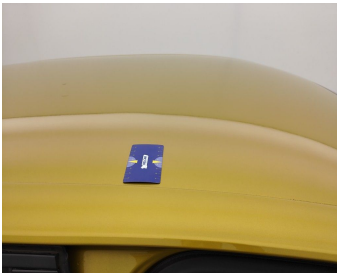
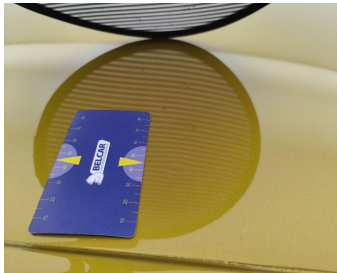
| Damages | Type | Acceptable |
|---|---|---|
| 161 | Roof // Smart Repair Medium | Y |

Roof // Smart Repair Medium-dent

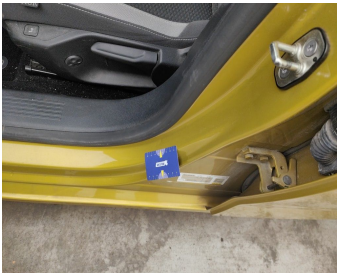
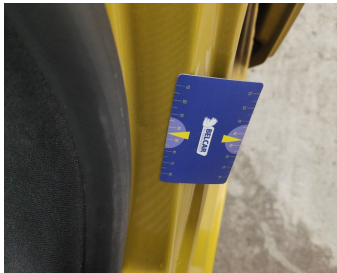
| Damages | Type | Acceptable |
|---|---|---|
| 91 | Rocker Panel Left // Smart Repair Medium | Y |

Rocker Panel Left // Smart Repair Medium-dent

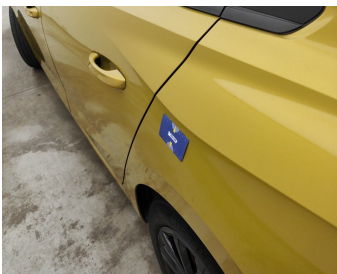
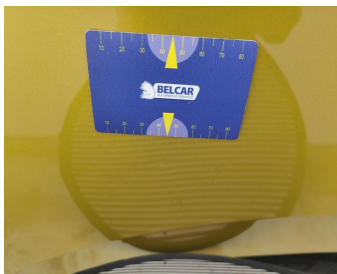
| Damages | Type | Acceptable |
|---|---|---|
| 110 | Wing Rear Left // Smart Repair Small | Y |

Wing Rear Left // Smart Repair Small-dent

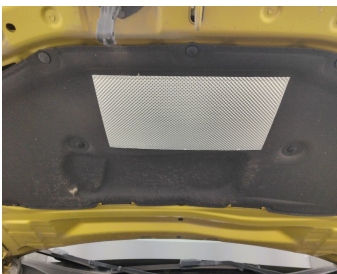
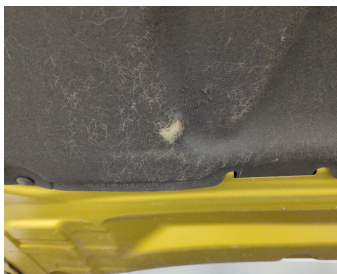
| Damages | Type | Acceptable |
|---|---|---|
| 38 | Front Bonnet / Insulation / Replace | Y |

Front Bonnet / Insulation / Replace-worn

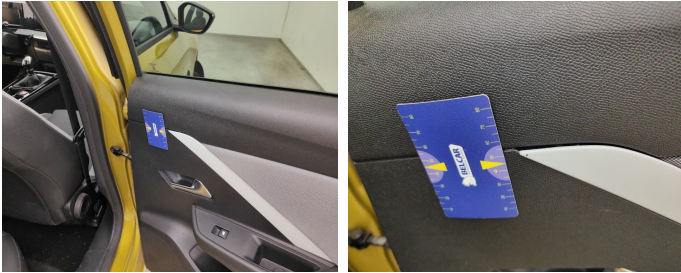
| Damages | Type | Acceptable |
|---|---|---|
| 641 | Rear Right Door Interior Coating // Repair | Y |

Rear Right Door Interior Coating // Repair-bad position

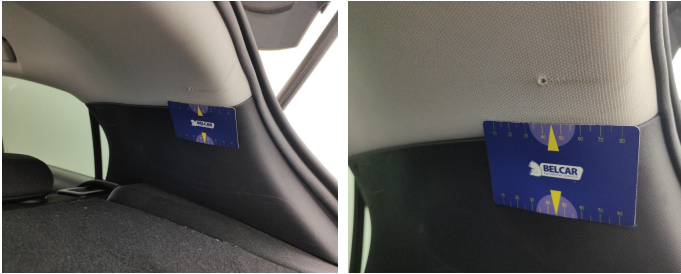
| Damages | Type | Acceptable |
|---|---|---|
| 540 | Interior // Repair 1 | N |

Interior // Repair 1-hole
