# INSPECTION REPORT

**End of contract**

| License plate | DU4219 |
| Make | Volvo XC40 B3 163 Core Aut |

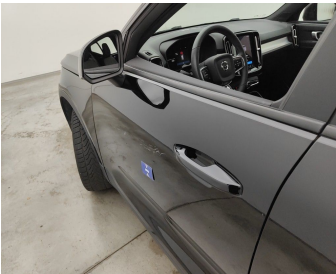
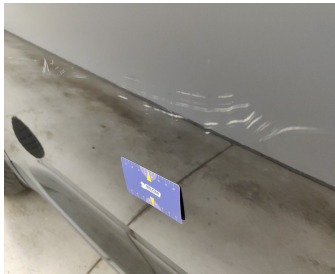
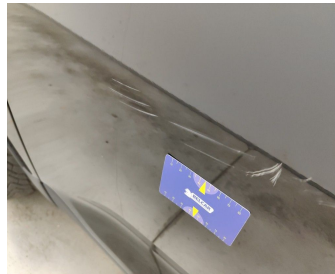
| Damages | Type | Acceptable |
|---|---|---|
| 83 | Door Front Left // Painting | N |

Door Front Left // Painting-scratch

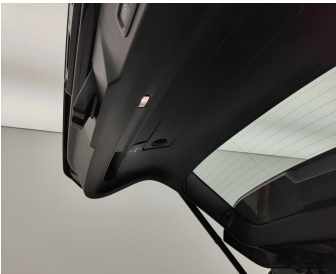
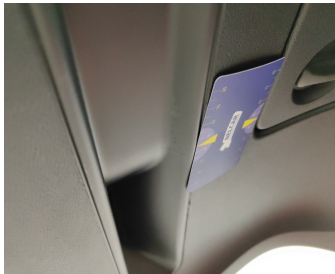
| Damages | Type | Acceptable |
|---|---|---|
| 594 | Trunk Lid Interior Coating / Complete Panel / Replace | Y |

Trunk Lid Interior Coating / Complete Panel / Replace-scratch

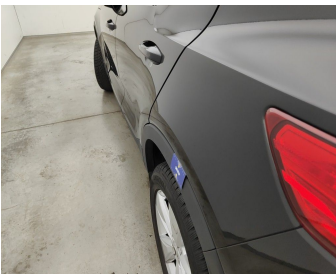
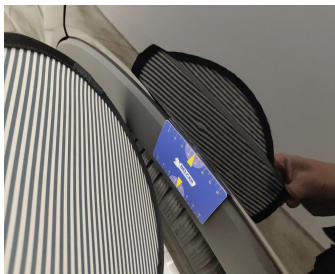
| Damages | Type | Acceptable |
|---|---|---|
| 110 | Wing Rear Left // Smart Repair Small | Y |

Wing Rear Left // Smart Repair Small-dent

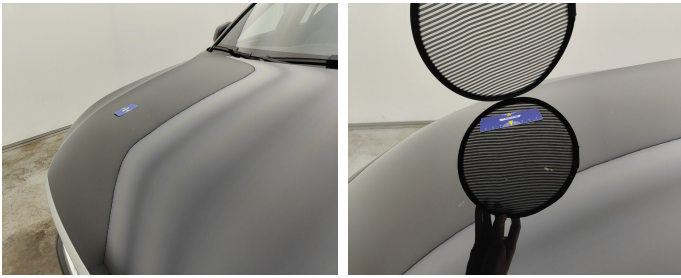
| Damages | Type | Acceptable |
|---|---|---|
| 31 | Front Bonnet // Smart Repair Small | Y |

Front Bonnet // Smart Repair Small-dent

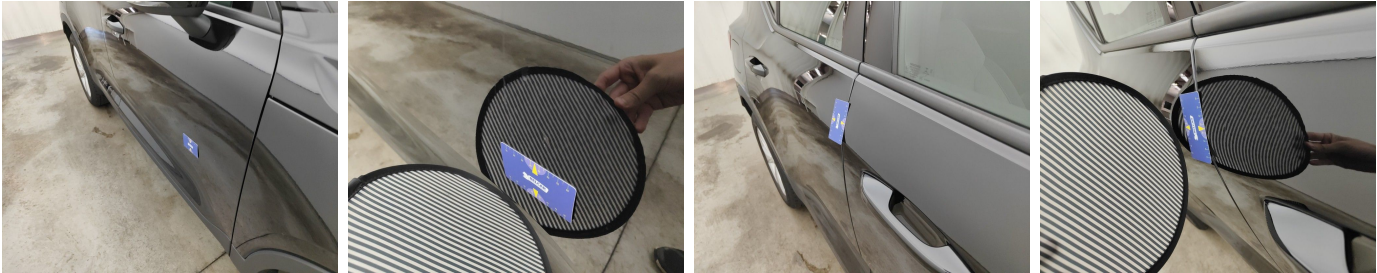
| Damages | Type | Acceptable |
|---|---|---|
| 214 | Door Front Right // Repair & Painting | Y |

Door Front Right // Repair & Painting-scratch + dent

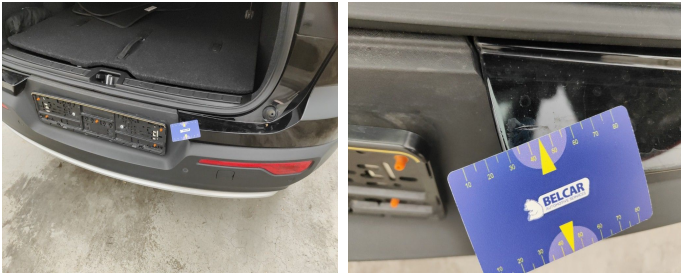
| Damages | Type | Acceptable |
|---|---|---|
| 133 | Bumper Rear // Painting | Y |

Bumper Rear // Painting-scratch

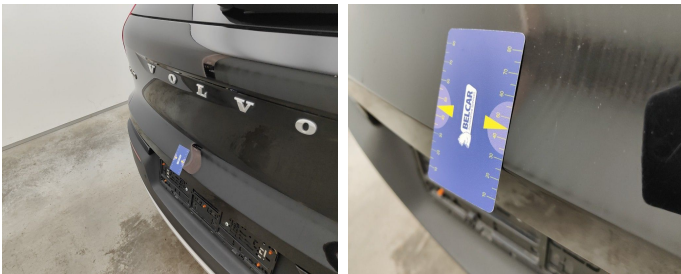
| Damages | Type | Acceptable |
|---|---|---|
| 156 | Rear Bonnet // Polish | Y |

Rear Bonnet // Polish-scratch

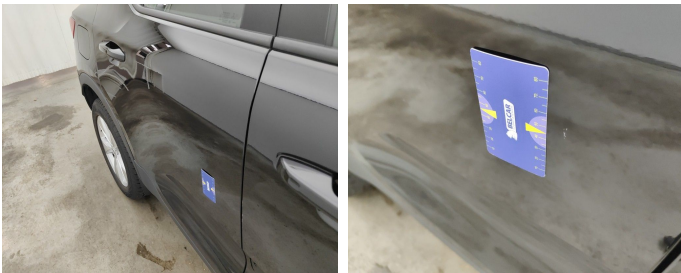
| Damages | Type | Acceptable |
|---|---|---|
| 196 | Door Rear Right // Polish | Y |

Door Rear Right // Polish-scratch

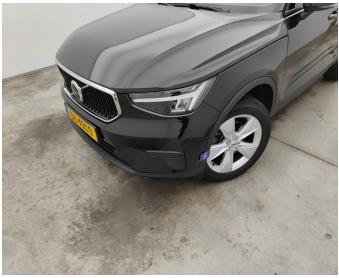
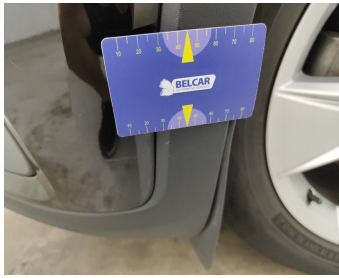
| Damages | Type | Acceptable |
|---|---|---|
| 19 | Bumper Front / Lower Cover Not Painted / Replace | Y |

Bumper Front / Lower Cover Not Painted / Replace-scratch

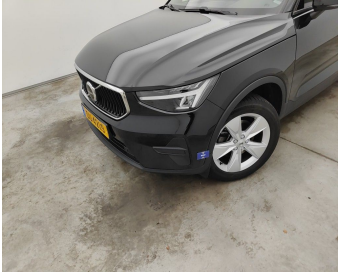
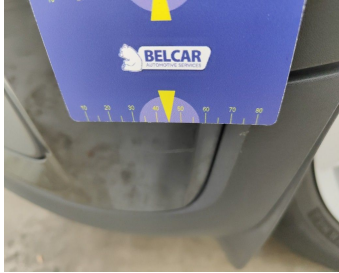
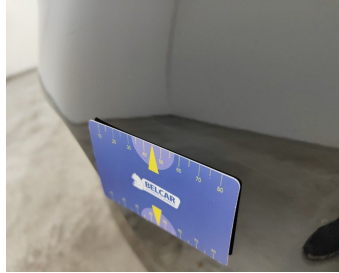
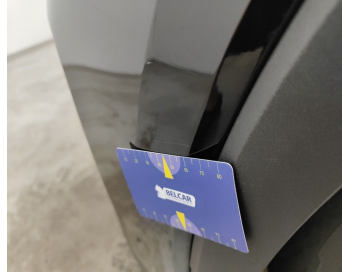
| Damages | Type | Acceptable |
|---|---|---|
| 13 | Bumper Front // Painting | Y |

Bumper Front // Painting-scratch
