# INSPECTION REPORT

**End of contract**

| License plate | 2BBV409 |
| Make | Opel Mokka 1.2 100 s/s Edition |

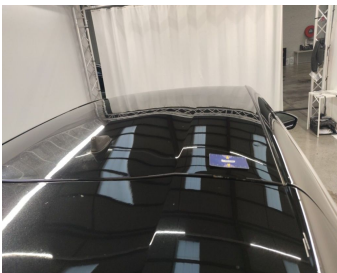
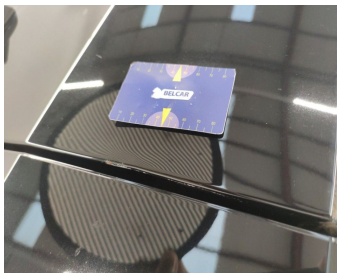
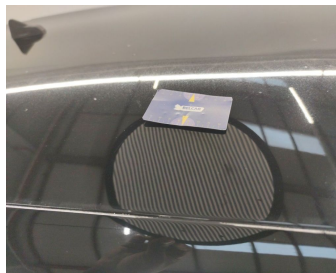
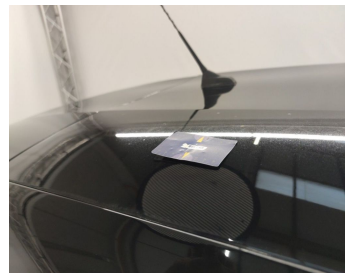
Roof // Repair & Painting-scratch + dent

| Damages | Type | Acceptable |
|---|---|---|
| 163 | Roof // Repair & Painting | N |

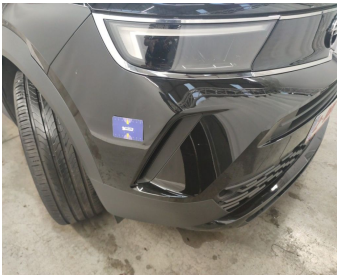
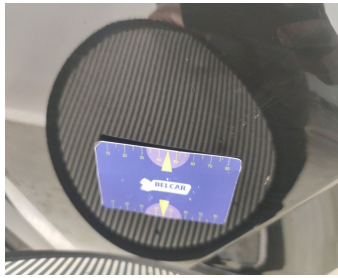
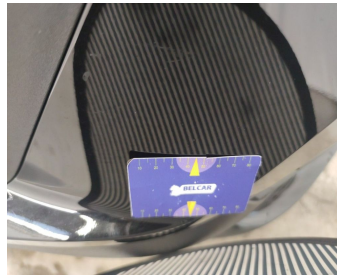
Bumper Front // Polish-bad repair

| Damages | Type | Acceptable |
|---|---|---|
| 16 | Bumper Front // Polish | Y |

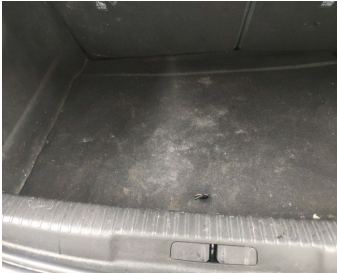
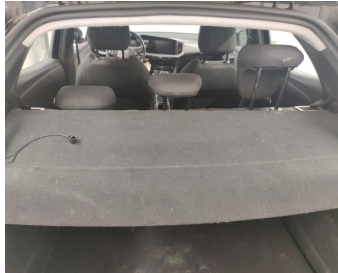
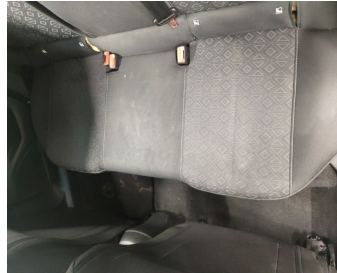
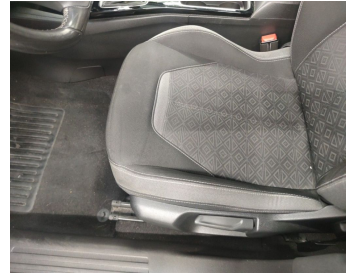
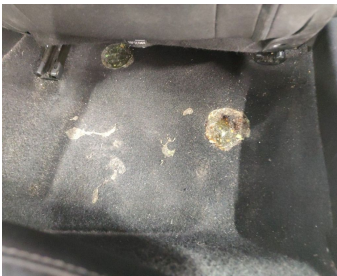
Interior Cleaning // Large-stain

| Damages | Type | Acceptable |
|---|---|---|
| 840 | Interior Cleaning // Large | N |

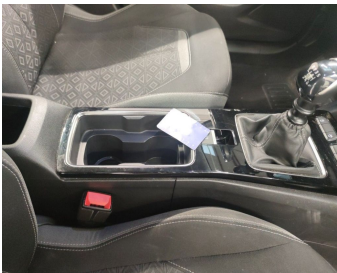
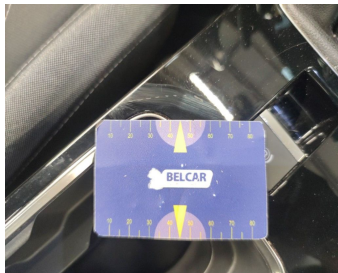
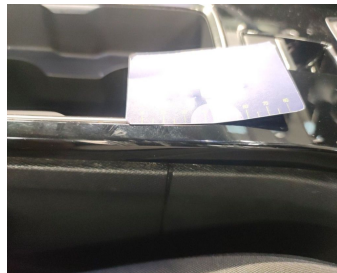
Central Console // Repair-worn

| Damages | Type | Acceptable |
|---|---|---|
| 551 | Central Console // Repair | Y |

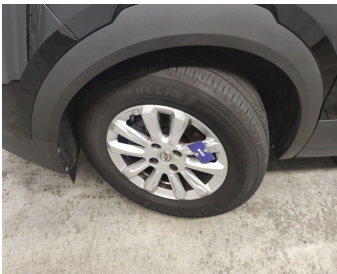
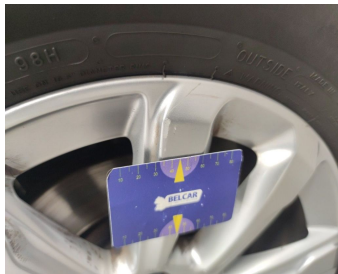
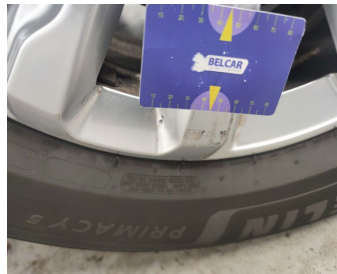
Wheel Alloy Front Left // Repair-scratch

| Damages | Type | Acceptable |
|---|---|---|
| 311 | Wheel Alloy Front Left // Repair | Y |

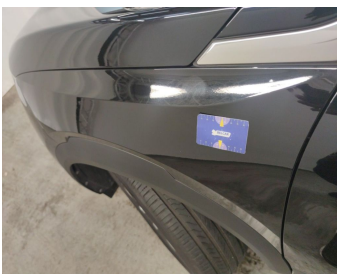
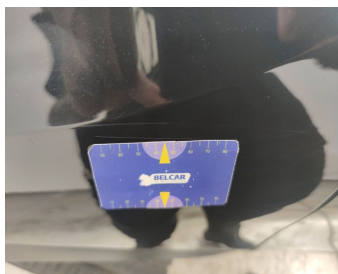
Wing Front Left // Polish-scratch

| Damages | Type | Acceptable |
|---|---|---|
| 66 | Wing Front Left // Polish | Y |

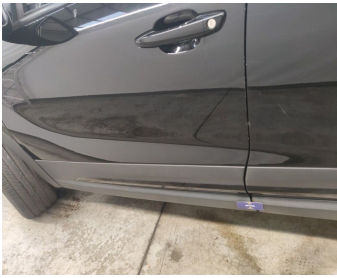
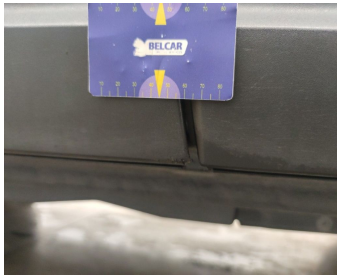
Door Front Left / Trim / Replace-scratch

| Damages | Type | Acceptable |
|---|---|---|
| 87 | Door Front Left / Trim / Replace | Y |

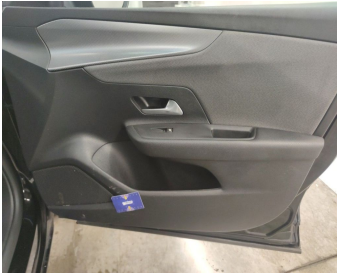
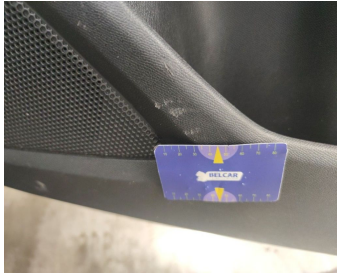
Front Right Door Interior Coating // Repair-scratch

| Damages | Type | Acceptable |
|---|---|---|
| 621 | Front Right Door Interior Coating // Repair | Y |

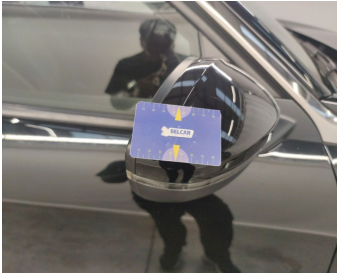
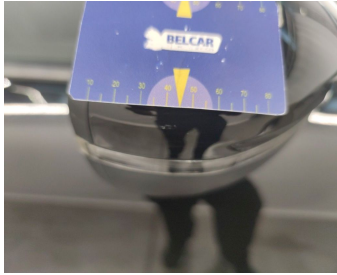
Side View Mirror Right // Painting-scratch

| Damages | Type | Acceptable |
|---|---|---|
| 222 | Side View Mirror Right // Painting | Y |

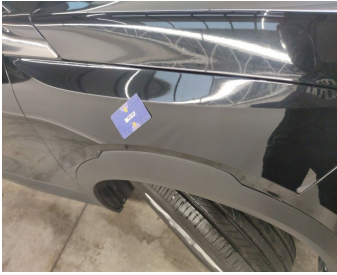
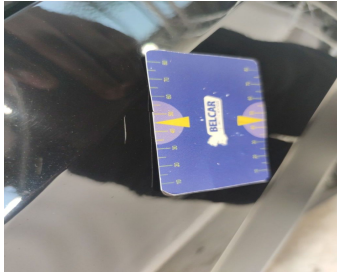
Wing Front right // Painting-scratch

| Damages | Type | Acceptable |
|---|---|---|
| 233 | Wing Front right // Painting | Y |

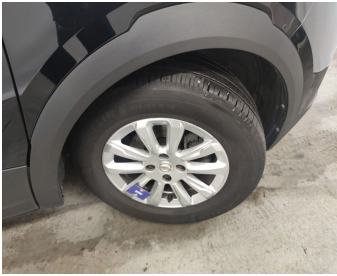
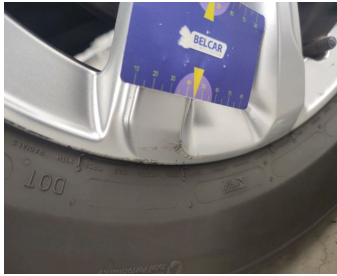
Wheel Alloy Front Right // Repair-scratch

| Damages | Type | Acceptable |
|---|---|---|
| 341 | Wheel Alloy Front Right // Repair | Y |

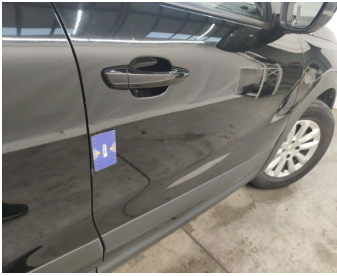
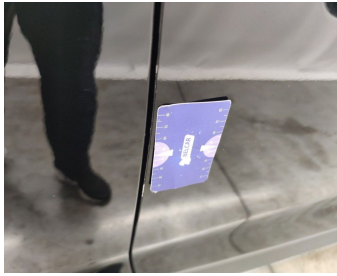
Door Front Right // Smart Repair Medium-scratch

| Damages | Type | Acceptable |
|---|---|---|
| 211 | Door Front Right // Smart Repair Medium | Y |

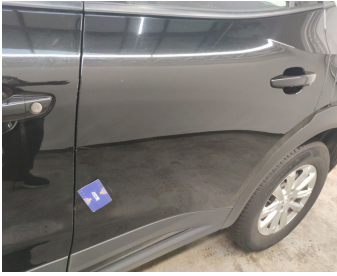
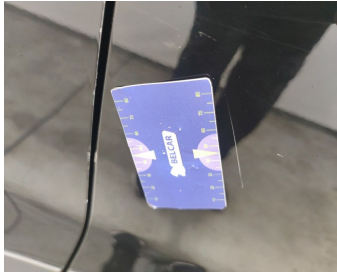
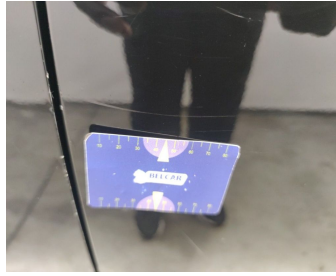
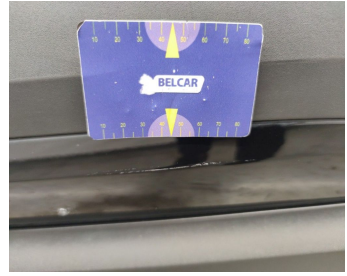
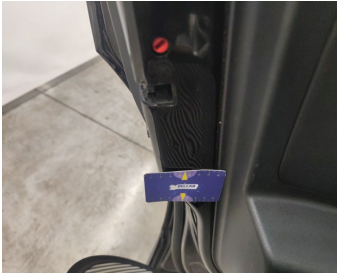
Door Rear Left // Smart Repair Large-dent

| Damages | Type | Acceptable |
|---|---|---|
| 102 | Door Rear Left // Smart Repair Large | N |

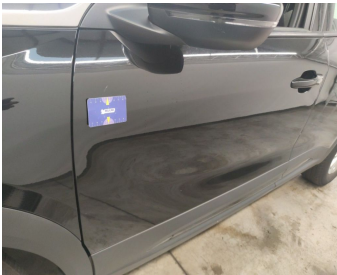
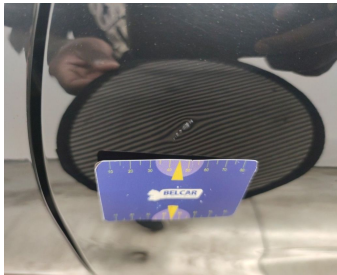
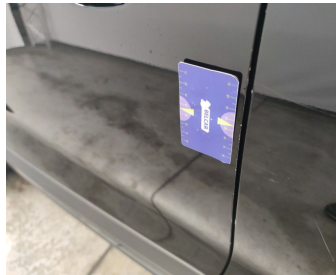
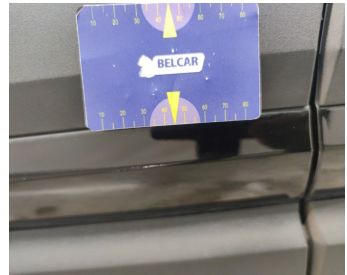
Door Front Left // Repair & Painting-scratch + dent

| Damages | Type | Acceptable |
|---|---|---|
| 84 | Door Front Left // Repair & Painting | N |

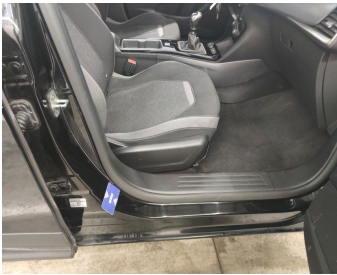
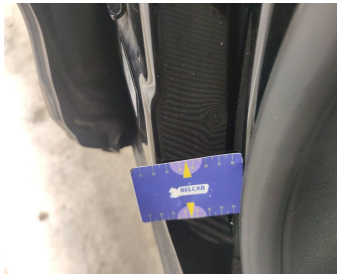
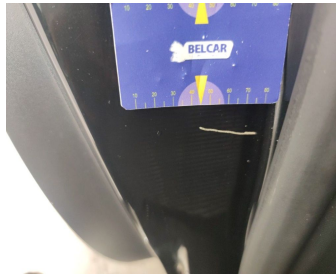
Rocker Panel Right // Smart Repair Medium-scratch + dent

| Damages | Type | Acceptable |
|---|---|---|
| 201 | Rocker Panel Right // Smart Repair Medium | N |

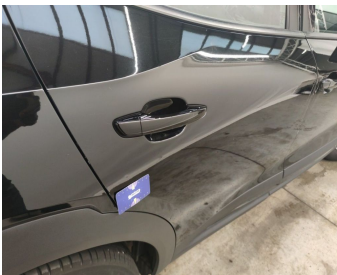
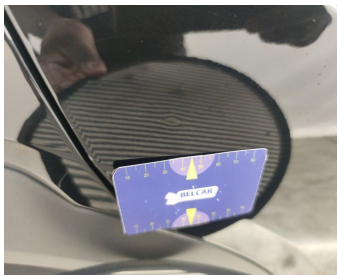
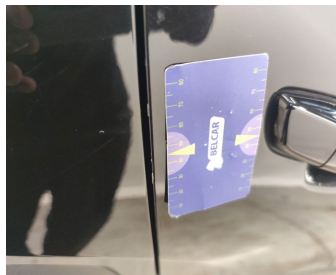
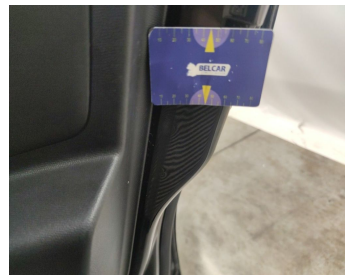
Door Rear Right // Smart Repair Medium-scratch + dent

| Damages | Type | Acceptable |
|---|---|---|
| 191 | Door Rear Right // Smart Repair Medium | Y |

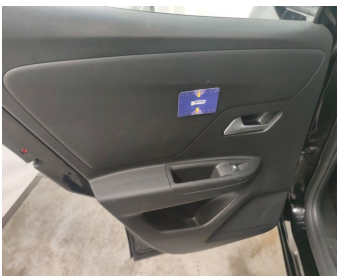
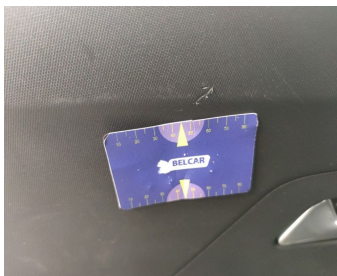
Rear Left Door Interior Coating // Replace Completely-scratch + dent

| Damages | Type | Acceptable |
|---|---|---|
| 634 | Rear Left Door Interior Coating // Replace Completely | N |

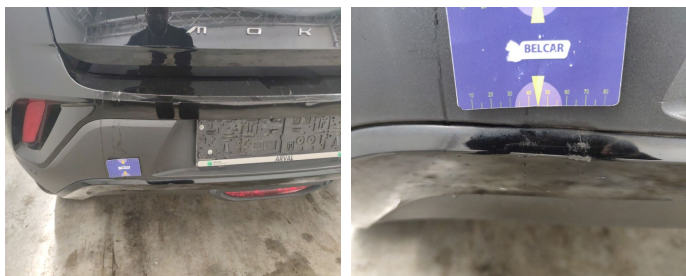
Bumper Rear / Spoiler / Replace-scratch

| Damages | Type | Acceptable |
|---|---|---|
| 139 | Bumper Rear / Spoiler / Replace | N |

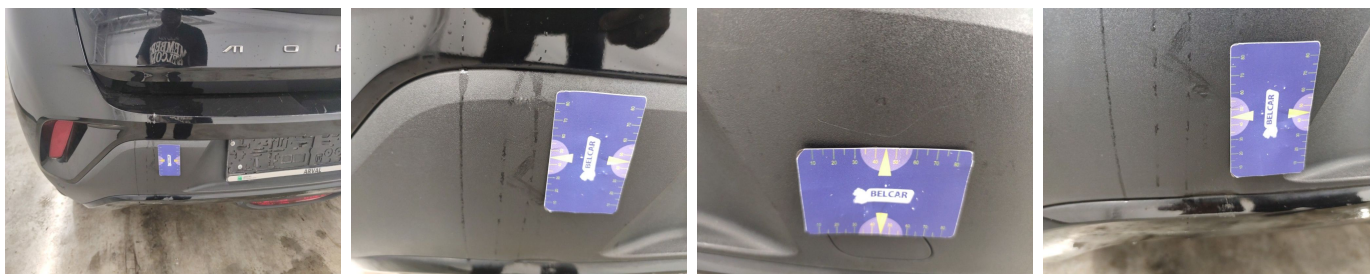
Bumper Rear / Lower Cover Not Painted / Replace-scratch

| Damages | Type | Acceptable |
|---|---|---|
| 138 | Bumper Rear / Lower Cover Not Painted / Replace | N |

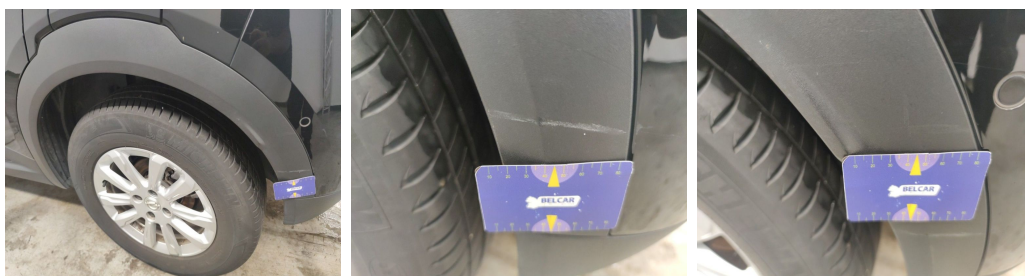
Wing Rear Left / Trim / Replace-scratch

| Damages | Type | Acceptable |
|---|---|---|
| 117 | Wing Rear Left / Trim / Replace | N |

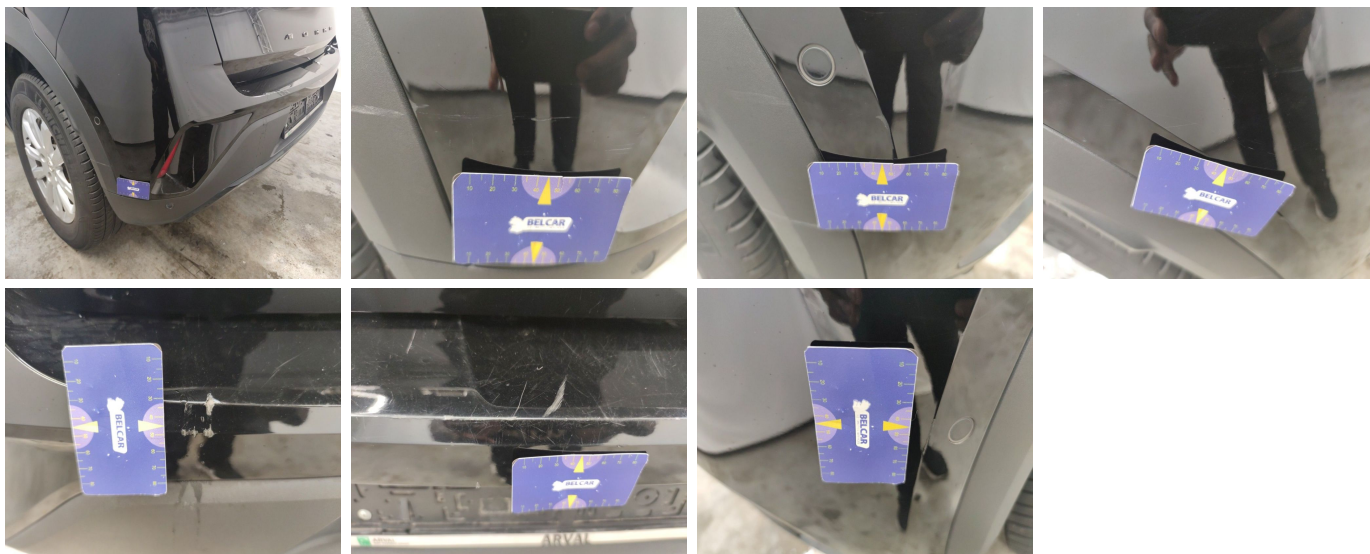
Bumper Rear // Repair & Painting-scratch + dent

| Damages | Type | Acceptable |
|---|---|---|
| 134 | Bumper Rear // Repair & Painting | N |
