# INSPECTION REPORT

**End of contract**

| License plate | 2CMN067 |
| Make | Mercedes CLA SB 250 e Business |

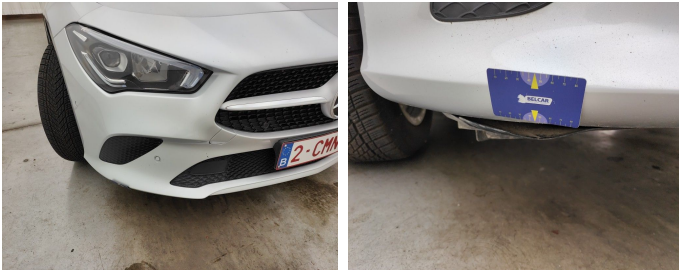
Wing Front right / Inner Fender / Replace-bad position

| Damages | Type | Acceptable |
|---|---|---|
| 239 | Wing Front right / Inner Fender / Replace | Y |

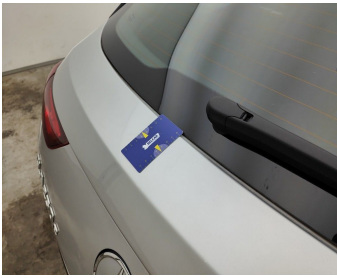
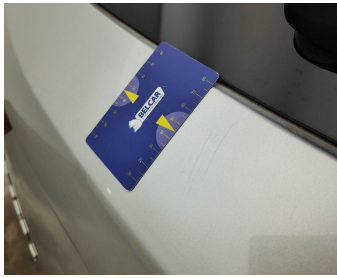
Rear Bonnet // Polish-scratch

| Damages | Type | Acceptable |
|---|---|---|
| 156 | Rear Bonnet // Polish | Y |

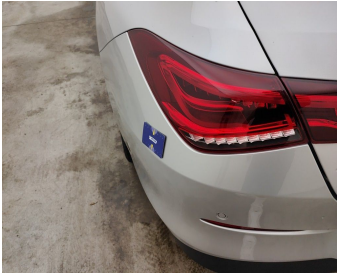
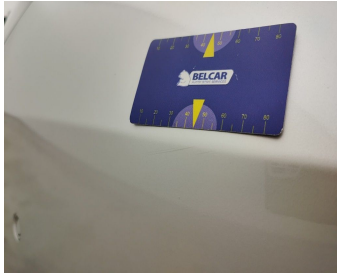
Bumper Rear // Polish-scratch

| Damages | Type | Acceptable |
|---|---|---|
| 136 | Bumper Rear // Polish | Y |

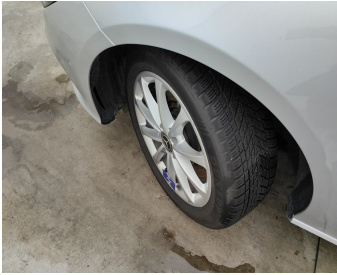
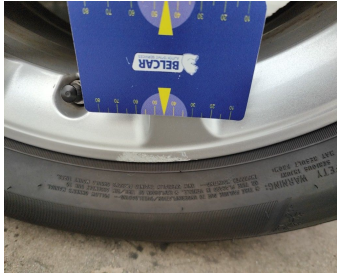
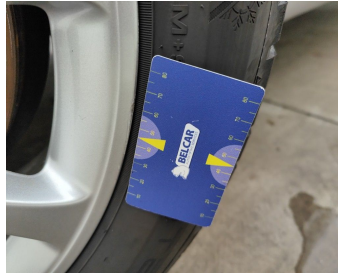
Wheel Alloy Front Left // Repair-scratch

| Damages | Type | Acceptable |
|---|---|---|
| 311 | Wheel Alloy Front Left // Repair | Y |

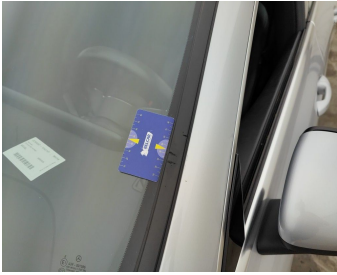
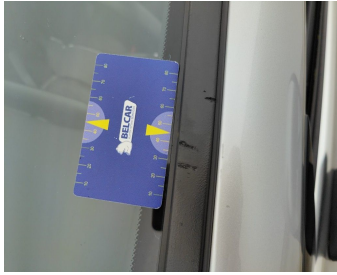
Windshield / Trim / Replace-scratch

| Damages | Type | Acceptable |
|---|---|---|
| 44 | Windshield / Trim / Replace | Y |

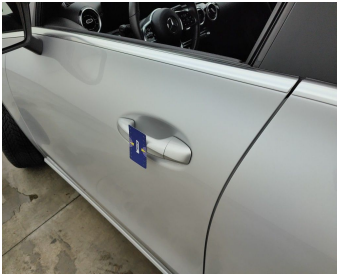
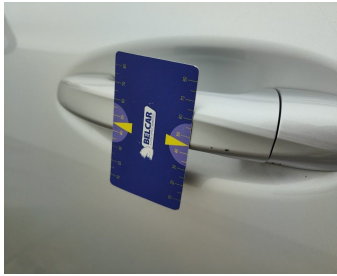
Door Front Left // Smart Repair Medium-scratch

| Damages | Type | Acceptable |
|---|---|---|
| 81 | Door Front Left // Smart Repair Medium | Y |

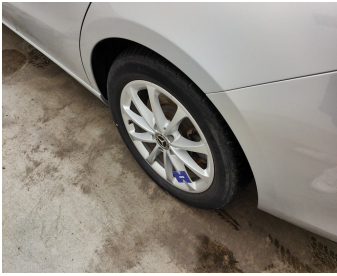
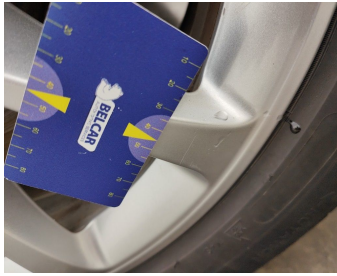
Wheel Alloy Rear Left // Repair-scratch

| Damages | Type | Acceptable |
|---|---|---|
| 321 | Wheel Alloy Rear Left // Repair | Y |

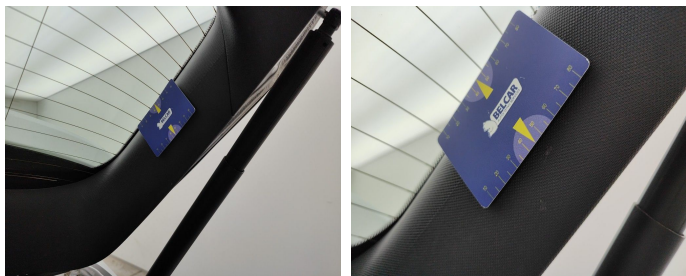
Trunk Lid Interior Coating / Complete Panel / Replace-scratch

| Damages | Type | Acceptable |
|---|---|---|
| 594 | Trunk Lid Interior Coating / Complete Panel / Replace | Y |

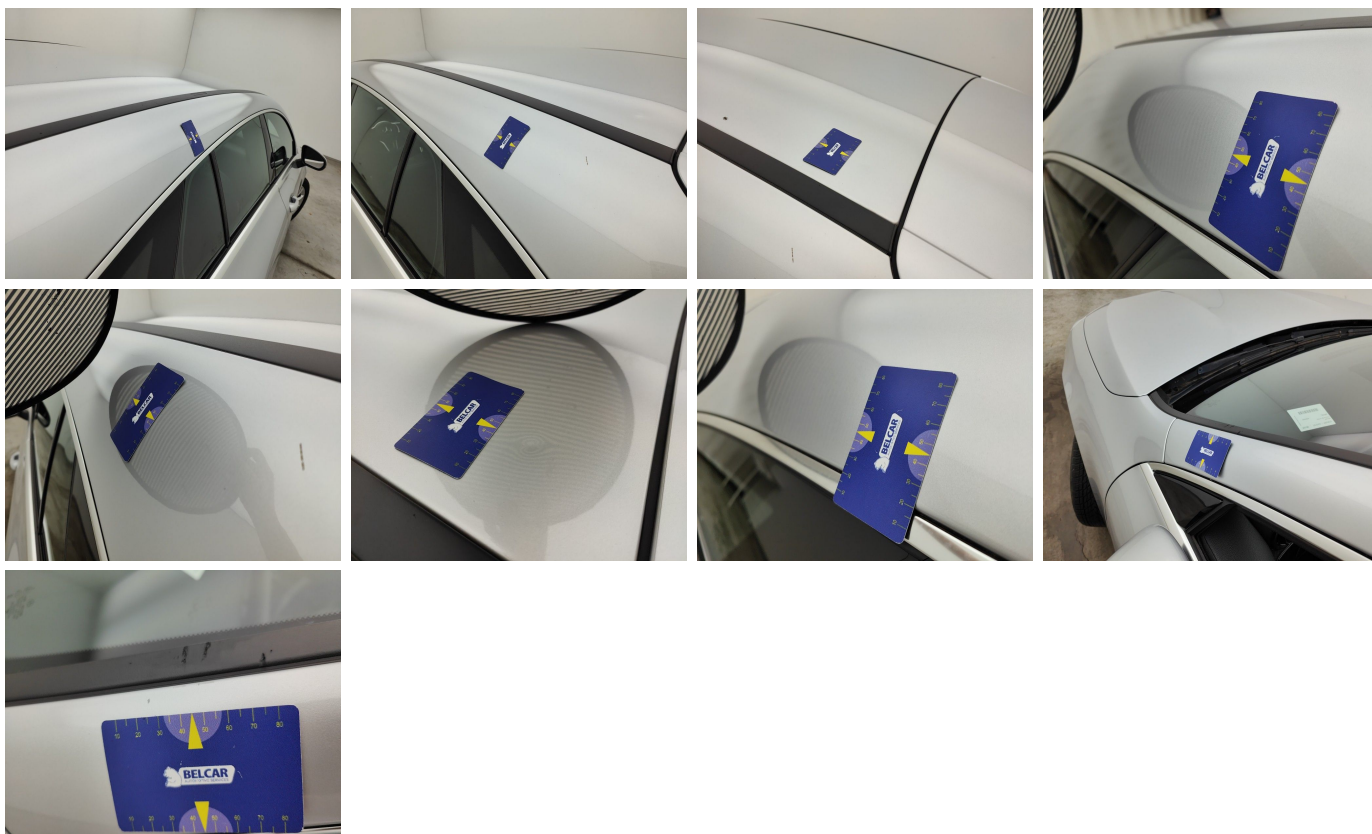
Roof // Smart Repair Medium-dent

| Damages | Type | Acceptable |
|---|---|---|
| 161 | Roof // Smart Repair Medium | Y |

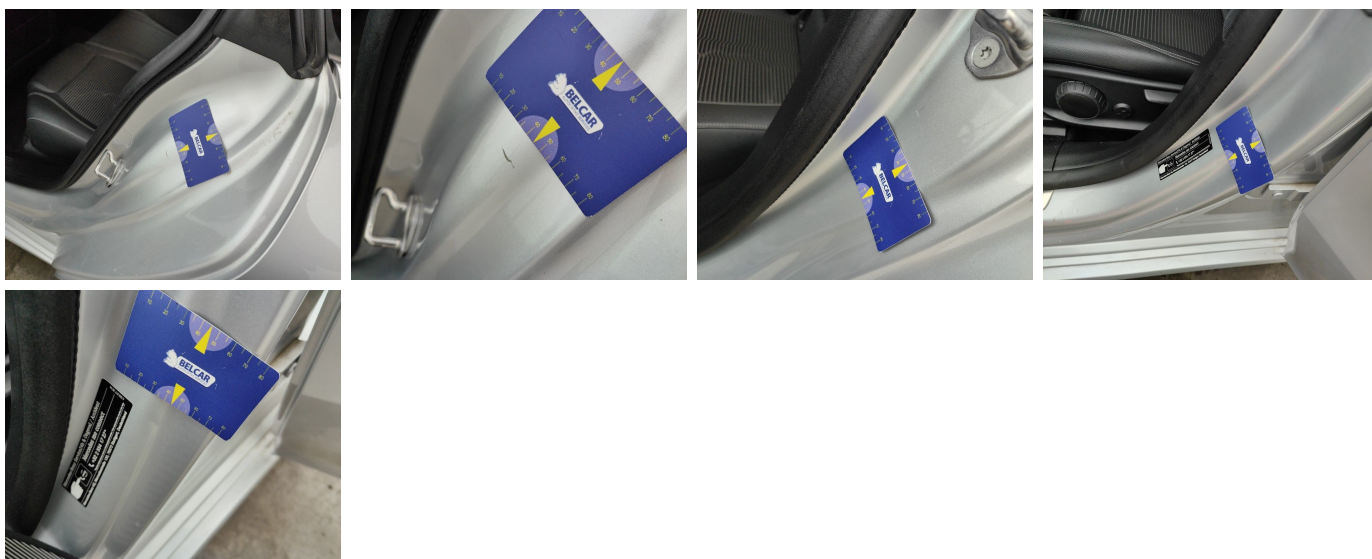
Rocker Panel Left // Smart Repair Medium-dent

| Damages | Type | Acceptable |
|---|---|---|
| 91 | Rocker Panel Left // Smart Repair Medium | Y |

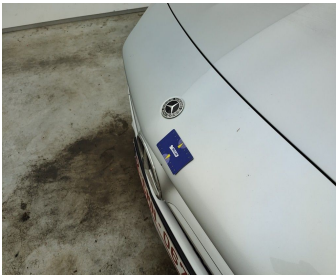
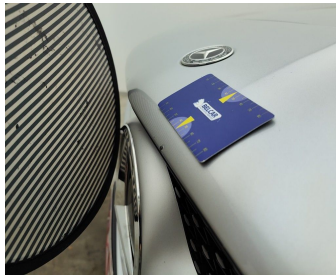
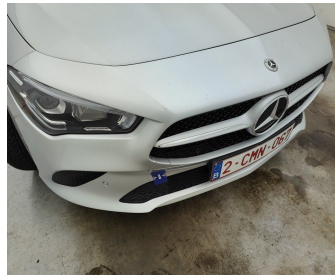
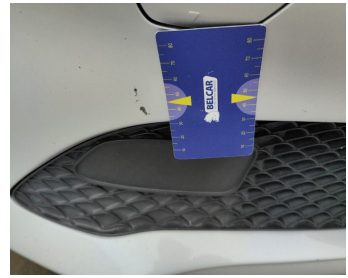
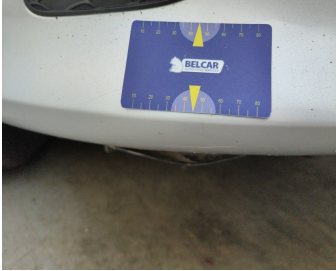
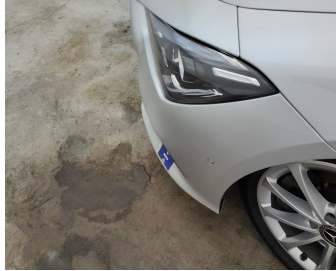
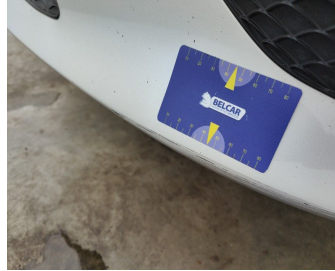
Bumper Front // Repair & Painting-scratch + dent

| Damages | Type | Acceptable |
|---|---|---|
| 14 | Bumper Front // Repair & Painting | N |

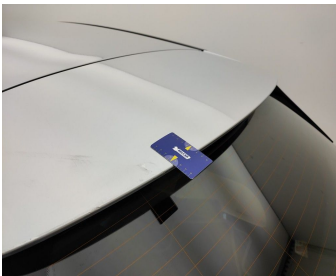
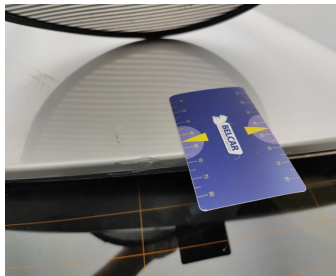
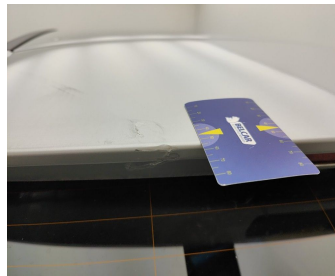
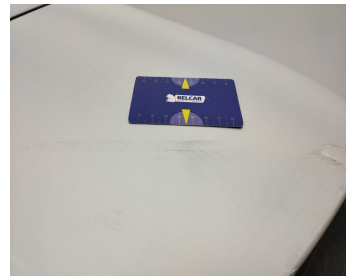
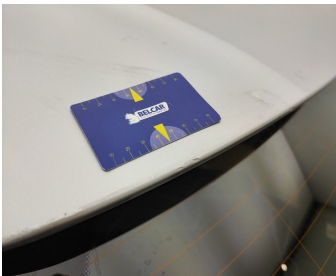
Rear Bonnet // Smart Repair Large-scratch + dent

| Damages | Type | Acceptable |
|---|---|---|
| 152 | Rear Bonnet // Smart Repair Large | N |

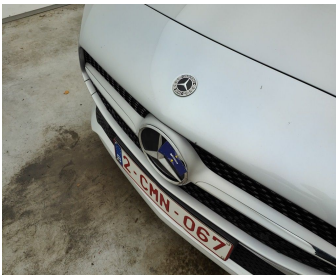
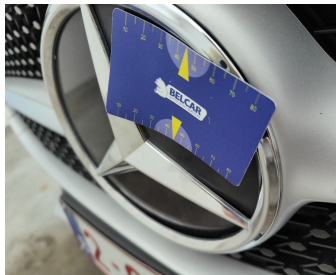
Front / Logo / Replace-cracked

| Damages | Type | Acceptable |
|---|---|---|
| 27 | Front / Logo / Replace | N |

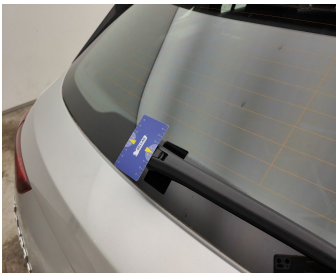
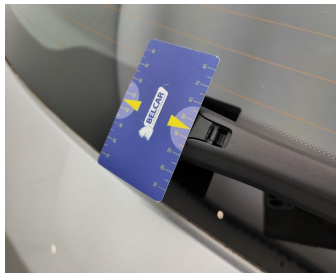
Back Side / Whiper Arm / Replace-cracked

| Damages | Type | Acceptable |
|---|---|---|
| 147 | Back Side / Whiper Arm / Replace | N |

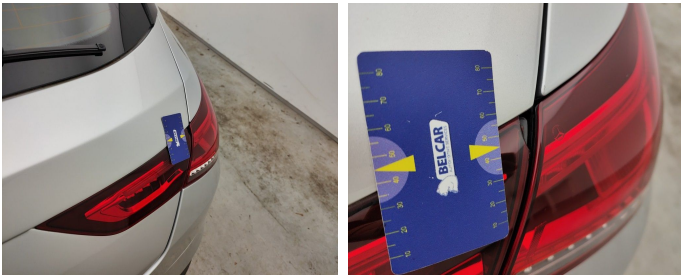
Light / Rear Right On Rear Bonnet / Replace-cracked

| Damages | Type | Acceptable |
|---|---|---|
| 175 | Light / Rear Right On Rear Bonnet / Replace | N |

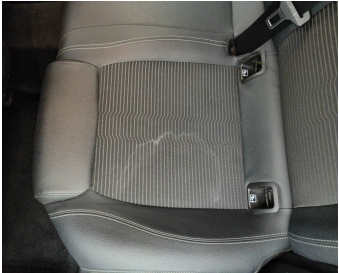
Interior Cleaning // Small-stain

| Damages | Type | Acceptable |
|---|---|---|
| 860 | Interior Cleaning // Small | N |

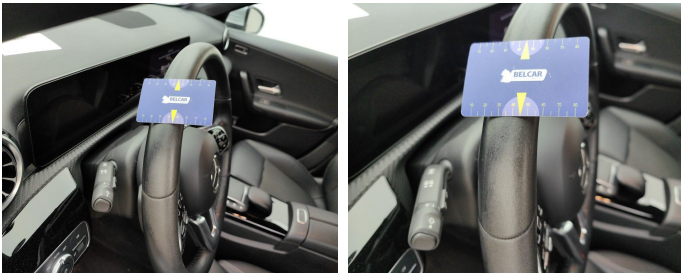
Dashboard / Steering Wheel / Replace-worn

| Damages | Type | Acceptable |
|---|---|---|
| 569 | Dashboard / Steering Wheel / Replace | Y |

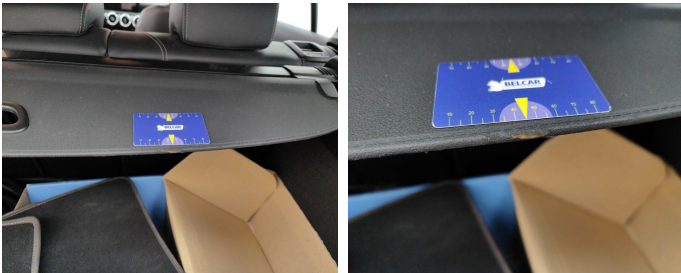
Trunk Compartment / Boot Cover / Replace-worn

| Damages | Type | Acceptable |
|---|---|---|
| 538 | Trunk Compartment / Boot Cover / Replace | Y |

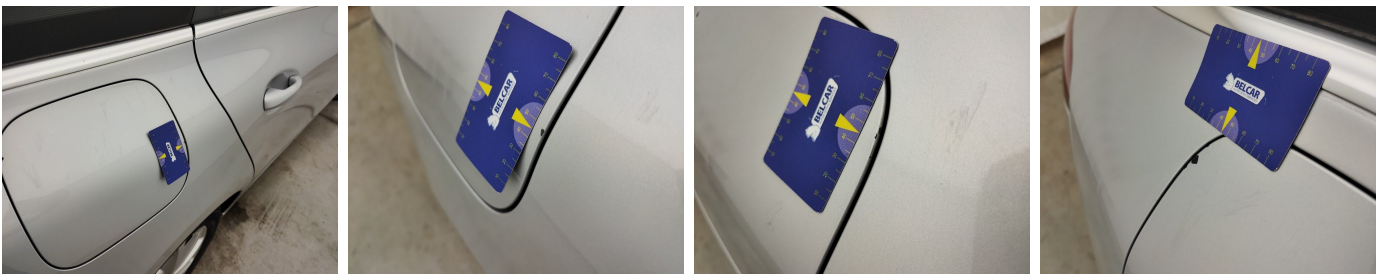
Wing Rear Right // Smart Repair Medium-stone chipping

| Damages | Type | Acceptable |
|---|---|---|
| 181 | Wing Rear Right // Smart Repair Medium | Y |

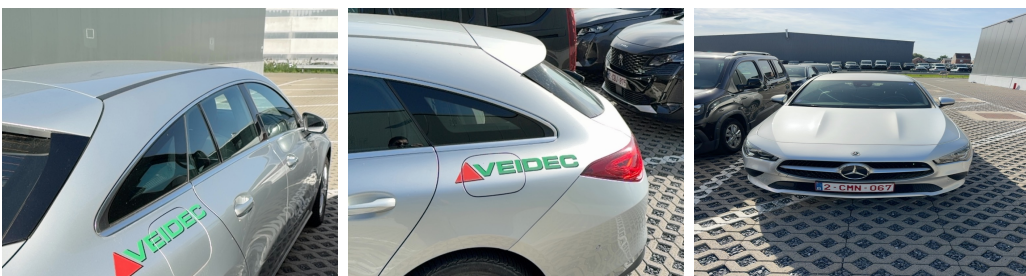
Lettering Removal 15min-Remainder stickers

| Damages | Type | Acceptable |
|---|---|---|
| 891 | Lettering Removal 15min | N |
