ARVAL
BNP PARIBAS GROUP

INSPECTION REPORT

End of contract

File	306479
License plate	2AGC501
Vehicle identification number	W1K2050141R618651
Dossier	2020 118 067
Make	Mercedes C 220 d 143kW Aut.
Mileage	143187
First registration	24/03/2021
client availability date	09/03/2026
inspectionDate	11/03/2026

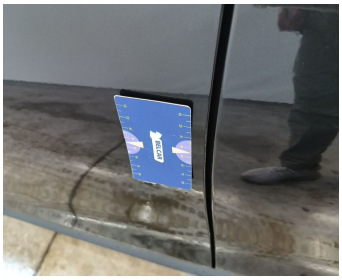
Damage within Renta-norm-

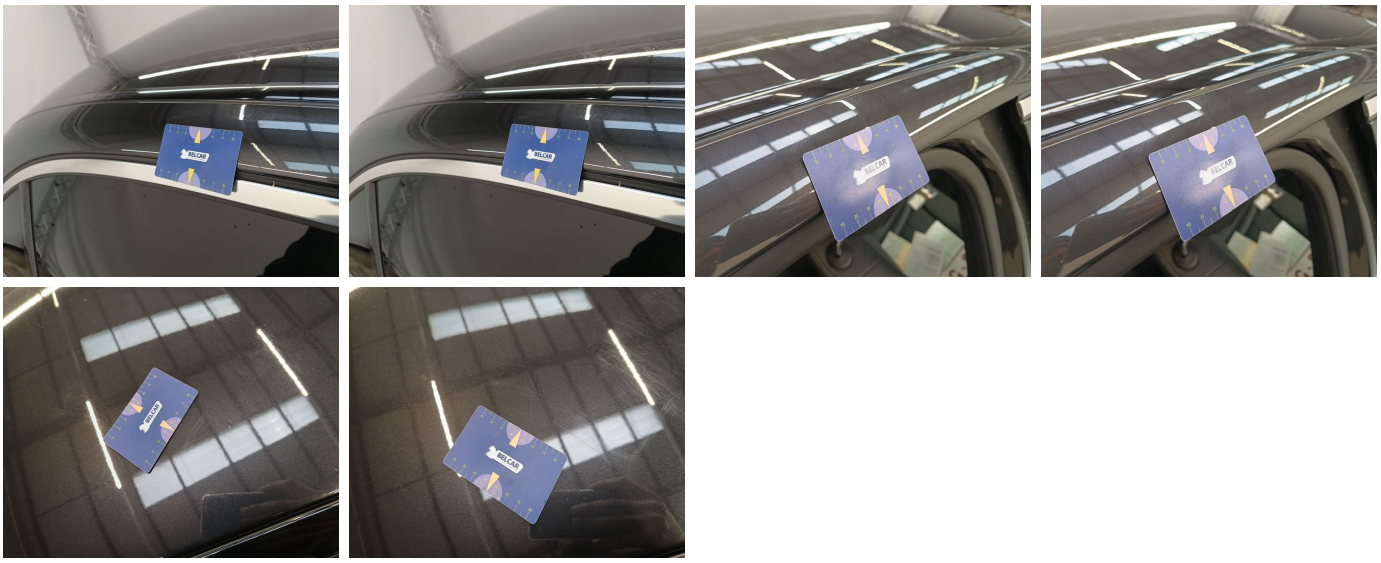
Wheel Two Tone Rear Left // Repair-scratch

Door Rear Right // Repair & Painting-scratch + dent

Bumper Front // Repair & Painting-scratch + dent

Seat Front Left / Bottom Coating / Replace-Incinerated

Wheel Two Tone Front Right // Repair-scratch

Wheel Two Tone Rear Right // Repair-scratch

Bumper Rear // Painting-scratch

Wheel Two Tone Front Left // Repair-scratch

Roof // Polish-scratch

Side View Mirror Right // Painting-scratch

Side View Mirror Right / Direction Indicator / Replace-scratch
