ARVAL
BNP PARIBAS GROUP

2AEX580

INSPECTION REPORT

End of contract

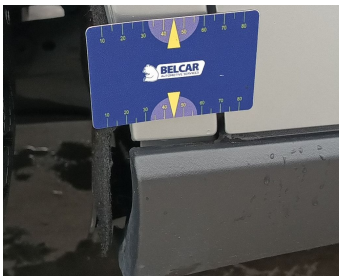
Rocker Panel Right / Cover Not Painted / Replace-cracked

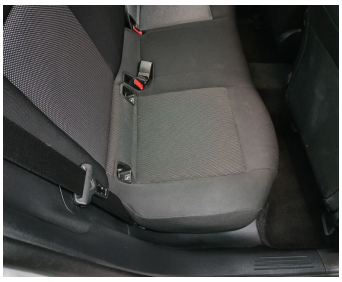
Interior Cleaning // Small-stain

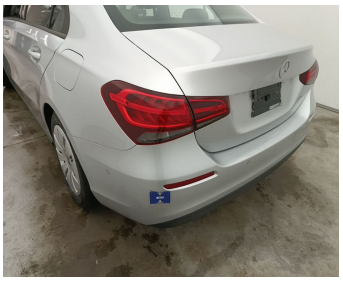
Bumper Rear // Painting-scratch
