**2BFD517**

# INSPECTION REPORT

**End of contract**

| Make | Hyundai Ioniq 1.6GDi Hybride F |

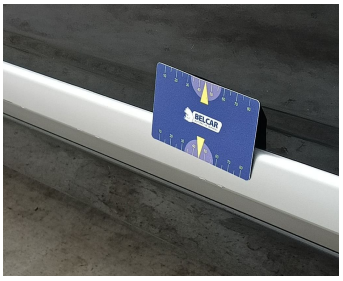
Bumper Front / Spoiler / Replace-stone chipping

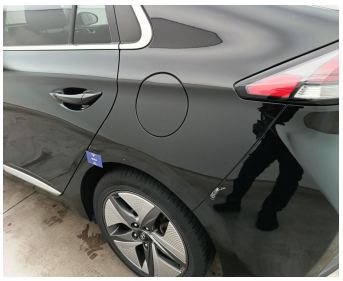
Bumper Rear // Repair & Painting-scratch + dent
