ARVAL
BNP PARIBAS GROUP

2ACB705

INSPECTION REPORT

End of contract

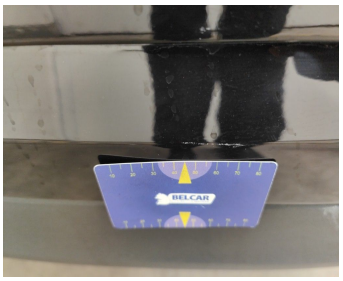
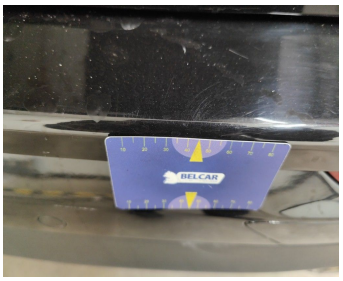
Damage within Renta-norm-scratch

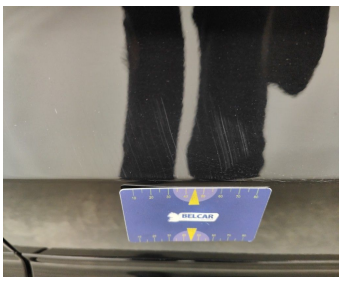
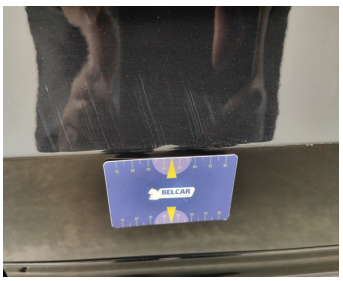
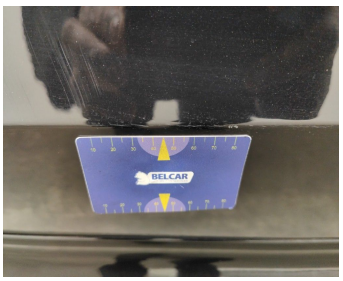
Bumper Rear // Polish-scratch
