# INSPECTION REPORT

End of contract

| License plate | 1YVA117 |
| Make | Opel Comb.1.5D 55kW 2.0T L1H1 |

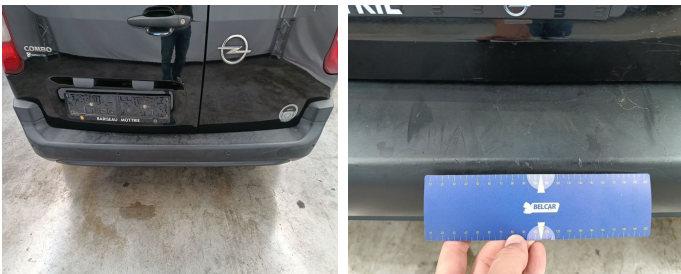
| Damages | Type | Acceptable |
|---|---|---|
| 137 | Bumper Rear // Replace without painting | Y |

Bumper Rear // Replace without painting-scratch

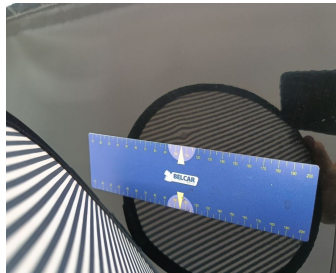
| Damages | Type | Acceptable |
|---|---|---|
| 194 | Door Rear Right // Repair & Painting | N |

Door Rear Right // Repair & Painting-scratch

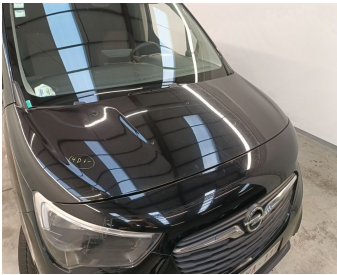
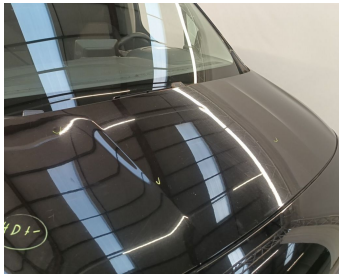
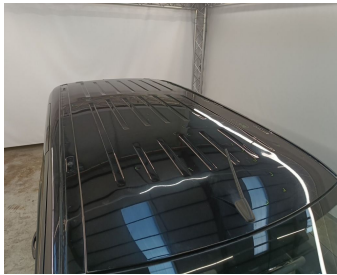
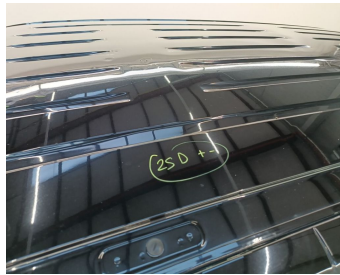
| Damages | Type | Acceptable |
|---|---|---|
| 801 | See External Expertise | N |

See External Expertise-
