# INSPECTION REPORT

**End of contract**

| License plate | 2AAM247 |
| Make | Opel Comb.1.5D 75kW 2.3T L2H1 |

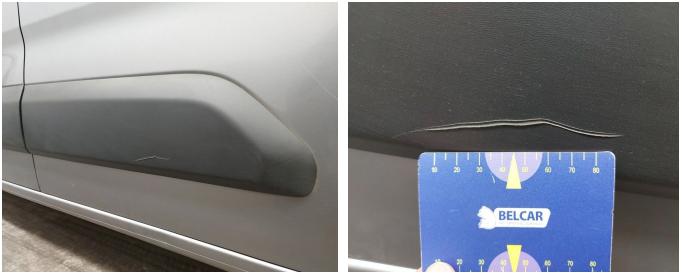
| Damages | Type | Acceptable |
|---|---|---|
| 107 | Door Rear Left / Trim / Replace | Y |

Door Rear Left / Trim / Replace-scratch
