# INSPECTION REPORT

**End of contract**

| License plate | 2ACK832 |
| Make | Opel Viv.TD 90kW 29 L3H1 Edit. |

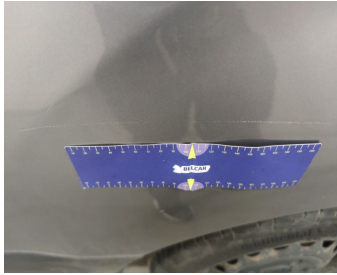
| Damages | Type | Acceptable |
|---|---|---|
| 183 | Wing Rear Right // Painting | Y |

Wing Rear Right // Painting-scratch

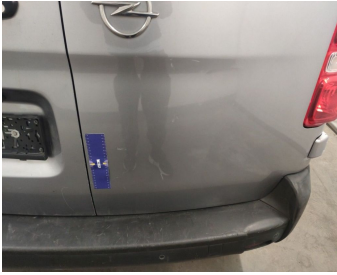
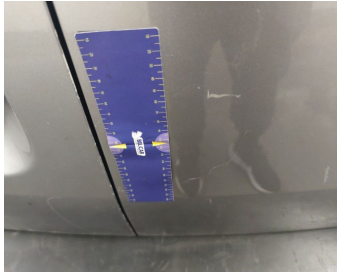
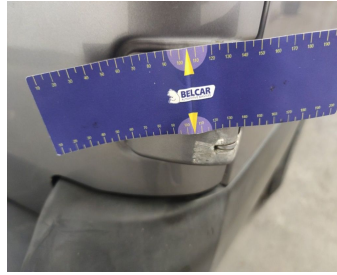
| Damages | Type | Acceptable |
|---|---|---|
| 303 | Rear Loading Door Right // Painting | N |

Rear Loading Door Right // Painting-scratch
