# INSPECTION REPORT

**End of contract**

| License plate | PR9020 |
| Make | Peugeot 5008 1.5Hdi 130 GT Pac |

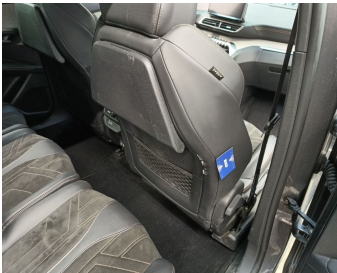
| Damages | Type | Acceptable |
|---|---|---|
| 423 | Seat Front Right / Rear Coating / Replace | N |

Seat Front Right / Rear Coating / Replace-tear

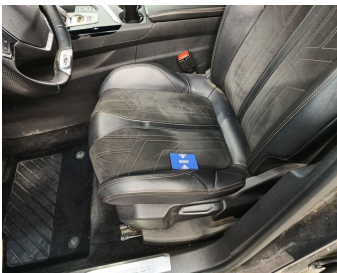
| Damages | Type | Acceptable |
|---|---|---|
| 412 | Seat Front Left / Bottom Coating / Replace | Y |

Seat Front Left / Bottom Coating / Replace-worn
