# INSPECTION REPORT

**End of contract**

| License plate | 1XNS467 |
| Make | Mercedes A Berline 180 d Bus.S |

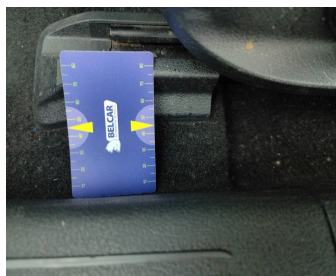
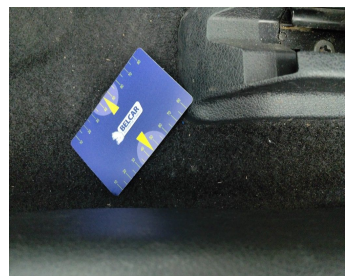
| Damages | Type | Acceptable |
|---|---|---|
| 544 | Interior / Floor Covering / Replace | N |

Interior / Floor Covering / Replace-Incinerated
