INSPECTION REPORT

End of contract

File	306687
License plate	1YVR863
Vehicle identification number	W1N2533111F908768
Dossier	2020 274 027
Make	Mercedes GLC Coupé 300de 4M
Mileage	92404
First registration	05/01/2021
client availability date	04/03/2026
inspectionDate	09/03/2026

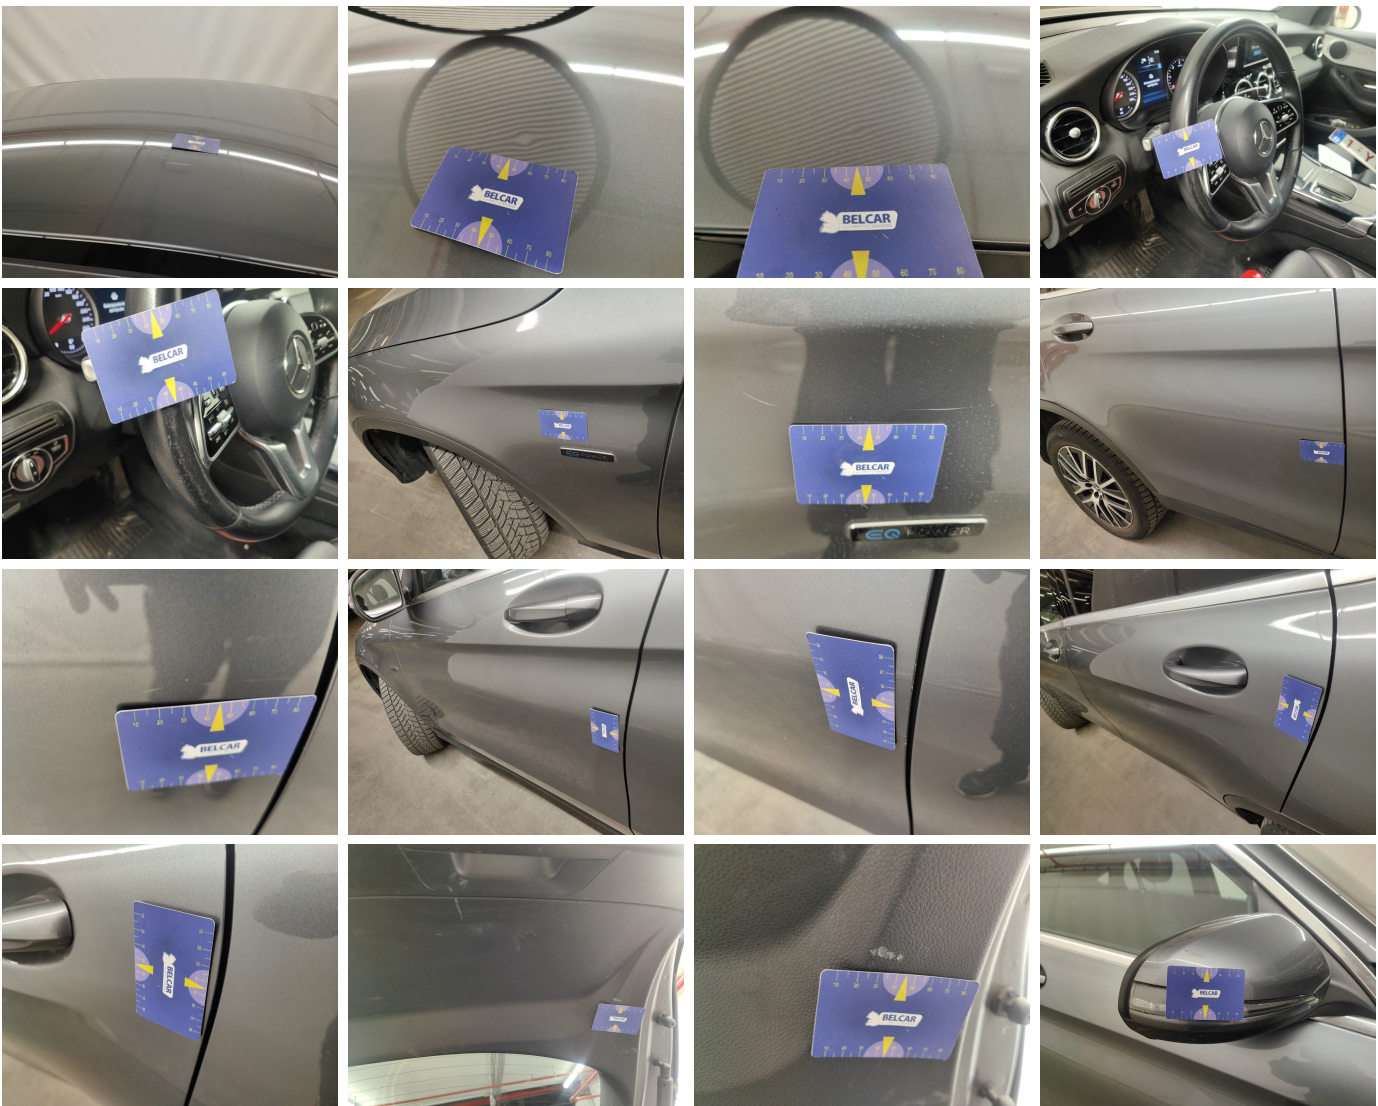
Damage Pictures

Damages	Type	Acceptable
32	Front Bonnet // Painting	N
78	Side View Mirror Left / Direction Indicator / Replace	N
91	Rocker Panel Left // Smart Repair Medium	N
116	Wing Rear Left // Polish	Y
228	Side View Mirror Right / Direction Indicator / Replace	N
340	Wheel Two Tone Front Right // Repair	N
421	Seat Front Right // Repair	N
