# INSPECTION REPORT

**End of contract**

| License plate | 2ATV828 |
| Make | Hyundai Tuc.TGD <sup>i</sup> PHEV 195kW 4x |

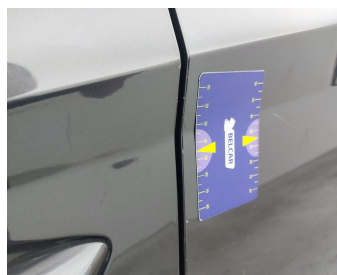
| Damages | Type | Acceptable |
|---|---|---|
| 103 | Door Rear Left // Painting | N |

Door Rear Left // Painting-scratch
