INSPECTION REPORT

End of contract

| License plate | XY4778 |
| Make | Peugeot 2008 1.2 PT 130 Allure |

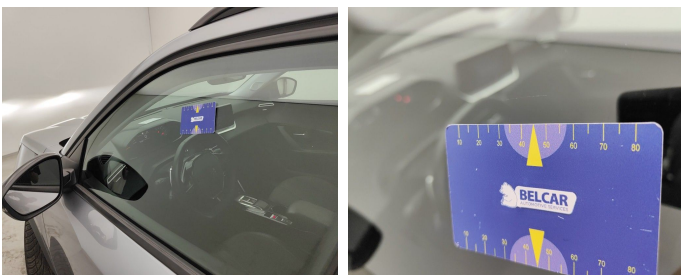
| Damages | Type | Acceptable |
|---|---|---|
| 89 | Door Front Left / Window / Replace | Y |

Door Front Left / Window / Replace-scratch
