# INSPECTION REPORT

**End of contract**

| License plate | 2BSH914 |
| Make | Peugeot 5008 1.5BHDi 96kW Allu |

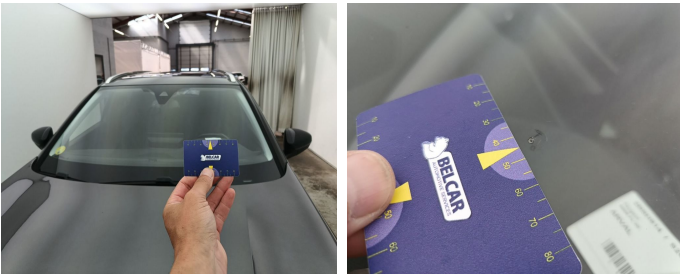
Windshield // Replace-glass damage

| Damages | Type | Acceptable |
|---|---|---|
| 41 | Windshield // Replace | N |

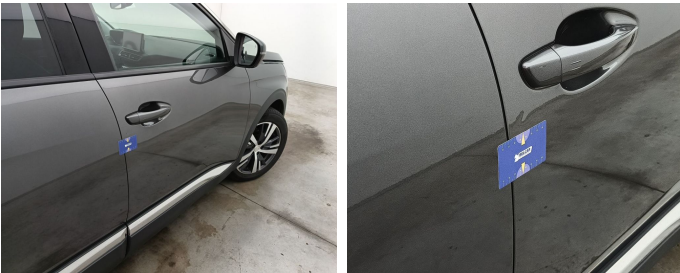
Door Front Right // Smart Repair Small-dent

| Damages | Type | Acceptable |
|---|---|---|
| 210 | Door Front Right // Smart Repair Small | Y |

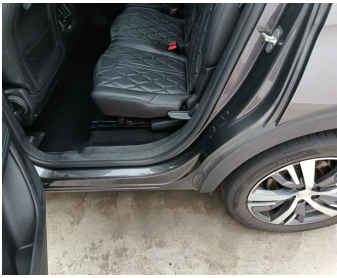
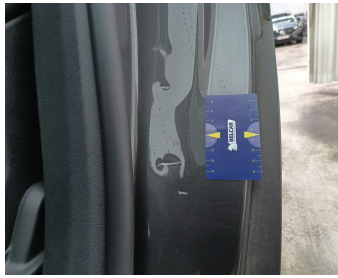
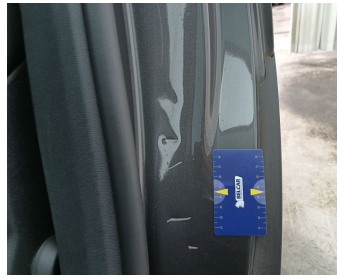
Rocker Panel Left // Smart Repair Medium-scratch + dent

| Damages | Type | Acceptable |
|---|---|---|
| 91 | Rocker Panel Left // Smart Repair Medium | N |

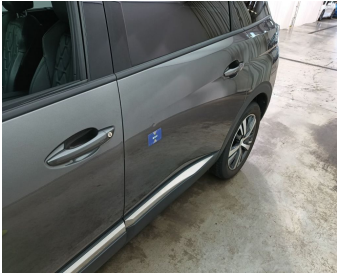
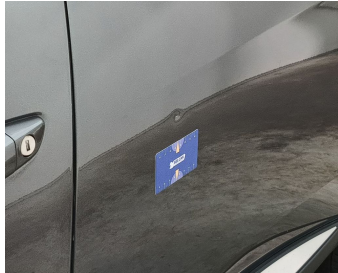
Door Rear Left // Smart Repair Small-scratch + dent

| Damages | Type | Acceptable |
|---|---|---|
| 100 | Door Rear Left // Smart Repair Small | N |

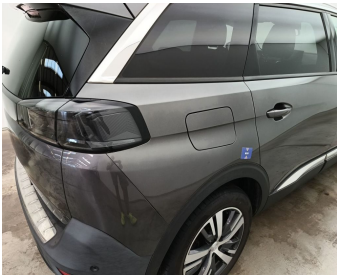
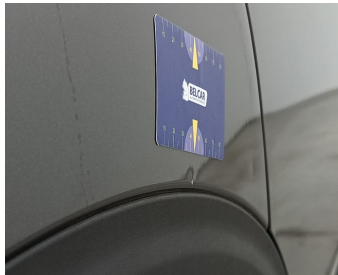
Wing Rear Right // Smart Repair Medium-scratch + dent

| Damages | Type | Acceptable |
|---|---|---|
| 181 | Wing Rear Right // Smart Repair Medium | N |

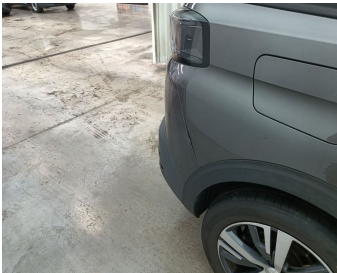
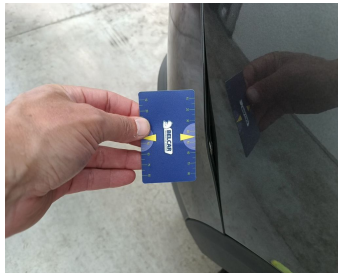
Bumper Rear // Replace & Painting-cracked

| Damages | Type | Acceptable |
|---|---|---|
| 135 | Bumper Rear // Replace & Painting | N |

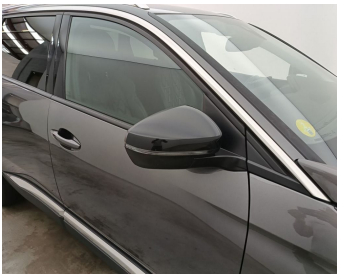
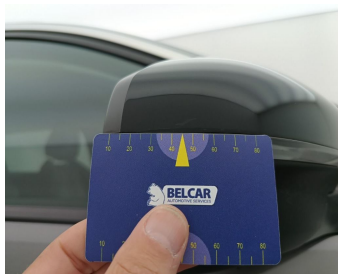
Side View Mirror Right // Polish-scratch

| Damages | Type | Acceptable |
|---|---|---|
| 225 | Side View Mirror Right // Polish | Y |

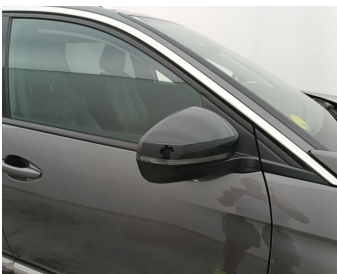
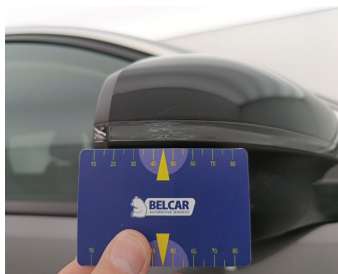
Side View Mirror Right / Direction Indicator / Replace-scratch

| Damages | Type | Acceptable |
|---|---|---|
| 228 | Side View Mirror Right / Direction Indicator / Replace | N |

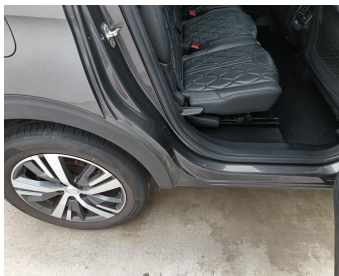
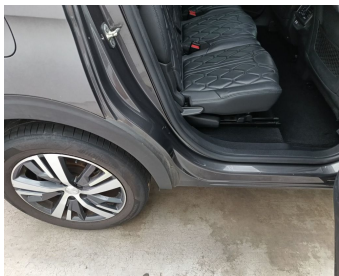
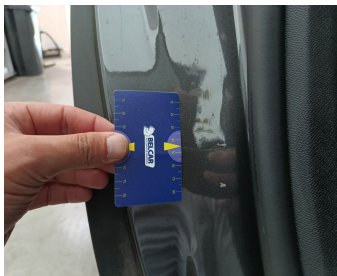
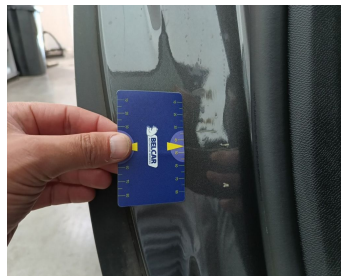
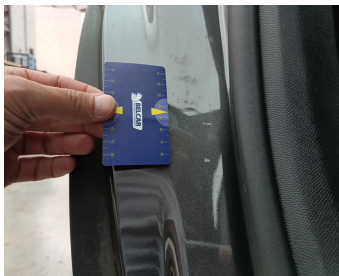
Rocker Panel Right // Smart Repair Medium-scratch

| Damages | Type | Acceptable |
|---|---|---|
| 201 | Rocker Panel Right // Smart Repair Medium | Y |

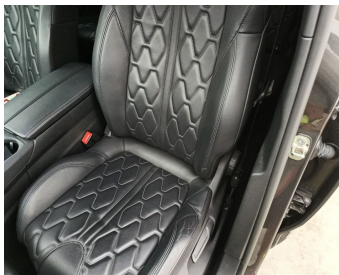
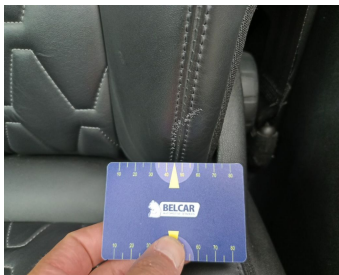
Seat Front Left / Rear Coating / Replace-scratch

| Damages | Type | Acceptable |
|---|---|---|
| 413 | Seat Front Left / Rear Coating / Replace | Y |

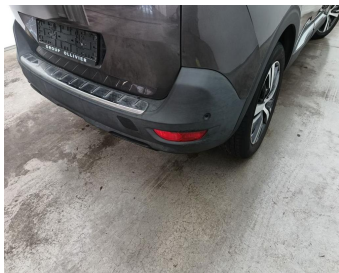
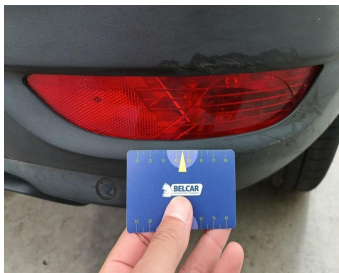
Bumper Rear / Lower Cover Not Painted / Replace-scratch

| Damages | Type | Acceptable |
|---|---|---|
| 138 | Bumper Rear / Lower Cover Not Painted / Replace | N |

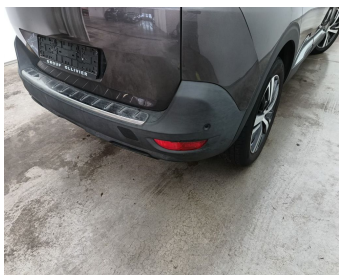
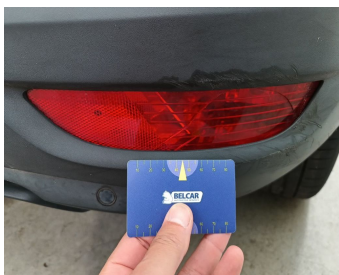
Back Side / Reflector R / Replace-cracked

| Damages | Type | Acceptable |
|---|---|---|
| 148 | Back Side / Reflector R / Replace | N |
