# INSPECTION REPORT

**End of contract**

| License plate | 2CKP469 |
| Make | Seat Leon 1.0eTSI 110 Move! DS |

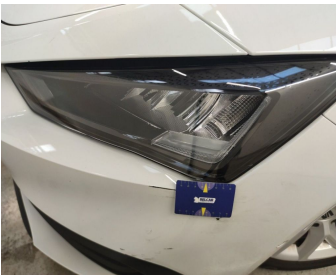
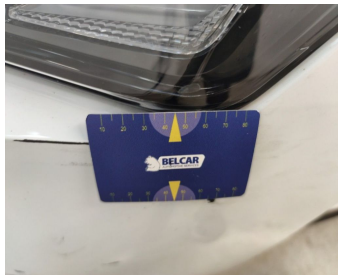
Headlight / Front left / Replace-scratch

| Damages | Type | Acceptable |
|---|---|---|
| 54 | Headlight / Front left / Replace | Y |

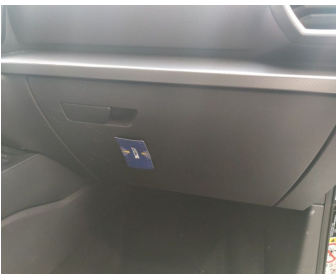
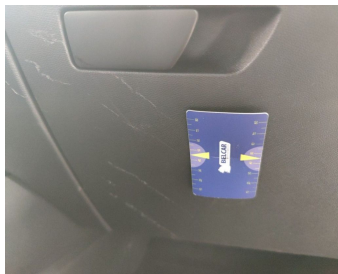
Dashboard / Storage Tray / Replace-scratch

| Damages | Type | Acceptable |
|---|---|---|
| 565 | Dashboard / Storage Tray / Replace | N |

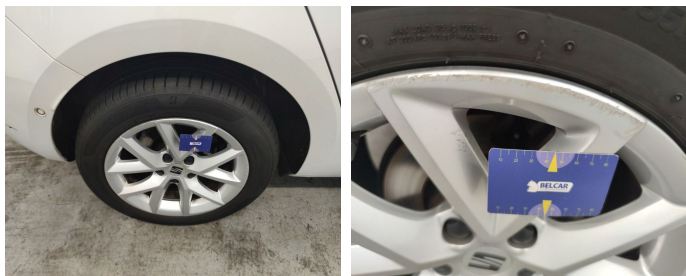
Wheel Alloy Rear Right // Repair-scratch

| Damages | Type | Acceptable |
|---|---|---|
| 331 | Wheel Alloy Rear Right // Repair | N |

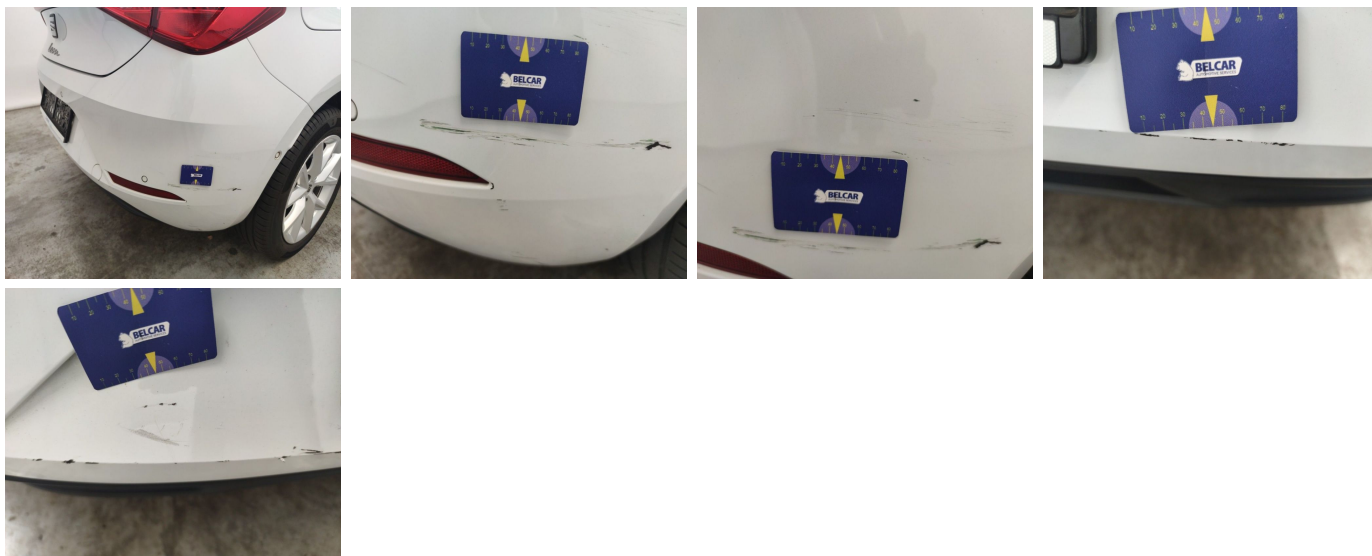
Bumper Rear // Painting-scratch

| Damages | Type | Acceptable |
|---|---|---|
| 133 | Bumper Rear // Painting | N |

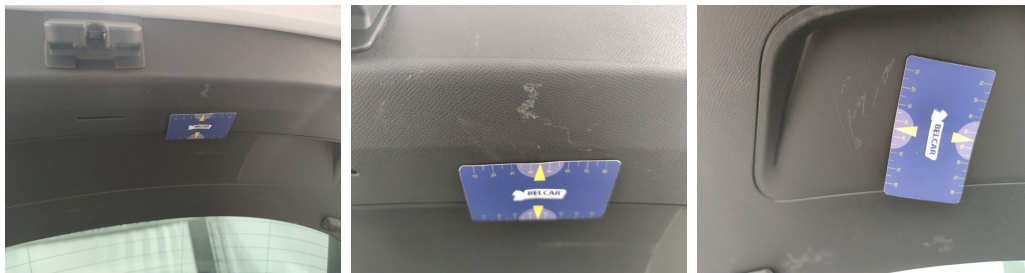
Trunk Lid Interior Coating / Complete Panel / Replace-scratch

| Damages | Type | Acceptable |
|---|---|---|
| 594 | Trunk Lid Interior Coating / Complete Panel / Replace | N |

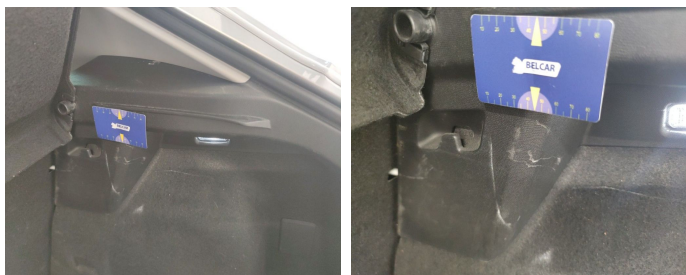
Trunk Compartment / Side Cover Right / Replace-scratch

| Damages | Type | Acceptable |
|---|---|---|
| 533 | Trunk Compartment / Side Cover Right / Replace | N |

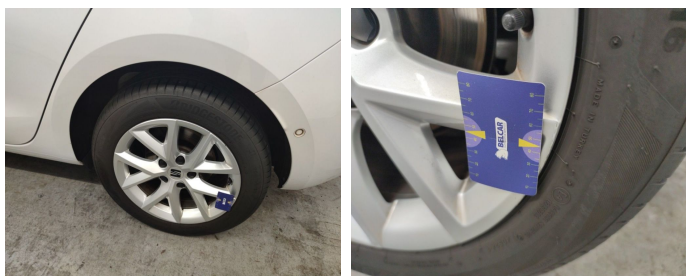
Wheel Alloy Rear Left // Repair-scratch

| Damages | Type | Acceptable |
|---|---|---|
| 321 | Wheel Alloy Rear Left // Repair | Y |

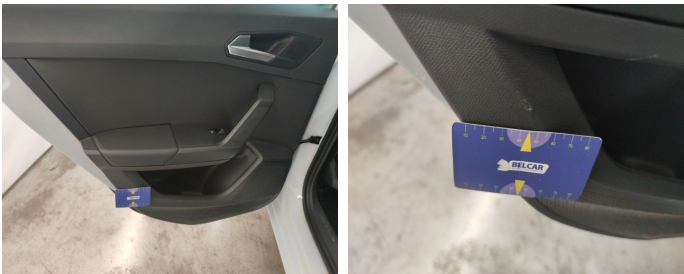
Interior // Repair 1-scratch

| Damages | Type | Acceptable |
|---|---|---|
| 540 | Interior // Repair 1 | N |

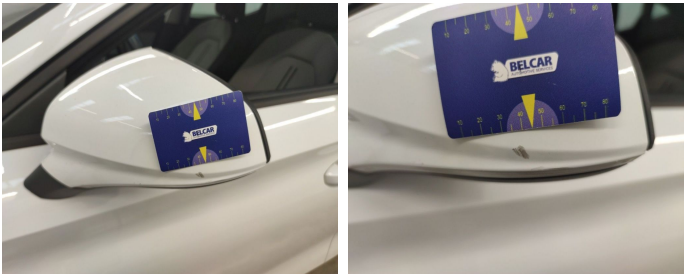
Side View Mirror Left // Painting-scratch

| Damages | Type | Acceptable |
|---|---|---|
| 72 | Side View Mirror Left // Painting | Y |

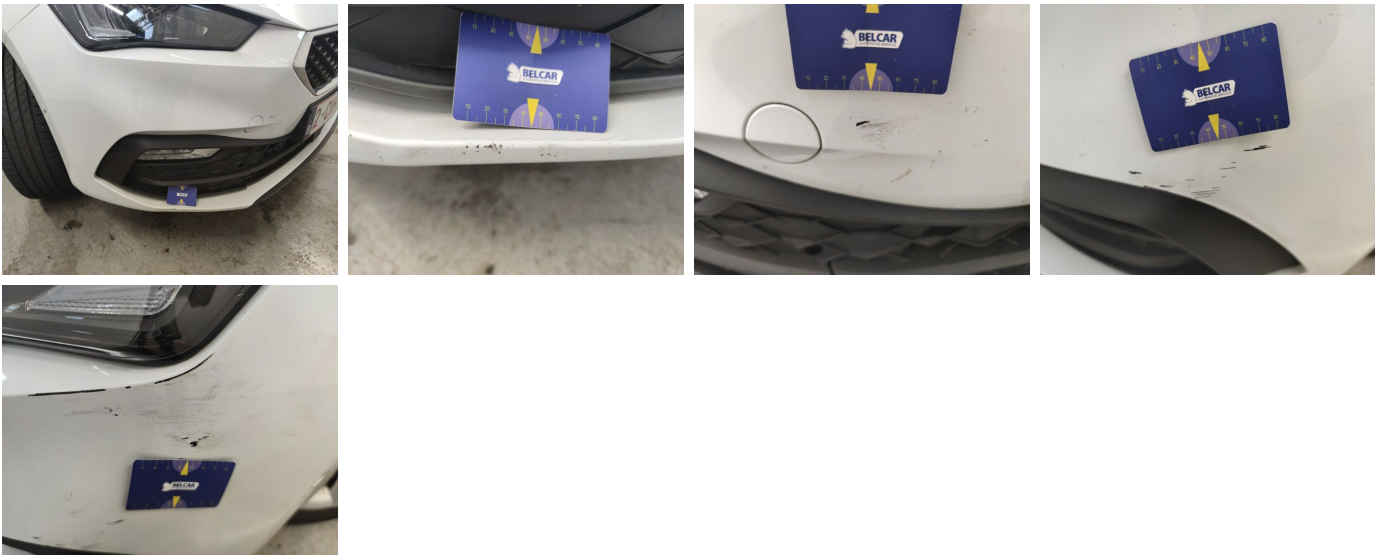
Bumper Front // Painting-scratch

| Damages | Type | Acceptable |
|---|---|---|
| 13 | Bumper Front // Painting | N |

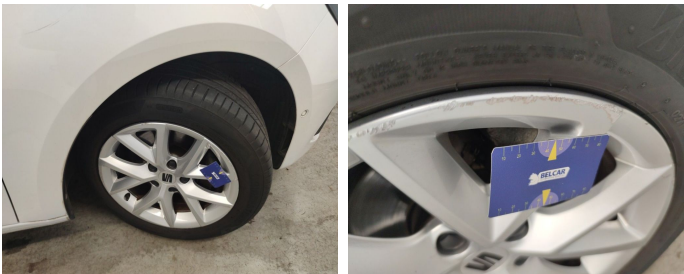
Wheel Alloy Front Right // Repair-scratch

| Damages | Type | Acceptable |
|---|---|---|
| 341 | Wheel Alloy Front Right // Repair | N |

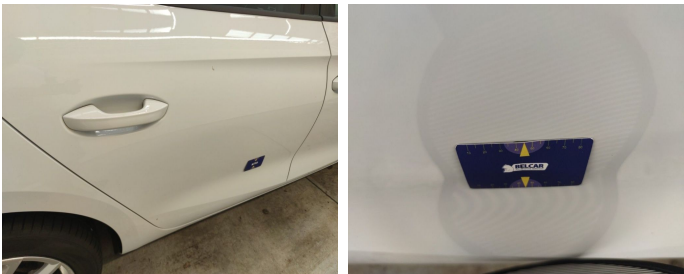
Door Rear Right // Smart Repair Small-dent

| Damages | Type | Acceptable |
|---|---|---|
| 190 | Door Rear Right // Smart Repair Small | Y |

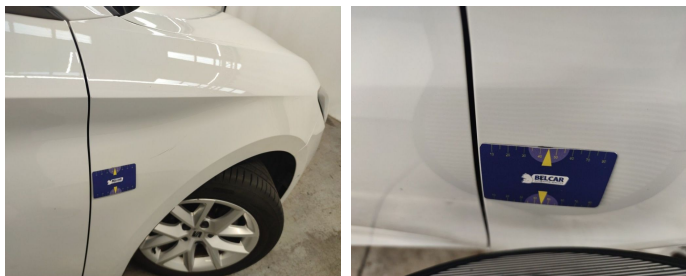
Wing Front right // Smart Repair Small-dent

| Damages | Type | Acceptable |
|---|---|---|
| 230 | Wing Front right // Smart Repair Small | Y |

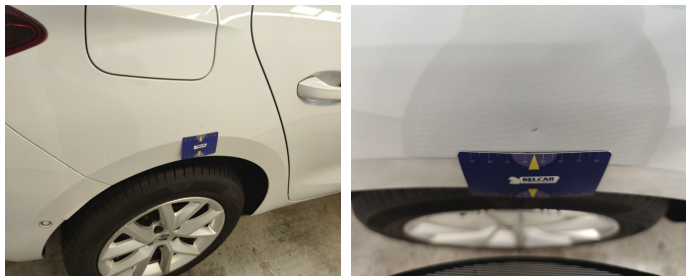
Wing Rear Right // Repair & Painting-scratch + dent

| Damages | Type | Acceptable |
|---|---|---|
| 184 | Wing Rear Right // Repair & Painting | N |

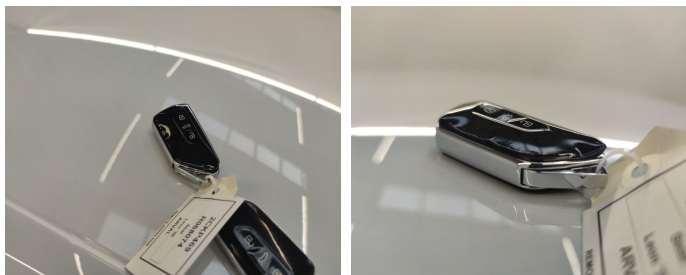
Key Price Range 2 //-bad repair

| Damages | Type | Acceptable |
|---|---|---|
| 883 | Key Price Range 2 // | N |

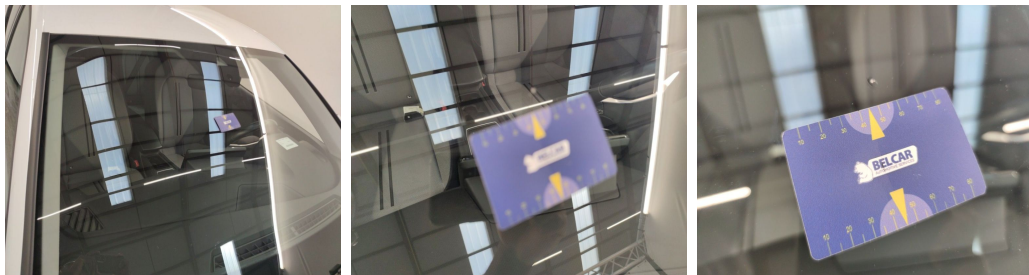
Windshield // Repair-cracked

| Damages | Type | Acceptable |
|---|---|---|
| 40 | Windshield // Repair | Y |

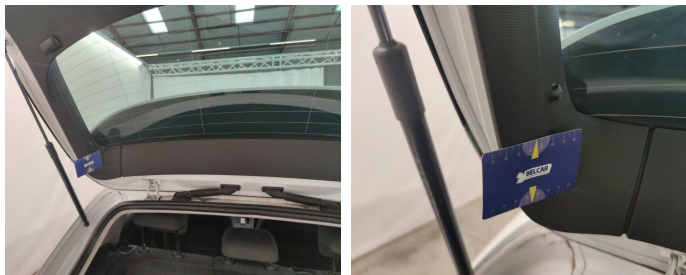
Trunk Compartment // Repair-cracked

| Damages | Type | Acceptable |
|---|---|---|
| 531 | Trunk Compartment // Repair | N |
