INSPECTION REPORT

End of contract

File	307187
License plate	2ASW159
Vehicle identification number	VR3FCYHZTMY510141
Dossier	2021 075 172
Make	Peugeot 508SW 1.5 BHDi Allure
Mileage	188240
First registration	05/07/2021
client availability date	03/03/2026
inspectionDate	24/03/2026

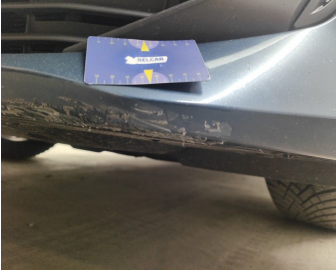
Bumper Front // Repair & Painting-scratch + dent

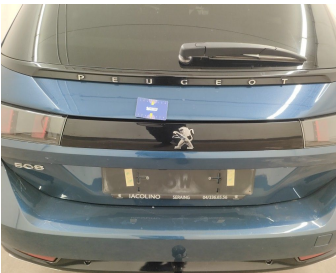
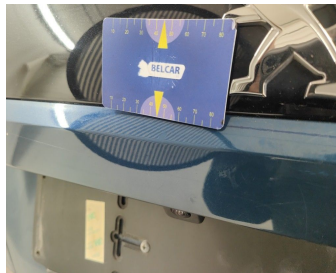
Rear Bonnet // Painting-bad repair

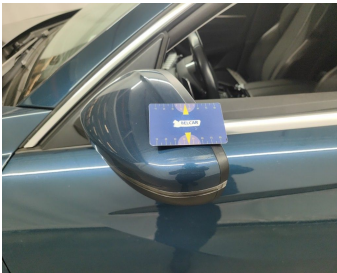
Side View Mirror Left // Painting-scratch
