INSPECTION REPORT

End of contract

| License plate | 1XNV675 |
| Make | Peugeot 3008 1.5BHdi 96kW Allu |

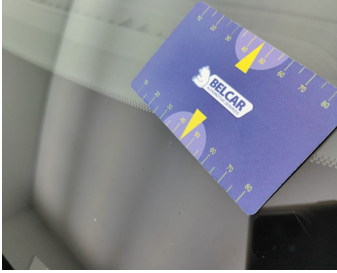
Windshield // Repair-scratch

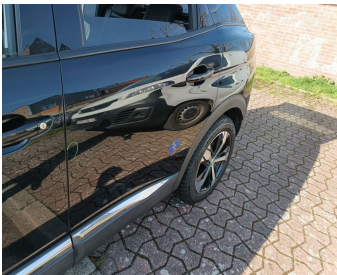
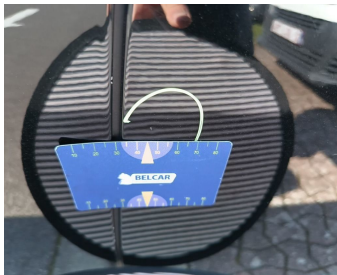
Door Rear Left // Painting-scratch + dent

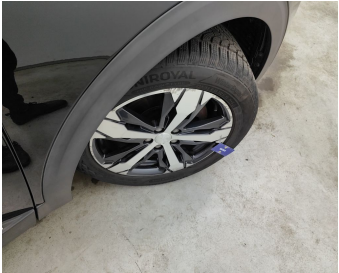
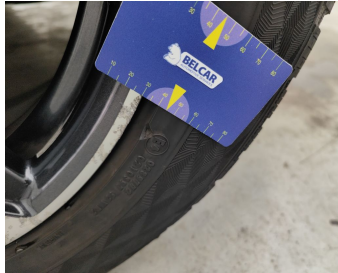
Tyre Front Right // Replace-tear

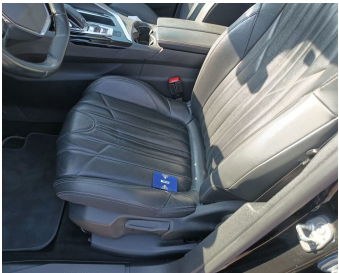
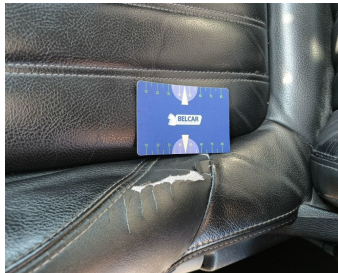
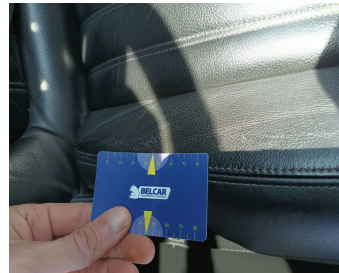
Seat Front Left / Complete Coating / Replace-worn

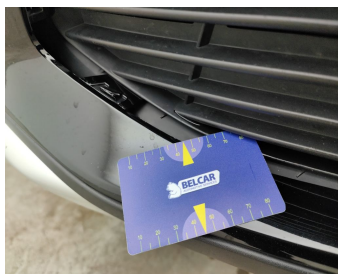
Bumper Front / Grid Left / Replace-bad position

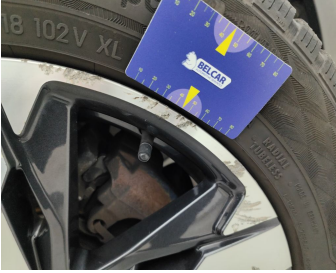
Wheel Two Tone Front Right // Repair-scratch

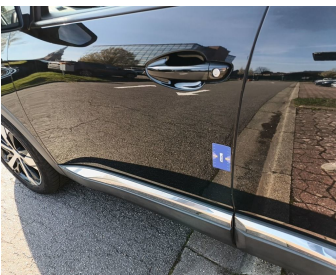
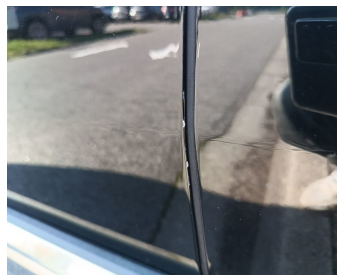
Door Front Left // Smart Repair Small-scratch

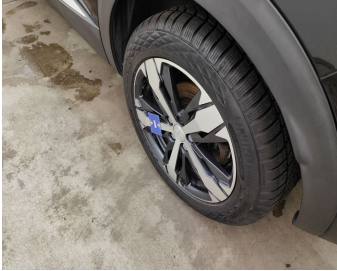
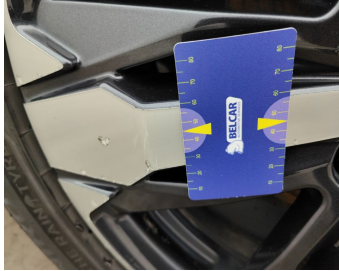
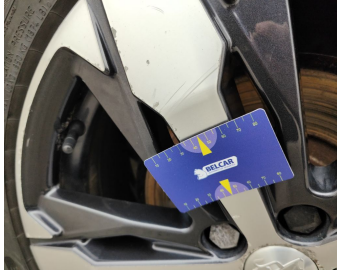
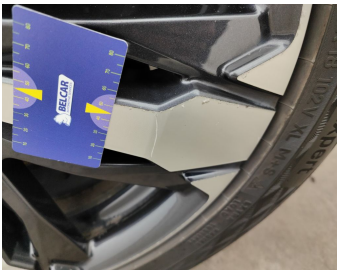
Wheel Two Tone Rear Left // Repair-scratch

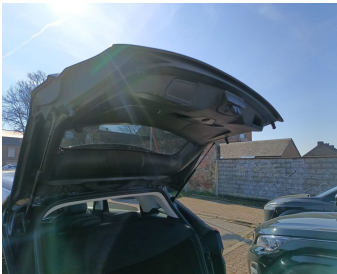
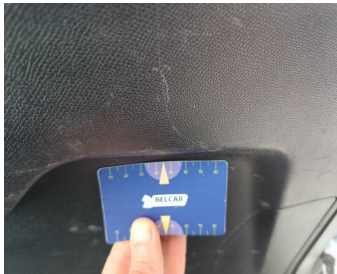
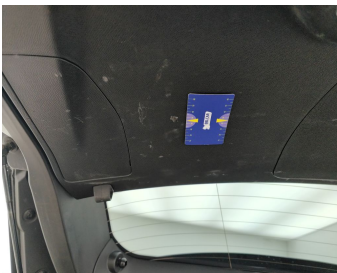
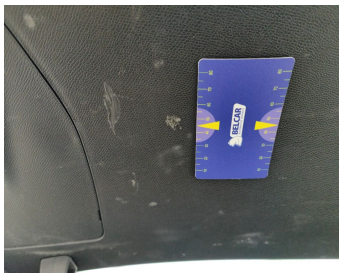
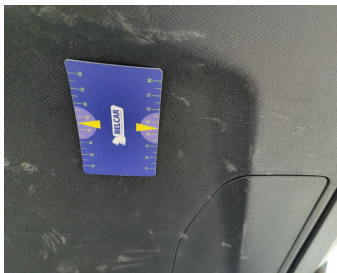
Trunk Lid Interior Coating / Complete Panel / Replace-scratch

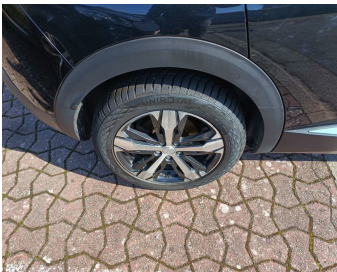
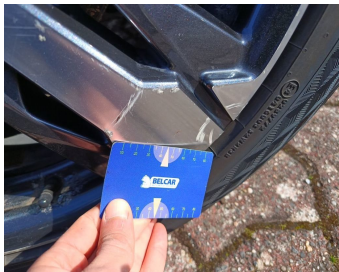
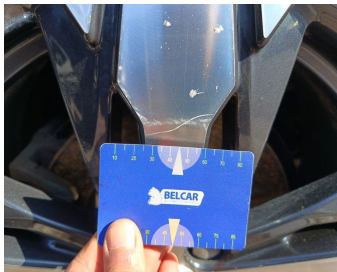
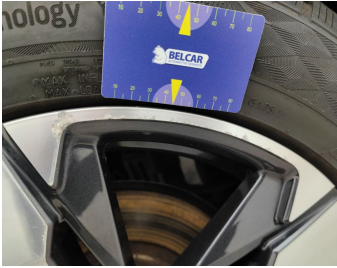
Wheel Two Tone Rear Right // Repair-scratch
